Survey No.LEL-7-23-2019

July 23, 2019

C/V Valuation Survey of Hopper Barge Vessel "PTC-550" Official No.1177301  
At your request, I inspected the above barge afloat in the Hudson River at the Troy wall,  
Troy, N.Y.

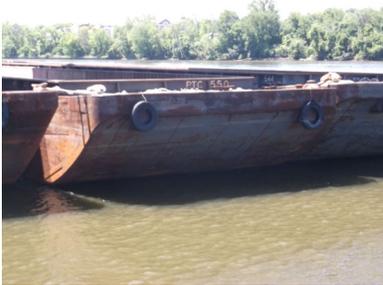
Bow rake afloat at Troy wall, Troy, NY

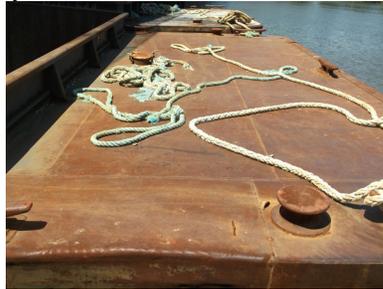
Coatings of bow deck area approximately failed 90%

Bow deck

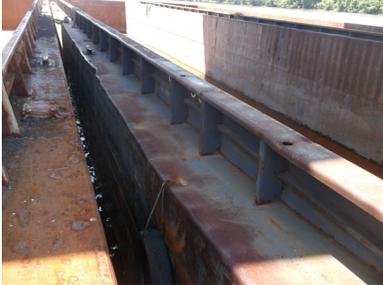
Starboard deck, hullside and bin wall

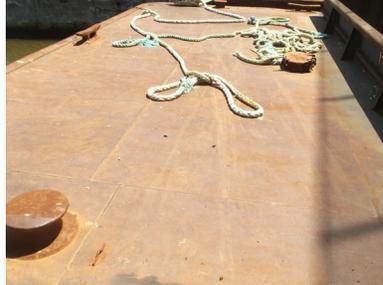
Coatings of stern deck area approximately failed 90%

Stern deck,

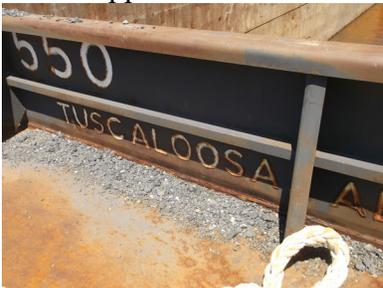
Stern hopper wall

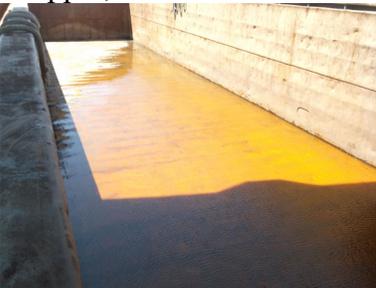
Hopper, water 4-6" at stern

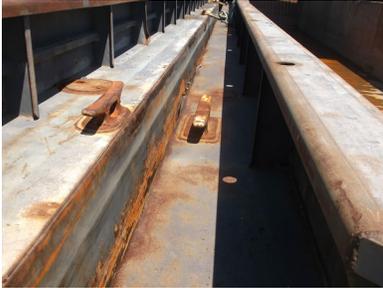
Port and starboard side shell plating waved and set in 0- 1 1/2" between frames.

Port side, hull, bin wall, deck

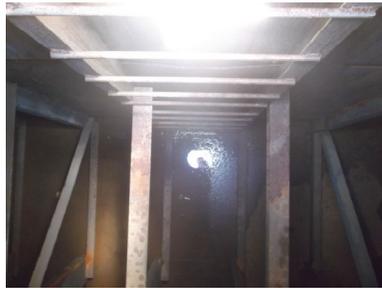
Coatings in void spaces viewed failed 90%, moderate rust, water in stern void appx. 2-3' voids 2,3,4,5 apprx 1-3' standing water, bow rake dry. All manhole covers are serviceable, gasketed and are equipped with strongbacks. Barge sits 2' lower in stern than bow waterline, no list observed port to starboard. No holes observed at shell plating observed.

Stern ladder, framing, standing water

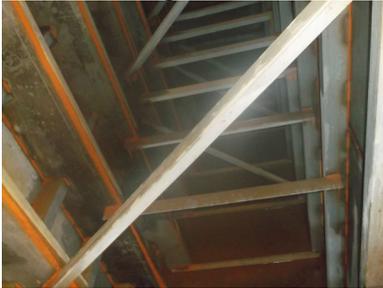
Stern framing

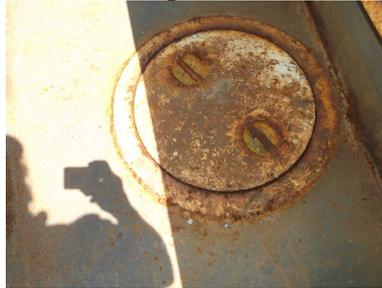
Port midship, flush manhole

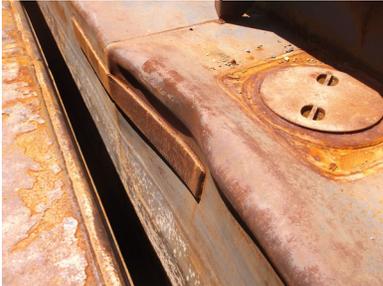
Several heavy indents Port & Strbrd at deck edges (see pic's)

Strbrd deck heavy indent

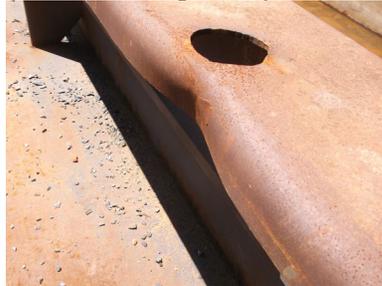
Bin wall top heavy indent

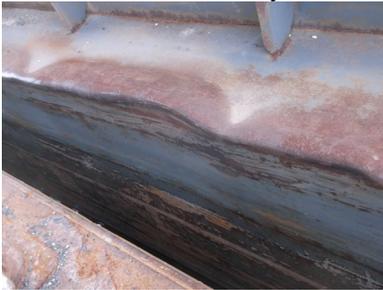
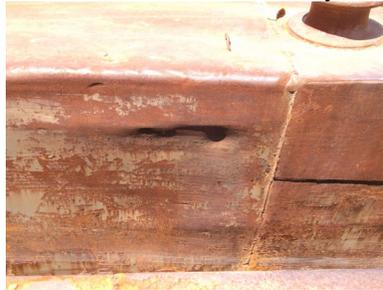
Starboard deck, heavy indent 1-3”      Strbrd hullside, heavy indent

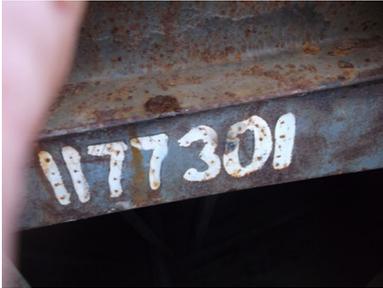
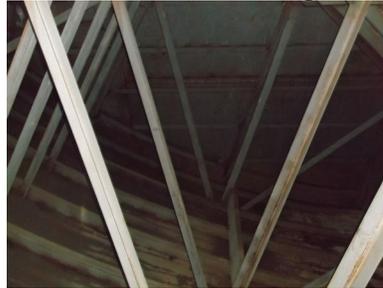
Official No. 1177301, bow manhole      Bow rake framing

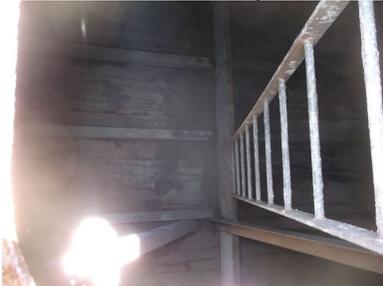
Bow rake ladder, dry

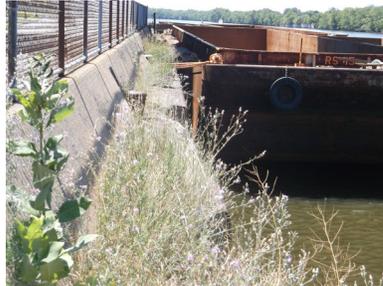
Fleeting area access
