Inspection Report

Property Address:
552 Colonial Ave
Souderton Pa 18964

A1 House Prep LLC and Inspections

Date: 04/14/20	Time: 11:00 AM	Report ID: 6824 Matthew Missimer
Property: 552 Colonial Ave Souderton Pa 18964	Customer: Matthew Missimer	Real Estate Professional: Lon Clemmer Sanford Alderfer Real Estate

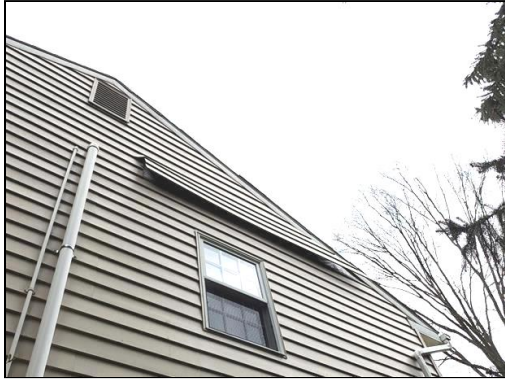
2.0 Item 1(Picture)

🏠 (1) Loose siding at the right and left side of the house. Recommend to secure siding as needed by a qualified professional.

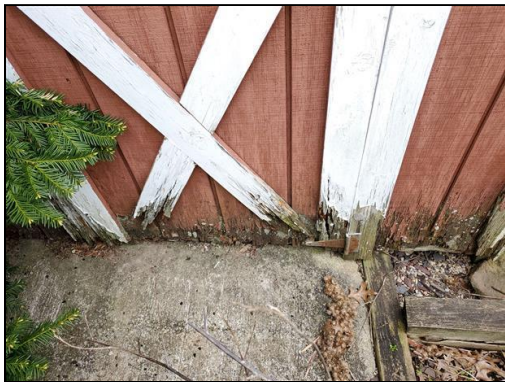
2.0 Item 4(Picture)

🏠 (2) Deteriorated wood siding at the bottom of shed and interior walls. Recommend to repair or replace deteriorated wood as needed by a qualified person or professional.

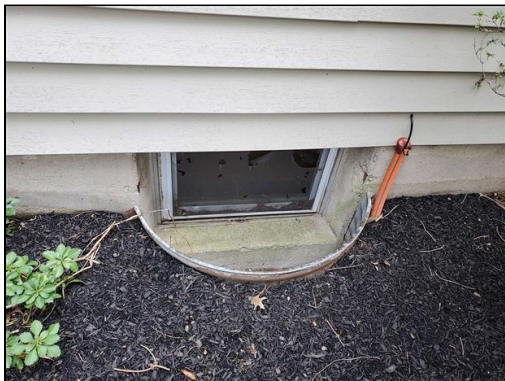
2.1 Item 1(Picture)

📌 Missing a window well covers. Suggest to install clear plastic well covers over window wells to prevent potential well saturation which could overflow window sill and spill into the basement. **This is considered optional.**

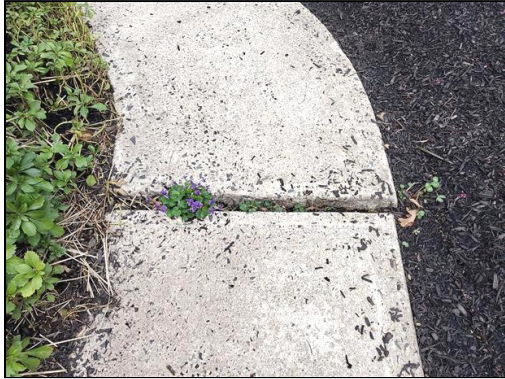
2.3 Item 1(Picture)

📍 (1) Rotated and uneven concrete walkway. Recommend to repair as needed by a qualified person or professional. Potential tripping hazard exists.

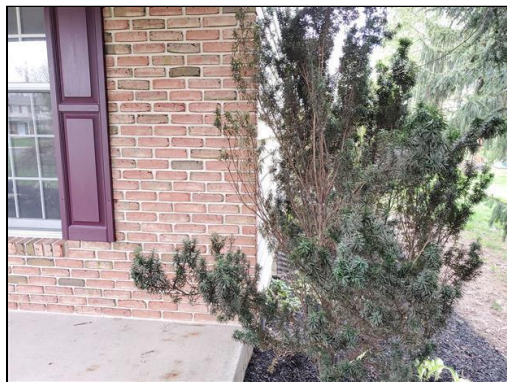
2.3 Item 9(Picture)

📍 (5) Shrubbbery and vegetation is growing too close to the siding for proper ventilation. Recommend to trim shrubbbery a minimum of of 12 to 16 inches away from the siding to restore proper ventilation. This would be considered normal maintenance.

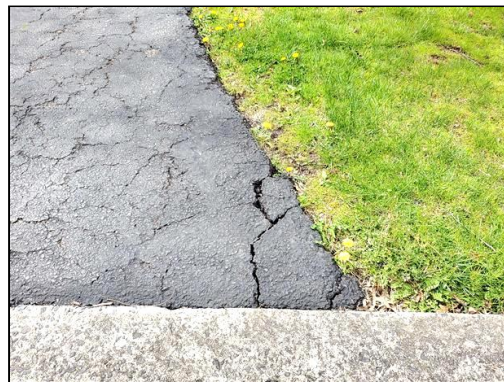
2.3 Item 14(Picture)

(6) Typical driveway settlement cracks. Recommend to repair or fill all cracks as needed by a qualified person. Also suggest to recoat driveway every 4 to 5 years. This would be considered normal maintenance.

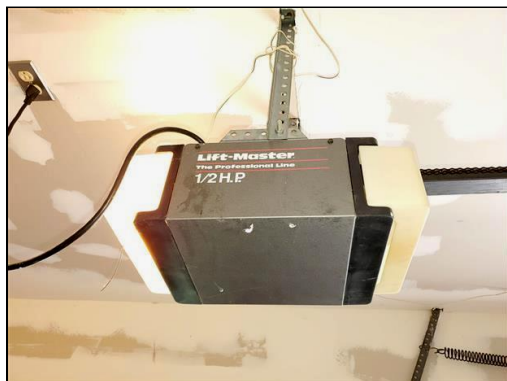
3.4 Item 1(Picture)

🏠 Both garage doors needed excessive pressure for the auto reverse function to work properly. Recommend to adjust doors as needed by a qualified person for auto reverse to work correctly. Potential safety hazard exists.

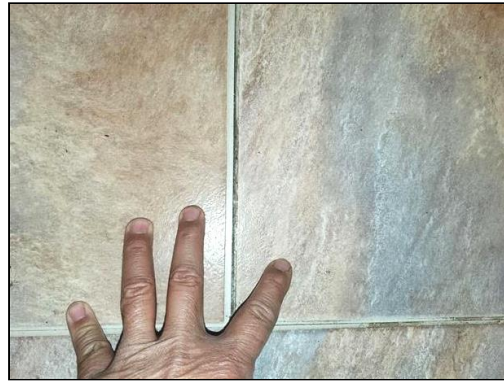
4.0 Item 1(Picture)

Excessive gap in the kitchen floor. Recommend to repair as needed by a qualified person.

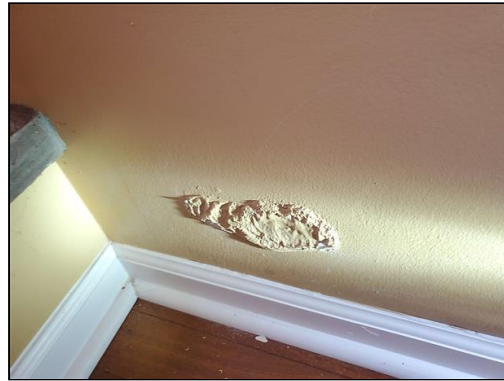
5.1.E Item 1(Picture)

Water damaged wall in the family room. Suggest to repair gap and downspout on the exterior and repair wall as needed by a qualified person.

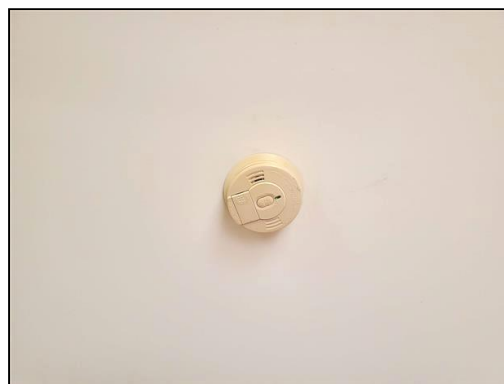
5.8.E Item 1(Picture)

Recommend to replace all older smoke detectors as discussed. Lifespan for smoke detectors is approximately 10 years. FYI

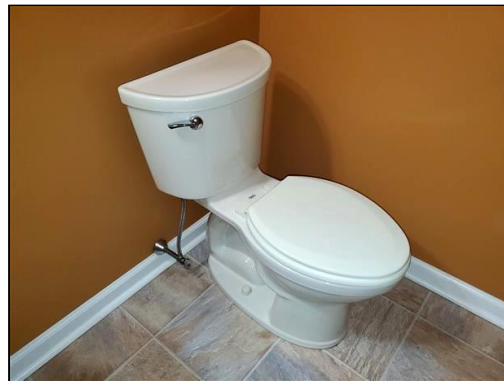
6.9.A Item 1(Picture)

The toilet is loose at floor at the 1/2 bath. Recommend to secure toilet the the floor as needed by a qualified person or plumber.

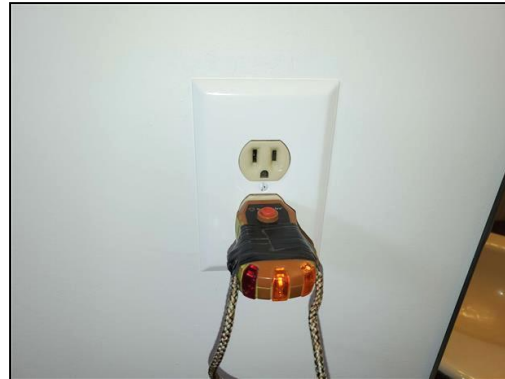
6.5.B Item 1(Picture)

🔧 No GFI receptacles are located in the hall bath room. Recommend to install GFI receptacles as needed by a qualified person. This would be considered an added safety precaution against a potential severe electrical shock.

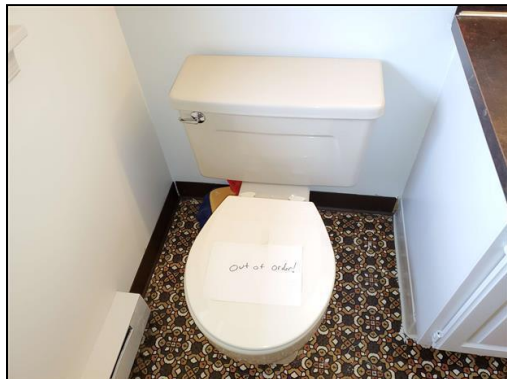
6.9.B Item 1(Picture)

Toilet in the hall bath very loose and nonfunctional. Recommend to repair as needed by a qualified plumber.

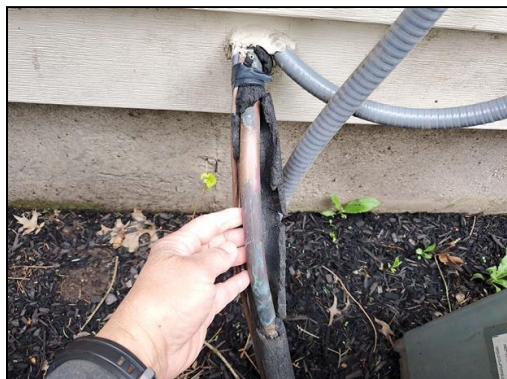
10.8 Item 1(Picture)

(1) Foam freon line cover is deteriorated and damaged. Recommend to replace foam cover as needed for maximum cooling efficiency and unit longevity. Replace as needed by a qualified person.

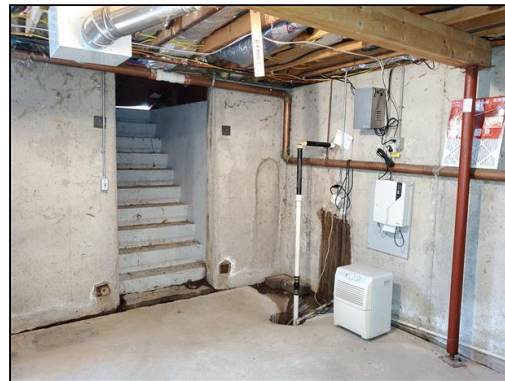
11.2 Item 1(Picture)

Recommend to install a door at the bottom of the steps. This will help prevent insect and rodent penetration. FYI

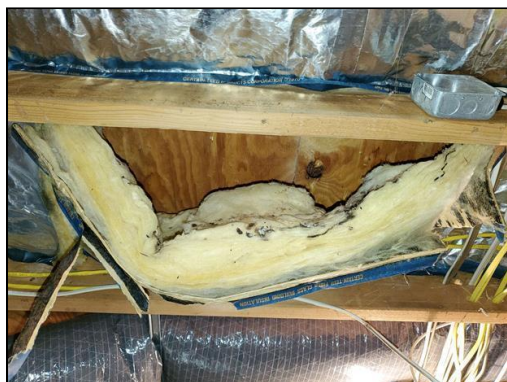
11.8 Item 1(Picture)

📌 Loose insulation in the basement ceiling. Recommend to secure as needed by a qualified person or professional.

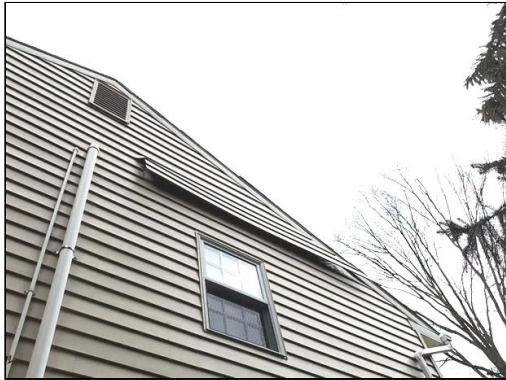
2.0 Item 1(Picture)

(1) Loose siding at the right and left side of the house. Recommend to secure siding as needed by a qualified professional.

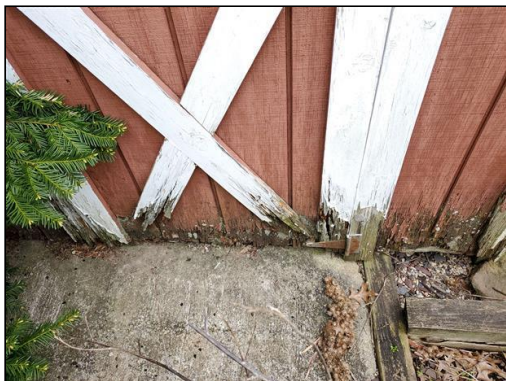
2.0 Item 4(Picture)

(2) Deteriorated wood siding at the bottom of shed and interior walls. Recommend to repair or replace deteriorated wood as needed by a qualified person or professional.

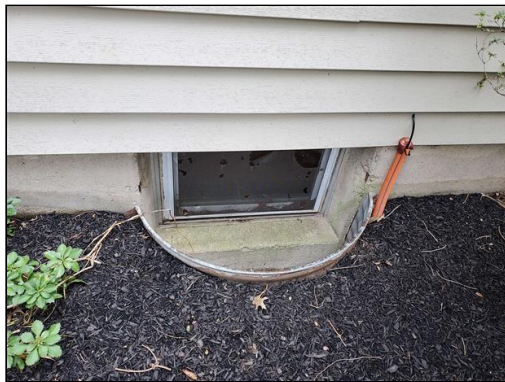
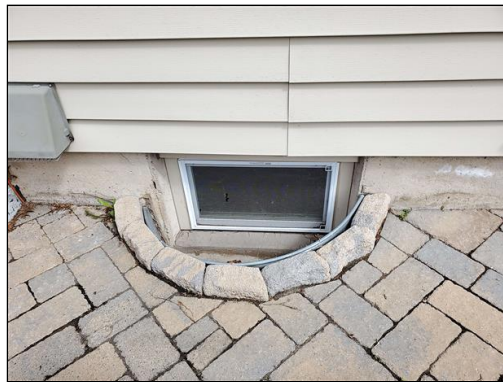
2.1 Item 1(Picture)

Missing a window well covers. Suggest to install clear plastic well covers over window wells to prevent potential well saturation which could overflow window sill and spill into the basement. **This is considered optional.**

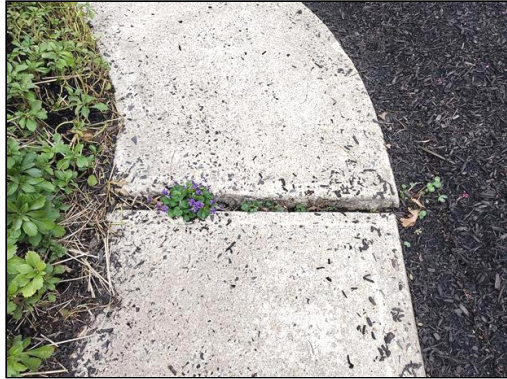
2.3 Item 1(Picture)

(1) Rotated and uneven concrete walkway. Recommend to repair as needed by a qualified person or professional. Potential tripping hazard exists.

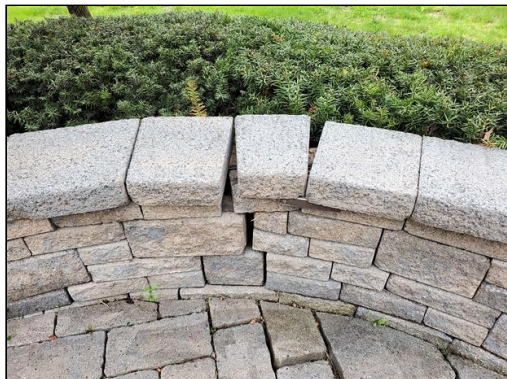
2.3 Item 6(Picture)

(2) Settled and separated patio wall at the rear of the house. Recommend to reset settled block as needed by a qualified person or professional.

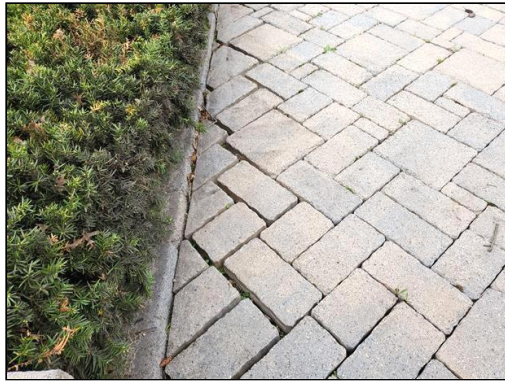
2.3 Item 7(Picture)

(3) Separated and rotated pavers at the rear of the house. Recommend to reset pavers as needed by a qualified person or professional.

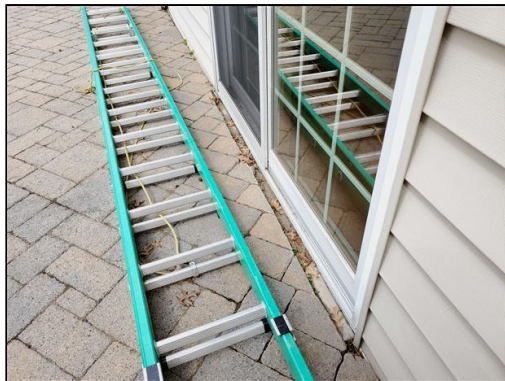
2.3 Item 8(Picture)

(4) Gap between pavers and foundation at the rear of the house. Recommend to fill gap as needed to prevent potential water penetration.

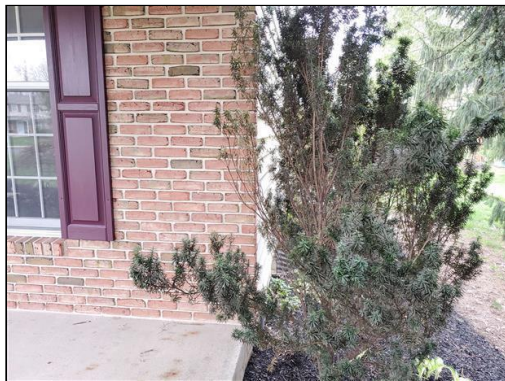
2.3 Item 9(Picture)

(5) Shrubbbery and vegetation is growing too close to the siding for proper ventilation. Recommend to trim shrubbbery a minimum of of 12 to 16 inches away from the siding to restore proper ventilation. This would be considered normal maintenance.

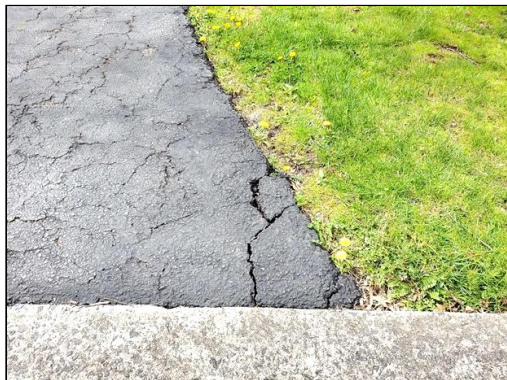
2.3 Item 14(Picture)

(6) Typical driveway settlement cracks. Recommend to repair or fill all cracks as needed by a qualified person. Also suggest to recoat driveway every 4 to 5 years. This would be considered normal maintenance.

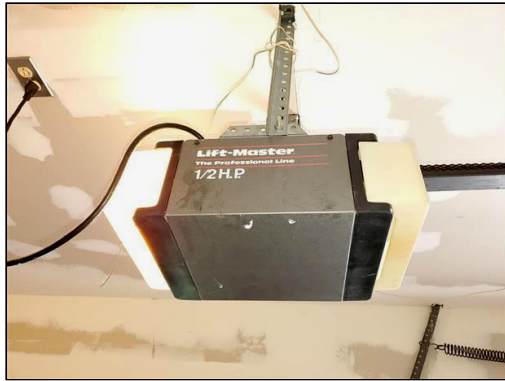
3.4 Item 1(Picture)

Both garage doors needed excessive pressure for the auto reverse function to work properly. Recommend to adjust doors as needed by a qualified person for auto reverse to work correctly. Potential safety hazard exists.

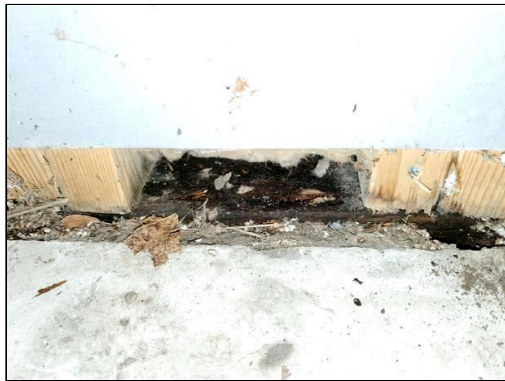
3.5 Item 1(Picture)

🏠 Rotted and deteriorated sill plate from excessive water penetration on the exterior. Recommend to properly grade the exterior and repair as needed to prevent water and insect damage.

Rotted and deteriorated sill plate from excessive water penetration on the exterior. Recommend to properly grade the exterior and repair as needed to prevent water and insect damage.

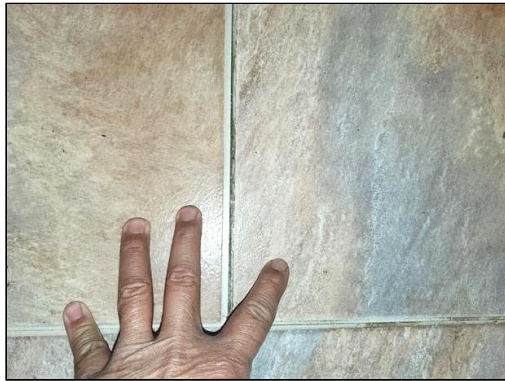
4.0 Item 1(Picture)

Excessive gap in the kitchen floor. Recommend to repair as needed by a qualified person.

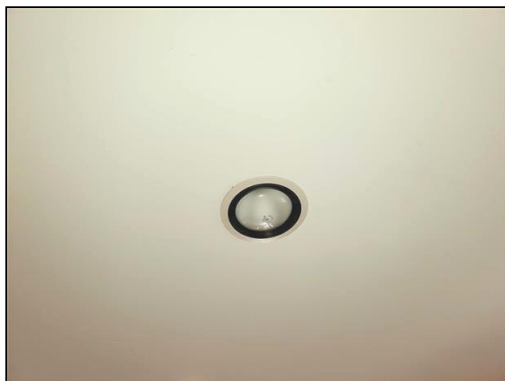
4.7 Item 3(Picture)

🏠 (2) One nonfunctional recessed light fixture in the kitchen. Recommend to replace the bulb and test for function.

(2) One nonfunctional recessed light fixture in the kitchen. Recommend to replace the bulb and test for function.

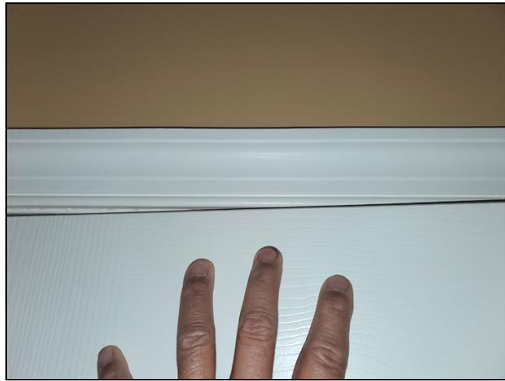
5.2.B Item 1(Picture)

Hollowcore door in the mudroom is binding in the door frame. Recommend to adjust door as needed to restore proper door function by a qualified person.

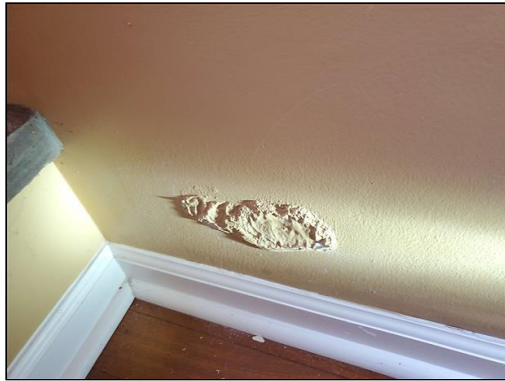
5.1.E Item 1(Picture)

Water damaged wall in the family room. Suggest to repair gap and downspout on the exterior and repair wall as needed by a qualified person.

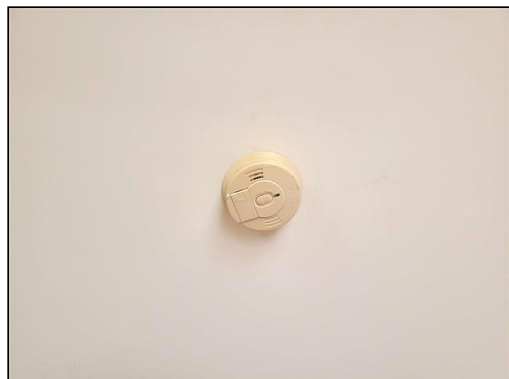
5.8.E Item 1(Picture)

Recommend to replace all older smoke detectors as discussed. Lifespan for smoke detectors is approximately 10 years. FYI

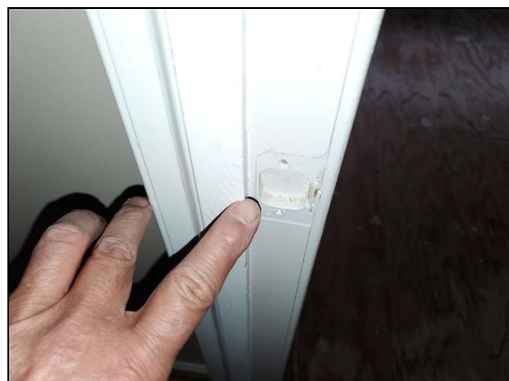
5.2.G Item 1(Picture)

Bedroom #2 entrance door is missing a striker plate. Recommend to install a striker plate as needed by a qualified person.

- 🏠 Bedroom #2 entrance door is missing a striker plate. Recommend to install a striker plate as needed by a qualified person.

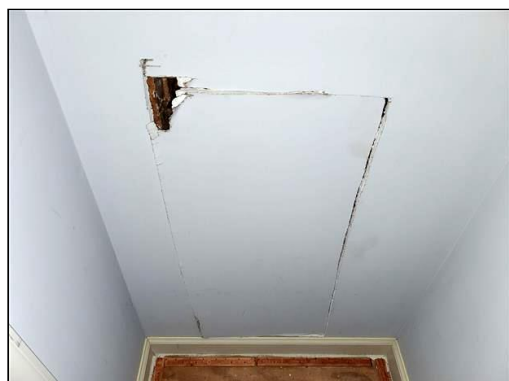
5.1.I Item 1(Picture)

Unfinished drywall in bedroom #4 closet. Recommend to repair or install a door as needed by a qualified person or professional.

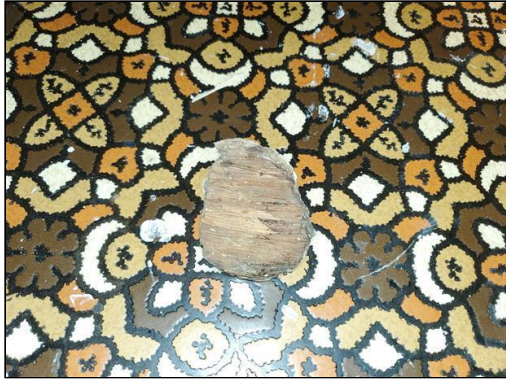
6.3.B Item 1(Picture)

Damaged vinyl floor in the hall bath. Recommend to repair or replace flooring as needed by a qualified person or professional.

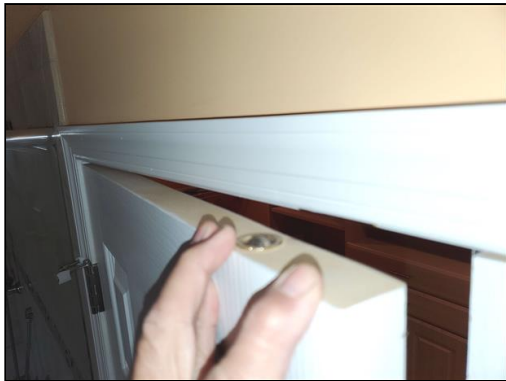
6.1.C Item 1(Picture)

Door hardware in the owners' suite bath is not latching properly. Recommend to adjust or repair hardware as needed by a qualified person.

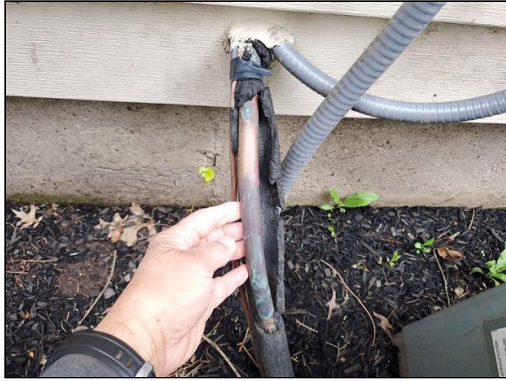
10.8 Item 1(Picture)

(1) Foam freon line cover is deteriorated and damaged. Recommend to replace foam cover as needed for maximum cooling efficiency and unit longevity. Replace as needed by a qualified person.

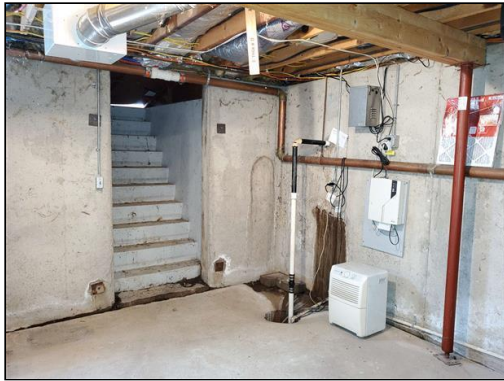
11.2 Item 1(Picture)

Recommend to install a door at the bottom of the steps. This will help prevent insect and rodent penetration. FYI

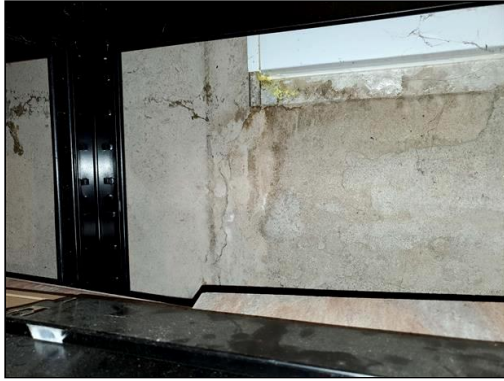
11.3 Item 4(Picture)

(3) Typical settlement crack located in the foundation wall. Recommend to seal crack as discussed using a hydraulic cement. This will enable you to monitor same area for potential further movement.

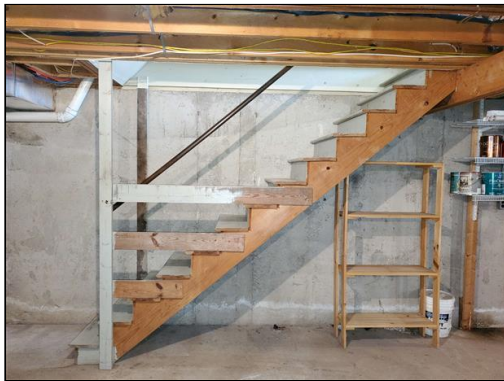
11.6 Item 1(Picture)

Missing guardrail at step area. Recommend to replace missing guardrail as needed by a qualified person. Potential safety hazard for small children exists.

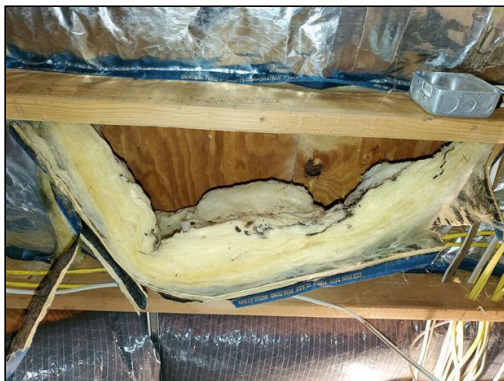
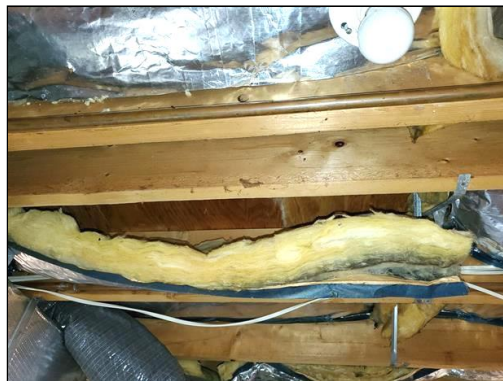
11.8 Item 1(Picture)

Loose insulation in the basement ceiling. Recommend to secure as needed by a qualified person or professional.

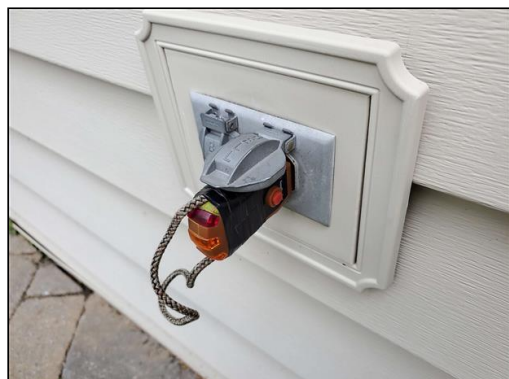
2.7 Item 1(Picture)

2 outside receptacles are non GFI receptacles. Suggest to convert to GFIs for added protection against a potentially lethal electrical shock. Replace as needed by a qualified person or electrician.

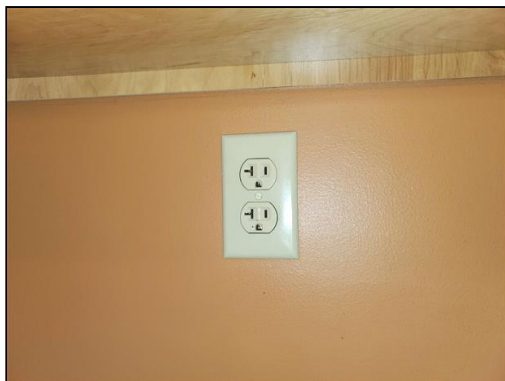
4.7 Item 1(Picture)

(1) Recommend to replace conventional outlets within 6 feet of kitchen sink with GFI receptacles. This would be considered an added safety precaution against a potential severe electrical shock.

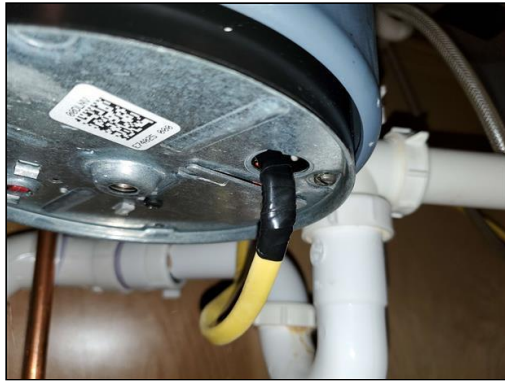
4.9 Item 1(Picture)

🔧 The food disposer wiring is missing a romex connector (anti-strain device). I recommend repair as needed.

The food disposer wiring is missing a romex connector (anti-strain device). I recommend repair as needed.

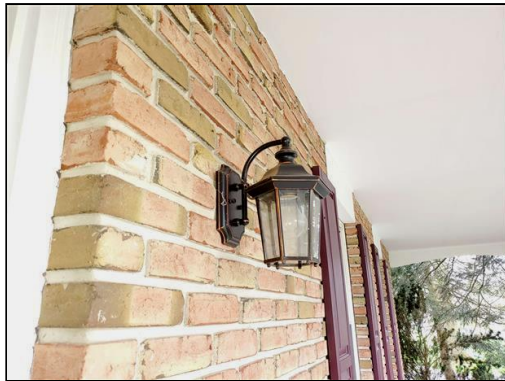
5.7.C Item 1(Picture)

Exterior light fixture was nonfunctional. Recommend to replace the bulb and test for function.

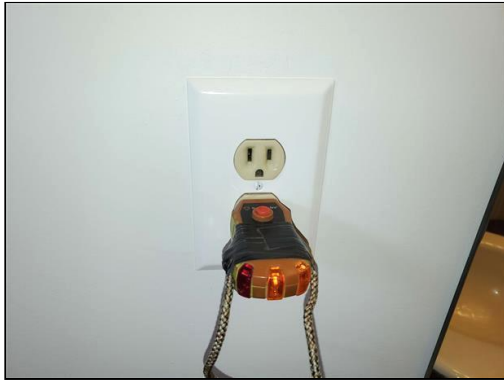
6.5.B Item 1(Picture)

No GFI receptacles are located in the hall bath room. Recommend to install GFI receptacles as needed by a qualified person. This would be considered an added safety precaution against a potential severe electrical shock.

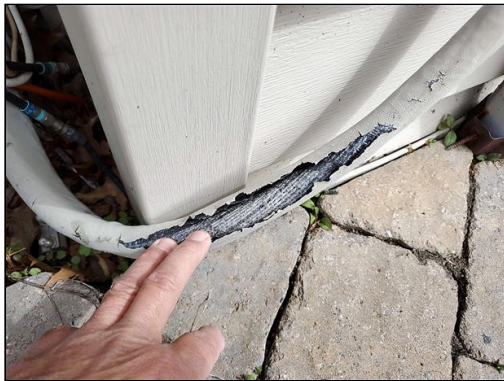
8.0 Item 1(Picture)

Main electrical line is frayed and deteriorated and in need of replacement. Recommend to replace main power line as needed by a qualified electrician. Potential safety hazard exist.

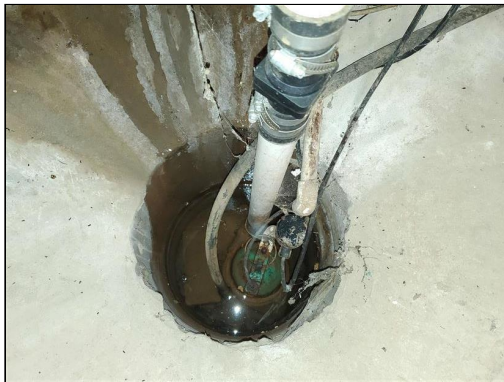
9.7 Item 1(Picture)

Missing a cover on the sump pump. Recommend to install a coverplate as needed by a qualified person.
