ASBESTOS SURVEY REPORT

BYRDSTOWN
COST CENTER NO. RFC024564
202 WEST MAIN STREET
BYRDSTOWN, TENNESSEE

Terracon Project No. 18097057
PO No. CA115618

October 26, 2009

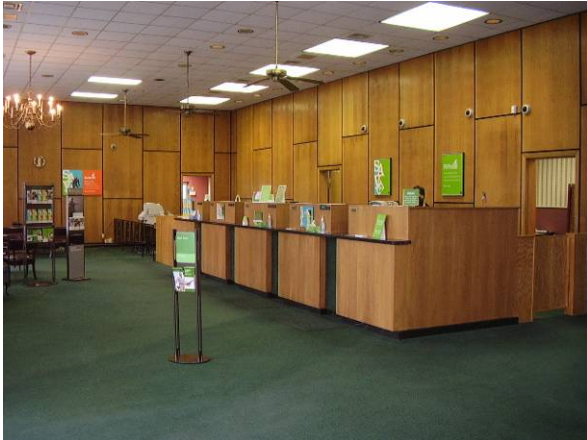
Photo #1 View of teller line.

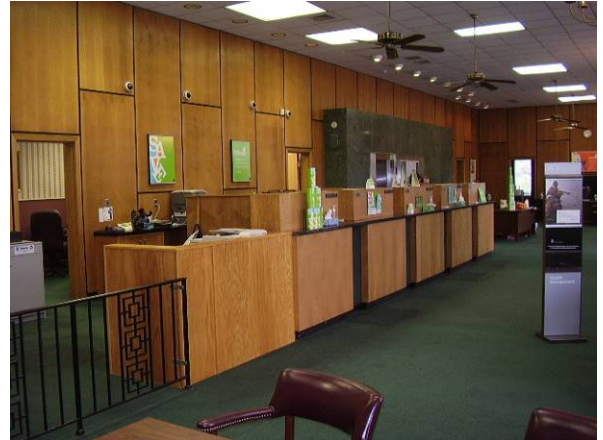
Photo #2 View of teller line.

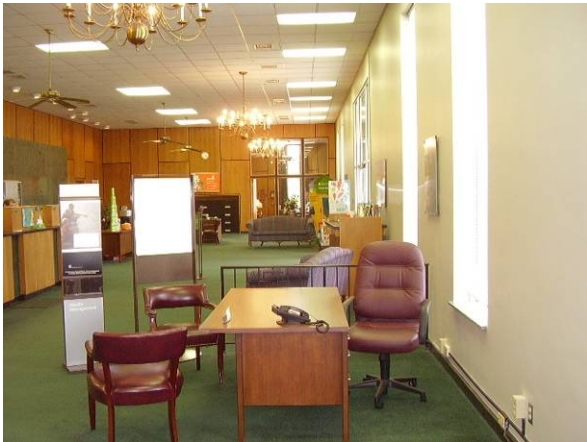
Photo #3 View of room 1 (lobby).

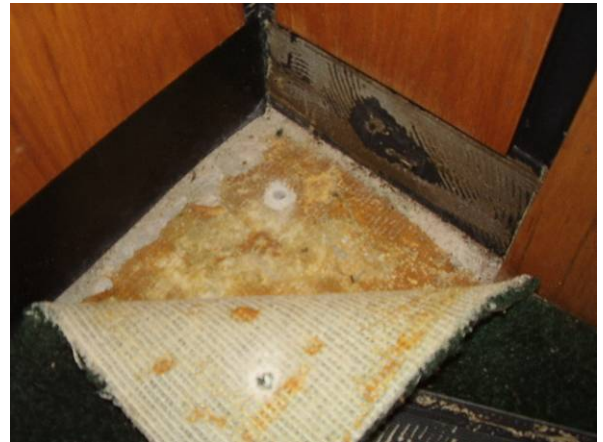
Photo #4 View of yellow carpet mastic and brown cove base mastic.

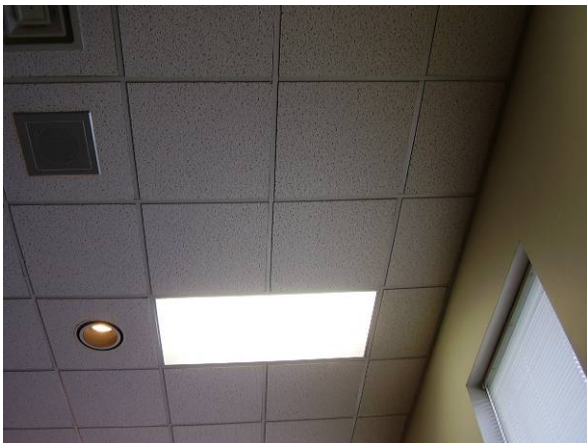
Photo #5 View of 2'x2', suspended ceiling tiles, white, pinhole, small cut, recessed.

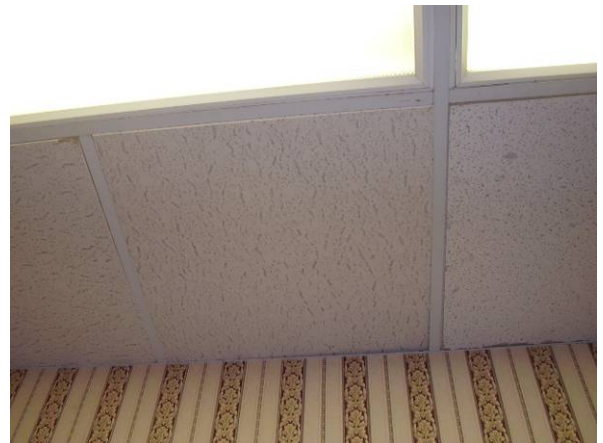
Photo #6 View of 2'x2', suspended ceiling tiles, white, pinhole, fissure, recessed.

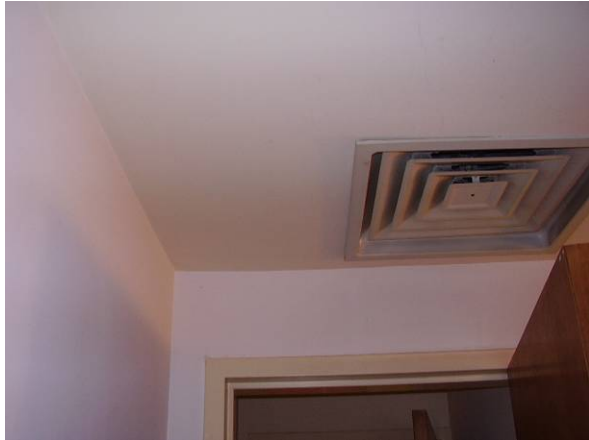
Photo #7 View of plaster wall and plaster ceiling.

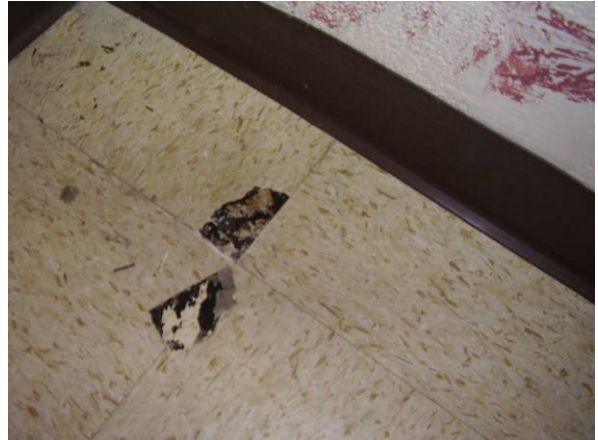
The 12"x12" Vinyl Floor Tile and associated black mastic located in rooms 5, 6, 8, 9, 10, 11, 12, 13, and 16, are considered Category I non-friable ACM in good condition.

Photo #8 The 12"x12", vinyl floor tile, off white with green specks and black mastic is considered an ACM.

Terracon recommends that the identified Category I and II non-friable ACM be removed and disposed of by a Tennessee-licensed asbestos abatement contractor prior to the renovation activity that will disturb the asbestos-containing materials.

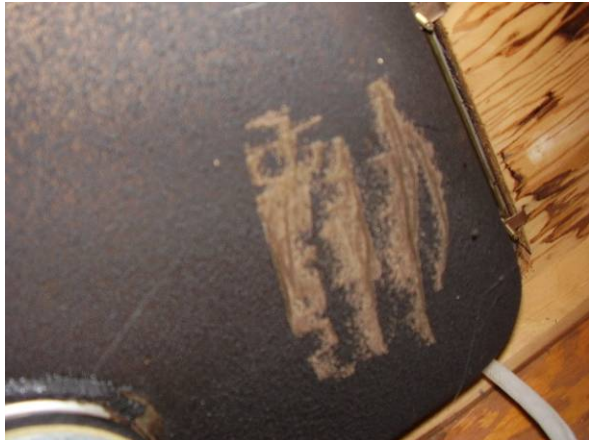
The black sink undercoat, located in room 8, is considered category I non-friable ACM in good condition.

Photo #9 The black sink undercoat is considered an ACM.

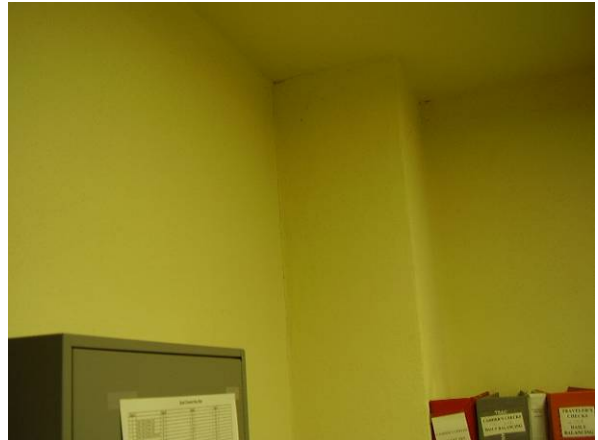
Photo #10 View of texture covering concrete brick wall.

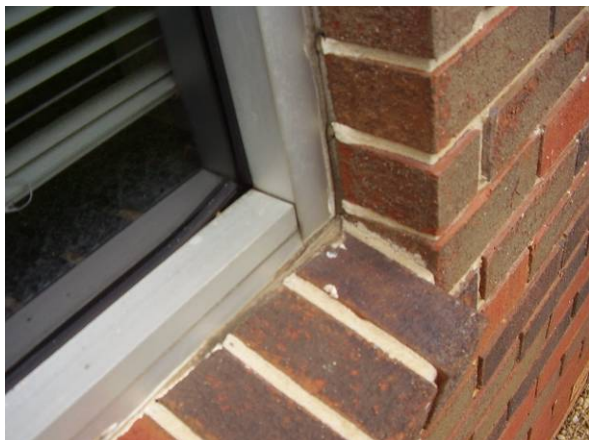
The gray window caulk located on the exterior of the building is considered a Category II non-friable ACM in good condition.

Photo #11 The window caulk located on the exterior of the building is considered an ACM.

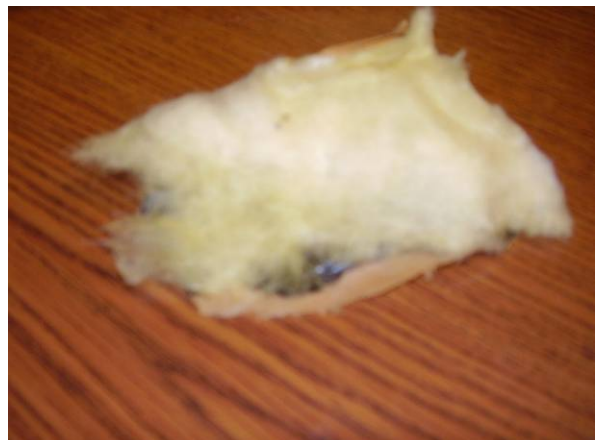
Photo #12 View of fiberglass insulated black backing.

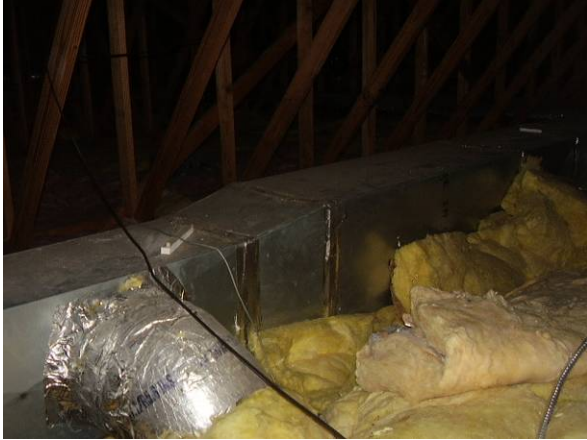
Photo #13 View of HVAC system above the suspended ceiling tiles.
