# Asbestos Survey Report

Trumann

825 Hwy 463 North

Terracon Project No. 35117085

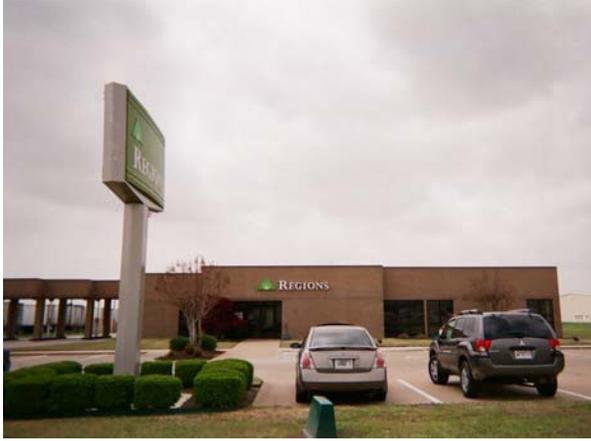
Photo #1 Overview of building.

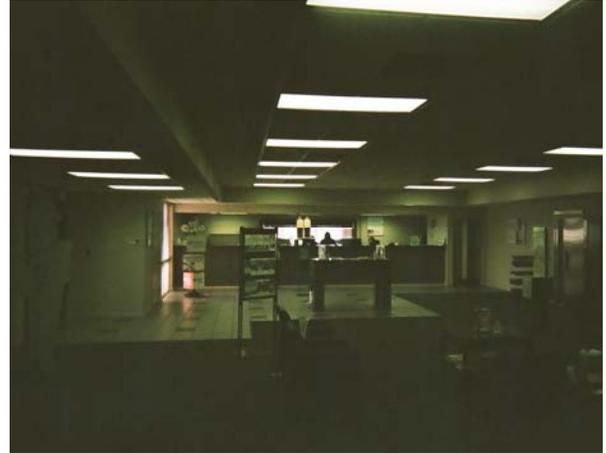
Photo #2 Lobby and tellers area (HA-3, HA-11)

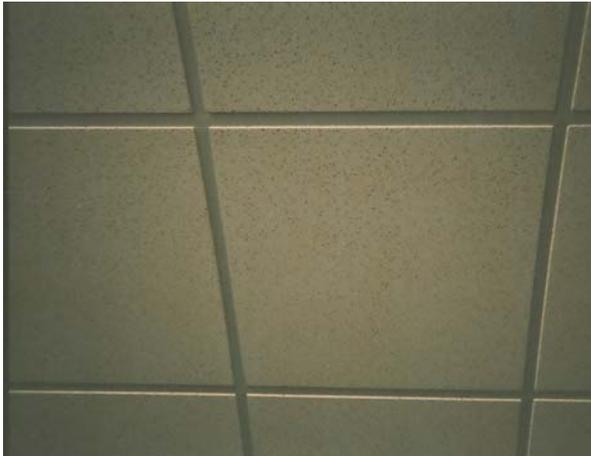
Photo #3 2'x2' ceiling tile (HA-4).

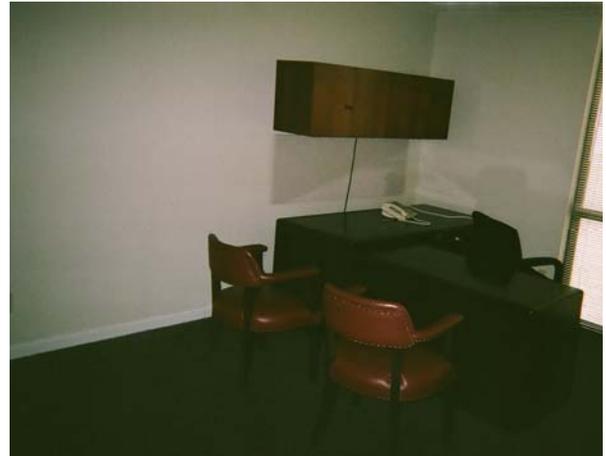
Photo #4 Office (HA-1, HA-8)

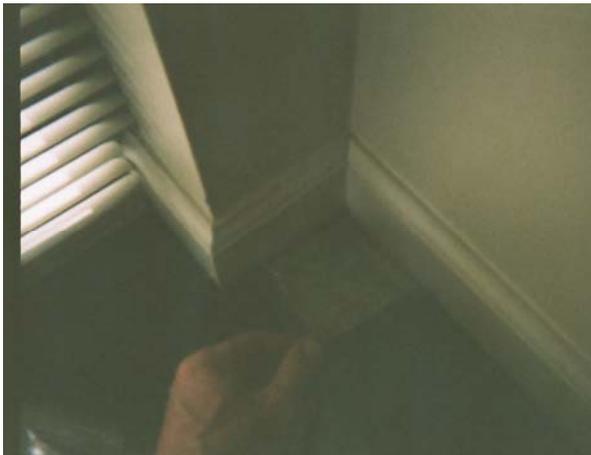
The roof system was not included in this survey. Terracon lifted floor covering in several areas in the building and did not observe additional floor coverings/layers; however, as Terracon could not assess beneath all floored areas, there may be isolated areas of additional suspect material present beneath floor covering.

Photo #5 Terracon observed below flooring.

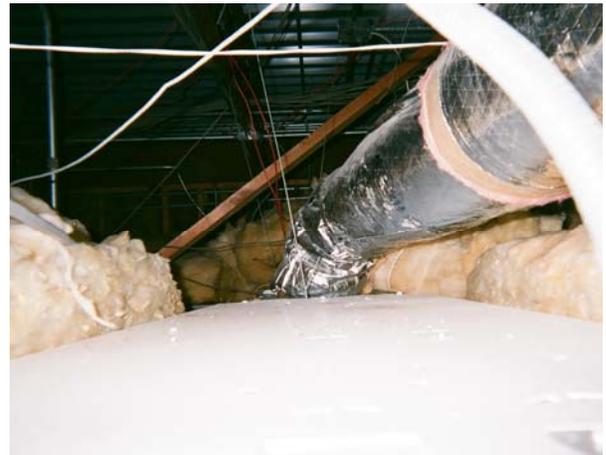
Photo #6 Terracon observed above the ceiling.

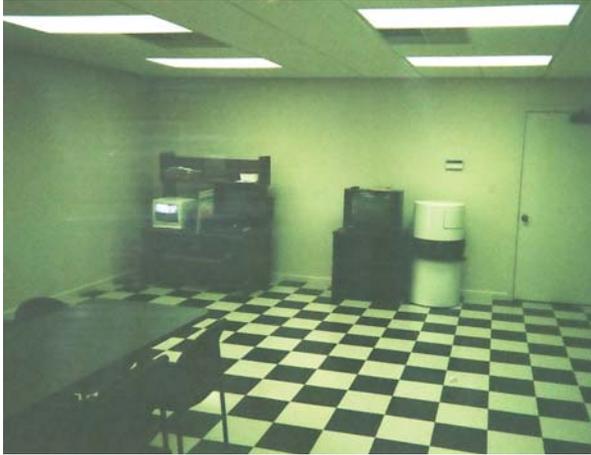
Photo #7 Break room (HA-2).

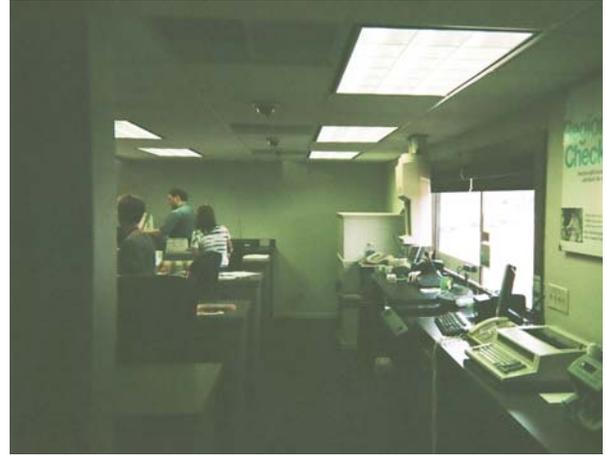
Photo #8 Drive thru tellers area.

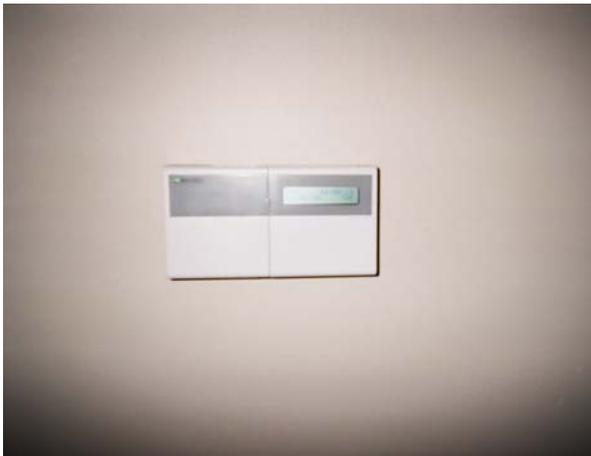
During the site visit, Terracon observed four (4) thermostats throughout the building. All four (4) thermostats were attached to drywall.

Photo #9 One of four thermostats on gypsum boards.

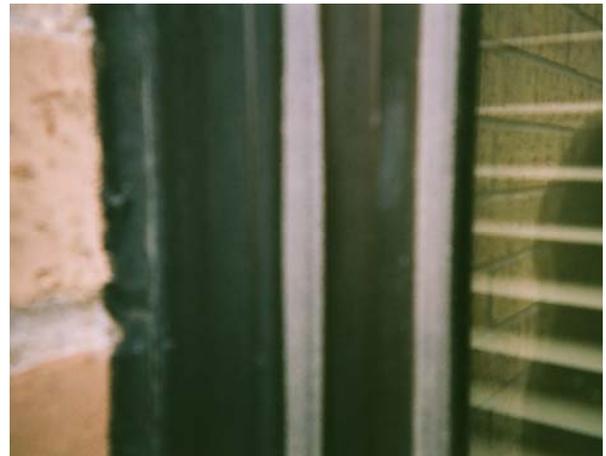
Photo #10 Sealant (HA-10).
