ASBESTOS SURVEY REPORT

**ENGLAND
COST CENTER NO. RFC004328
100 SOUTH ALLIS STREET
ENGLAND, ARKANSAS 72046**

**Terracon Project No. 94107574.001
PO No. CA398907AR**

October 14, 2010

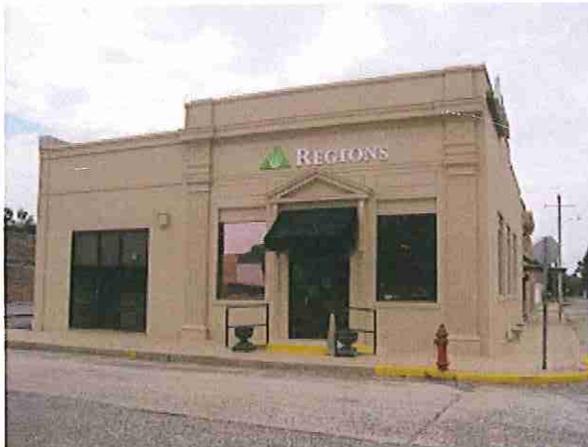
Photo #1 Front of bank.

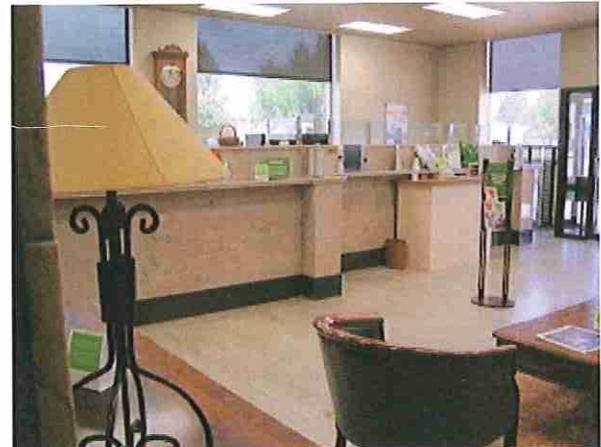
Photo #2 Lobby and teller line, light fixtures set in metal ceiling tile system.

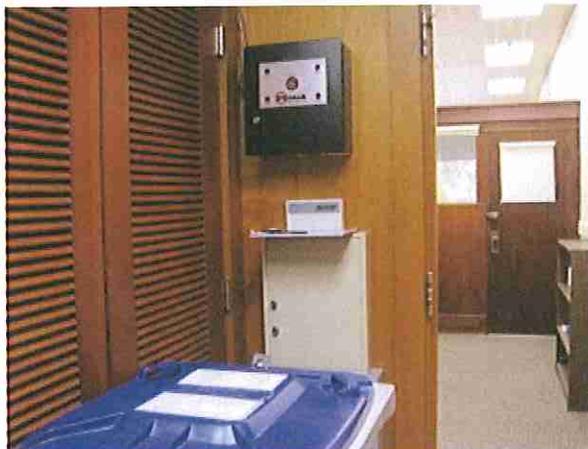
Photo #3 Thermostat on wall panel in kitchen.

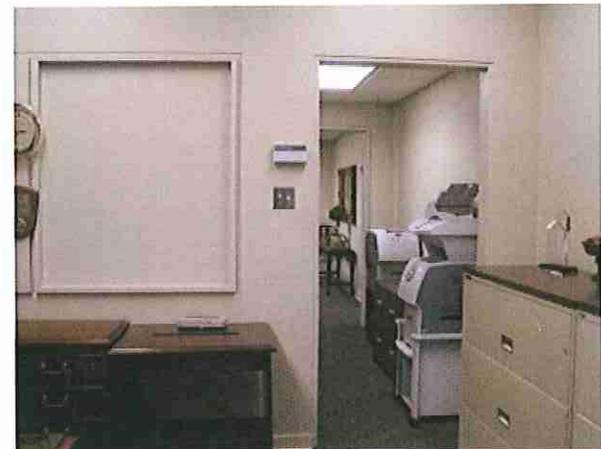
Photo #4 Thermostat on wall panel in office 1.

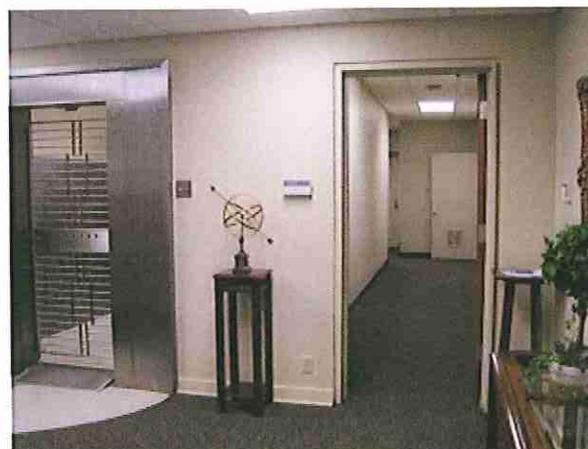
Photo #5 Thermostat on wall plaster in drive thru area.

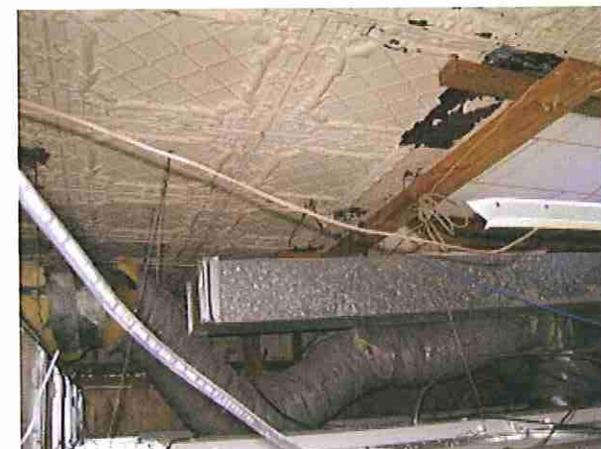
Photo #6 Duct work above lay-in ceiling tile system, 1' x 2' ceiling tile (white, smooth), and tin ceiling tile.

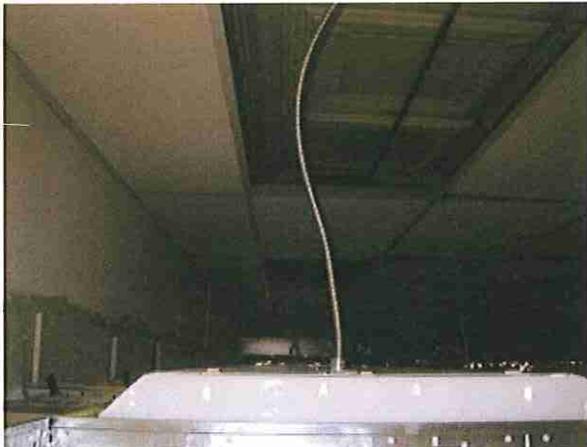
Photo #7 Multiple ceiling systems; 2' x 4' Ceiling tile (white, pinholes, and fissures) and tin ceiling tile above metal lay-in ceiling tile system.

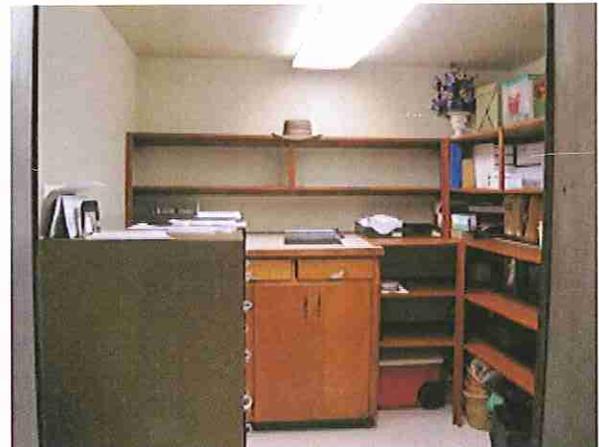
Photo #8 Light fixtures set in plaster.

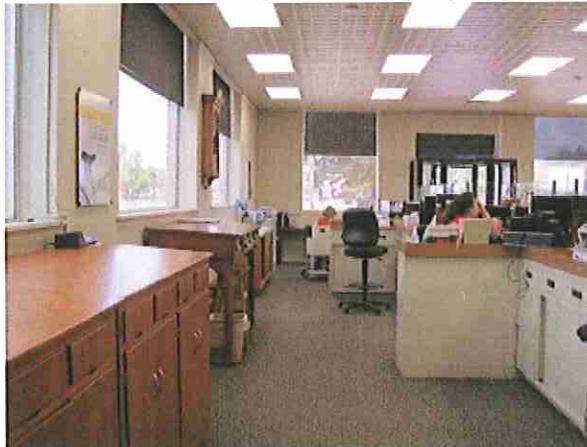
Photo #9 Wall plaster (multi-color, bumpy) and carpet mastic (green/yellow).

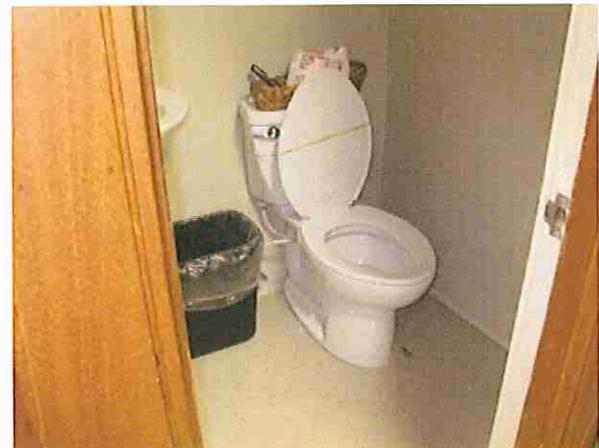
The wall/ceiling texture/drywall/joint compound (multi-color, semi-smooth) is located in the conference rooms, restroom 1, closet, and drive thru and is assessed as a non-friable ACM in good condition.

Photo #10 12" x 12" Floor tile (off-white) with mastic (yellow) and wall/ceiling texture/ drywall/joint compound (multi-color, semi-smooth).

The identified friable and non-friable ACM must be removed and disposed of by an ADEQ-licensed asbestos abatement contractor prior to renovation if the asbestos containing materials will be affected by the planned renovation activity.

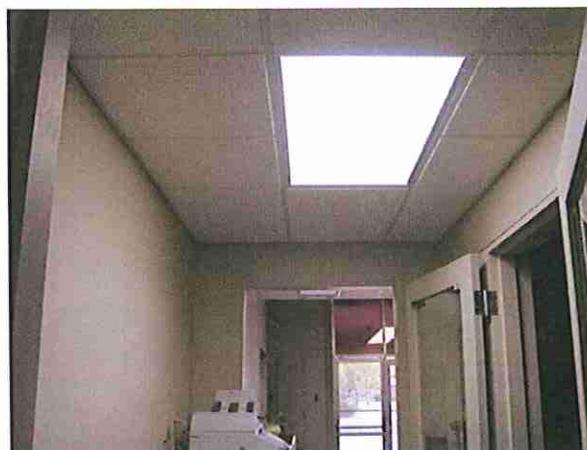
Photo #11 2' x 2' Ceiling tile (white, pinholes, indents).

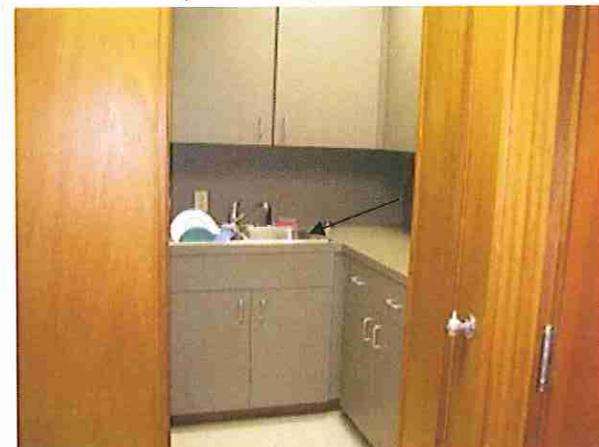
The sink undercoat (white) is located in the kitchen and is assessed as a non-friable ACM in good condition.

Photo #12 Sink undercoat (white).

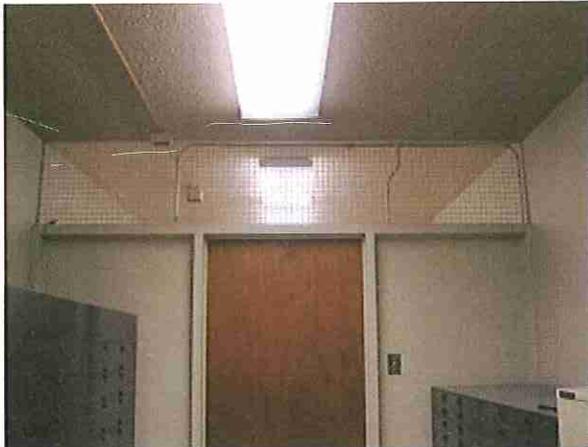
The spray applied ceiling texture (multi-color, rough) is located in the janitor's closet and vault and is assessed as a friable ACM in good condition.

Photo #13 Spray applied ceiling texture (multi-color, rough).

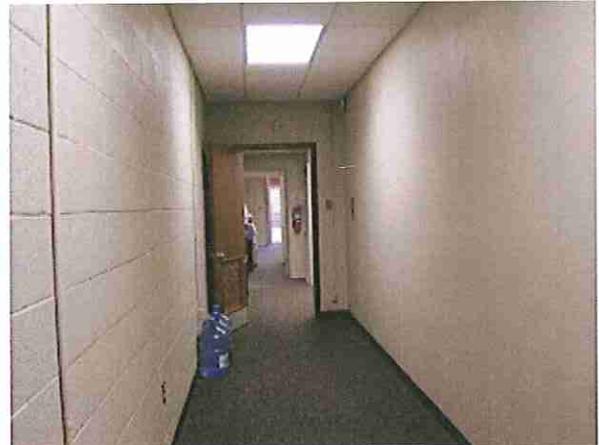
Photo #14 Texture (tan) associated with concrete, texture (tan) associated with CMU, and cove base mastic (tan).

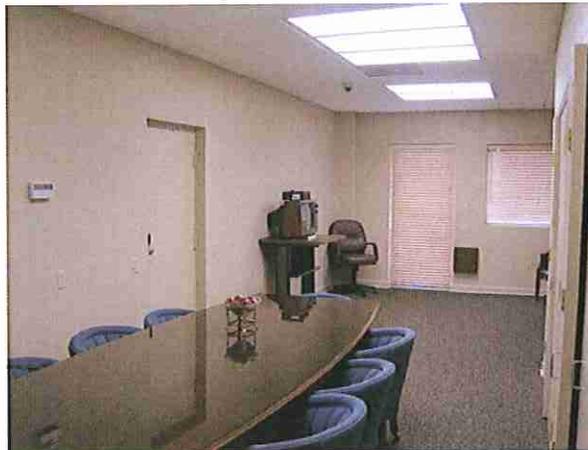
Photo #15 Drywall/joint compound associated with wall covering (multi-color).

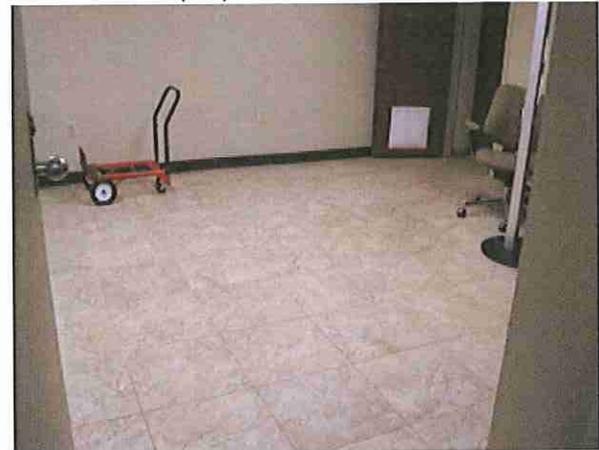
Photo #16 Grout (tan) associated with ceramic tile.

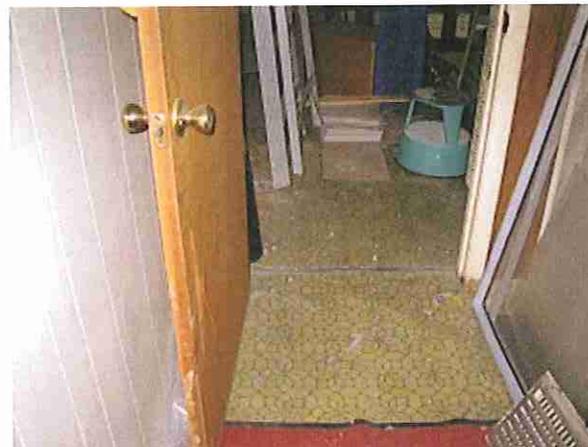
Photo #17 Resilient sheet flooring (green, flower).

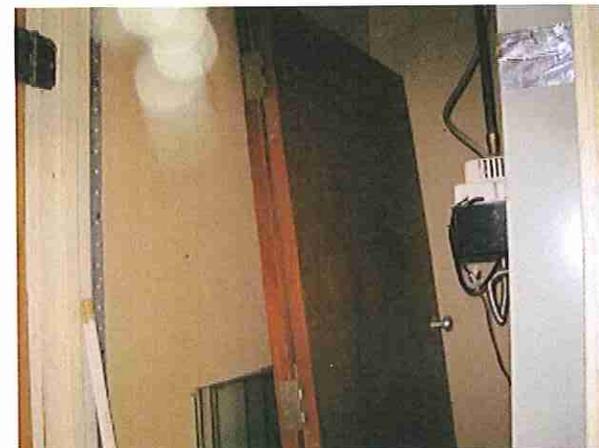
Photo #18 Drywall (unfinished).

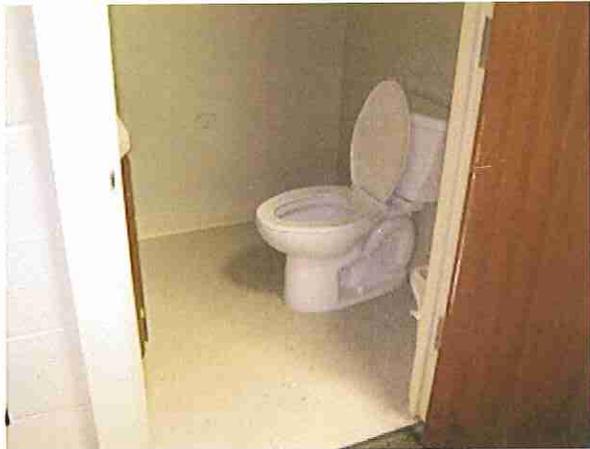
Photo #19 12" x 12" Floor tile (beige w/brown specks) with mastic (yellow) on resilient sheet flooring.

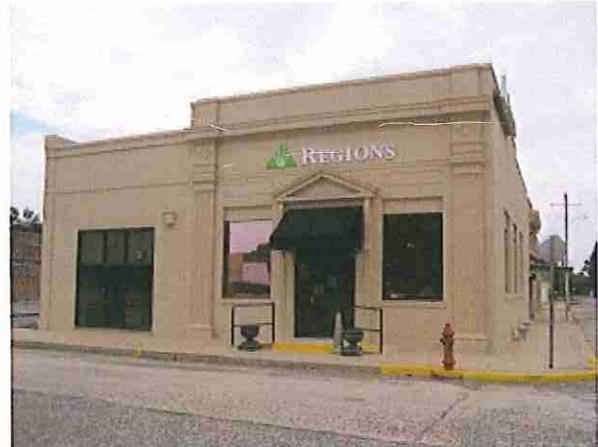
Photo #20 Exterior texture (tan).

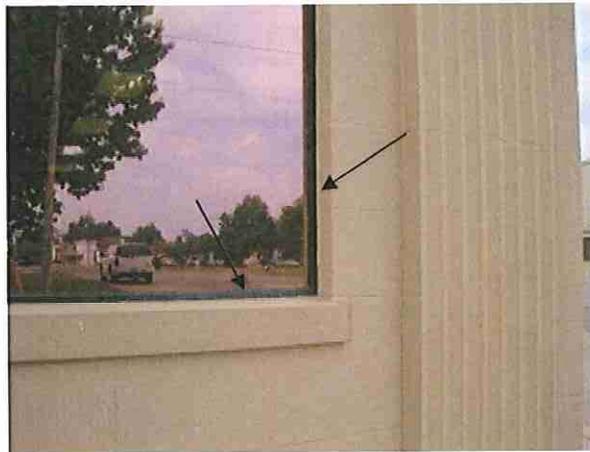
The exterior window caulk is located on the windows and is assessed as a non-friable ACM in good condition.

Photo #21 Exterior window caulk (gray) and exterior building caulk (brown).
