**ASBESTOS SURVEY REPORT**

**REGIONS BRANCH  
CROSSROADS  
RFC025304  
2532 CROSSROADS BOULEVARD  
WATERLOO, IOWA 50702**

**Terracon Project No. 13077029**

**November 2, 2007**

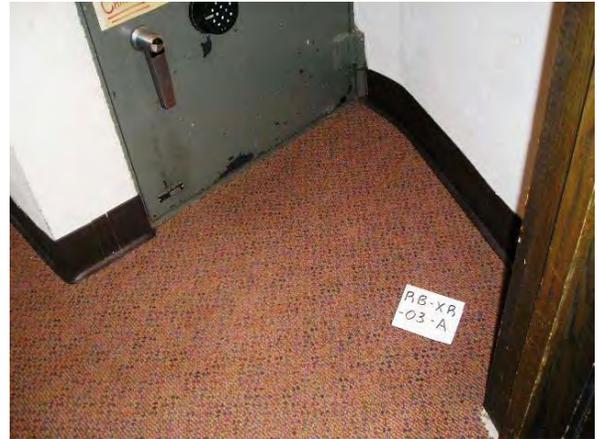
Photo #2 RB-XR-3A - Mastic under carpet is ACM (2.1% Chrysotile)

Terracon recommends that the identified ACM be removed and disposed of by an Iowa-permitted asbestos abatement contractor prior to the renovation activity that will disturb the asbestos-containing material identified.

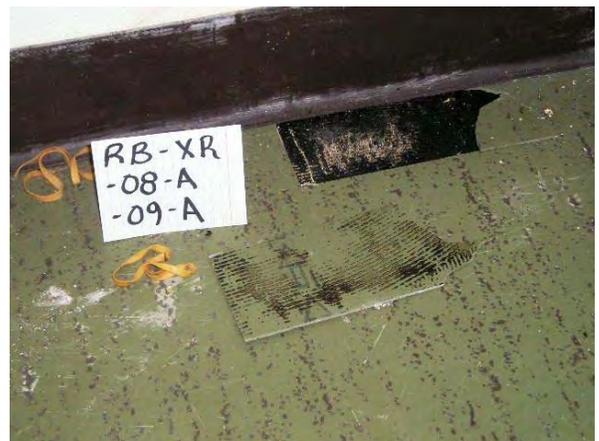
Photo #6 RB-XR-8A and RB-XR-9A - Tile and mastic are ACM (4.0% and 4.6% Chrysotile)

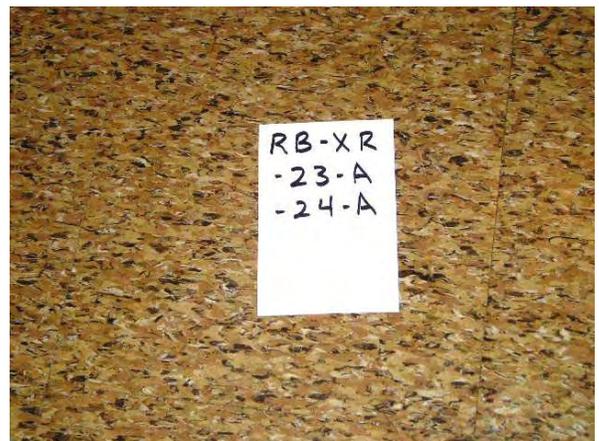
Photo #18 RB-XR-23A and RB-XR-24A -  
Tile and mastic are ACM (1.8% and  
3.1% Chrysotile)

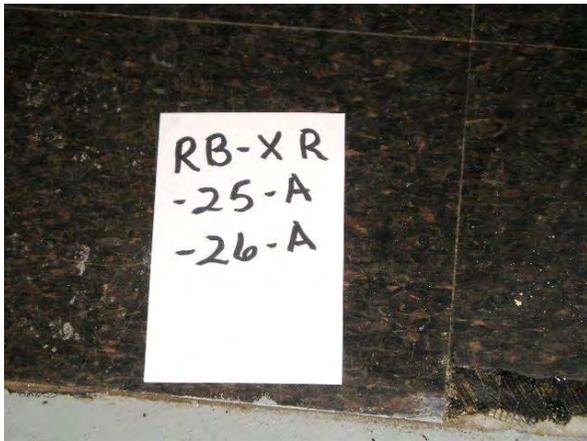
**Photo #20** RB-XR-25A and RB-XR-26A -  
Tile and mastic are ACM (1.6% and  
2.5% Chrysotile)

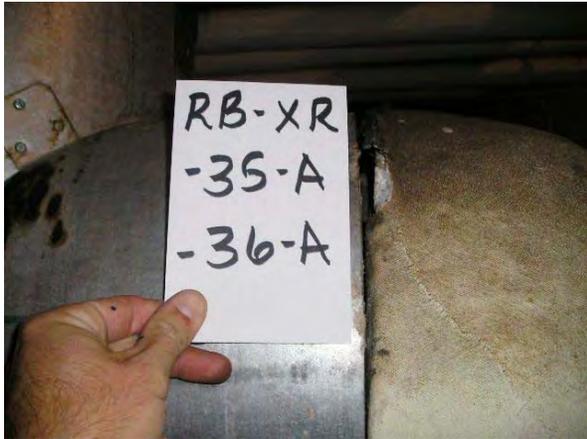
**Photo #27 RB-XR-35A and RB-XR-36A –  
Pipe insulation and wrap are ACM  
(15% and 4.9% Chrysotile)**
