Re: Limited Asbestos Sampling  
Site Name: Cape East Prairie Main  
Cost Center No. RFC027514  
127 East Main Street  
East Prairie, Missouri  
Terracon Project No. 15127054

Terracon Consultants, Inc. (Terracon) conducted limited asbestos sampling of the exterior areas and a re-inspection of the interior areas of the bank branch located at 127 East Main Street in East Prairie, Missouri. This limited sampling was conducted in general accordance with our Task Order Authorization dated May 21, 2012 and in accordance with the Master Service Agreement dated August 12, 2011. We understand that this sampling was requested due to planned renovation of the exterior areas and that a survey of the interior of the building was also completed in 2007 (Terracon Project No. 15077068, dated November 6, 2007). The roof system was not assessed.

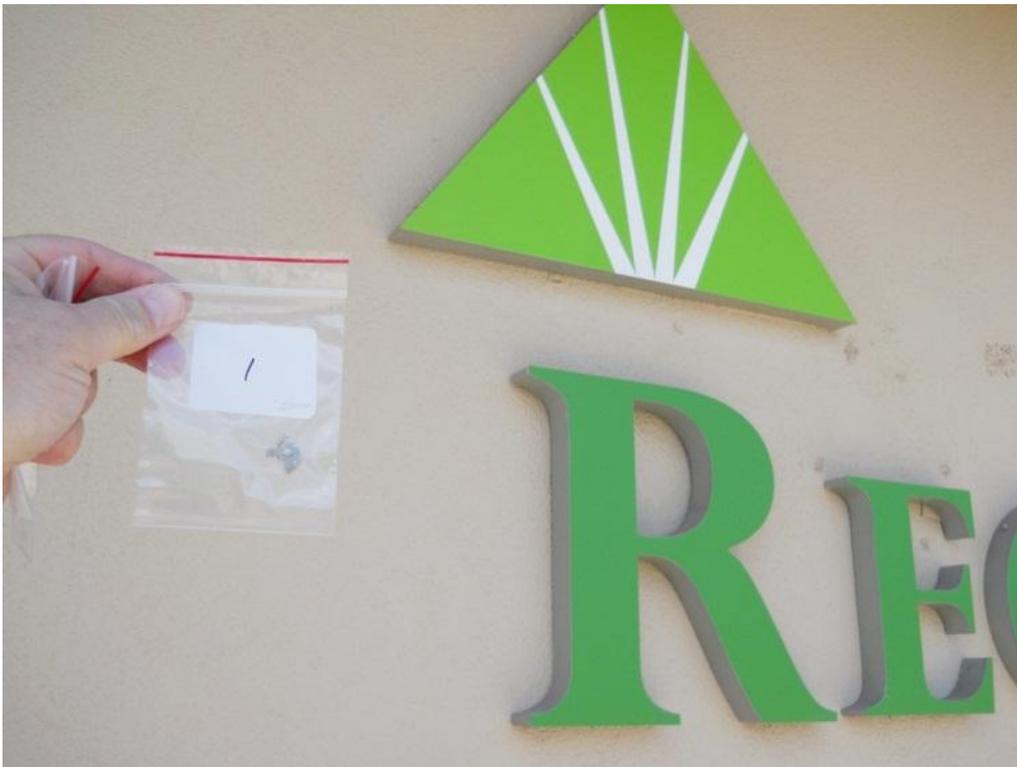
**View of exterior stucco.**

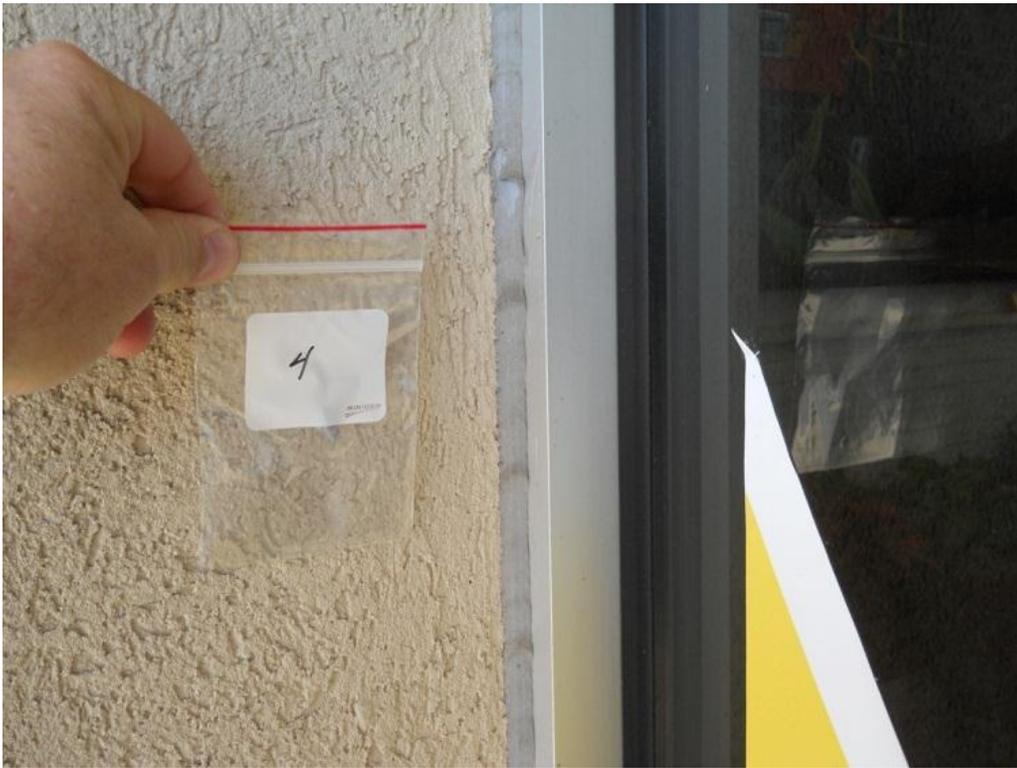
**View exterior gray caulk.**

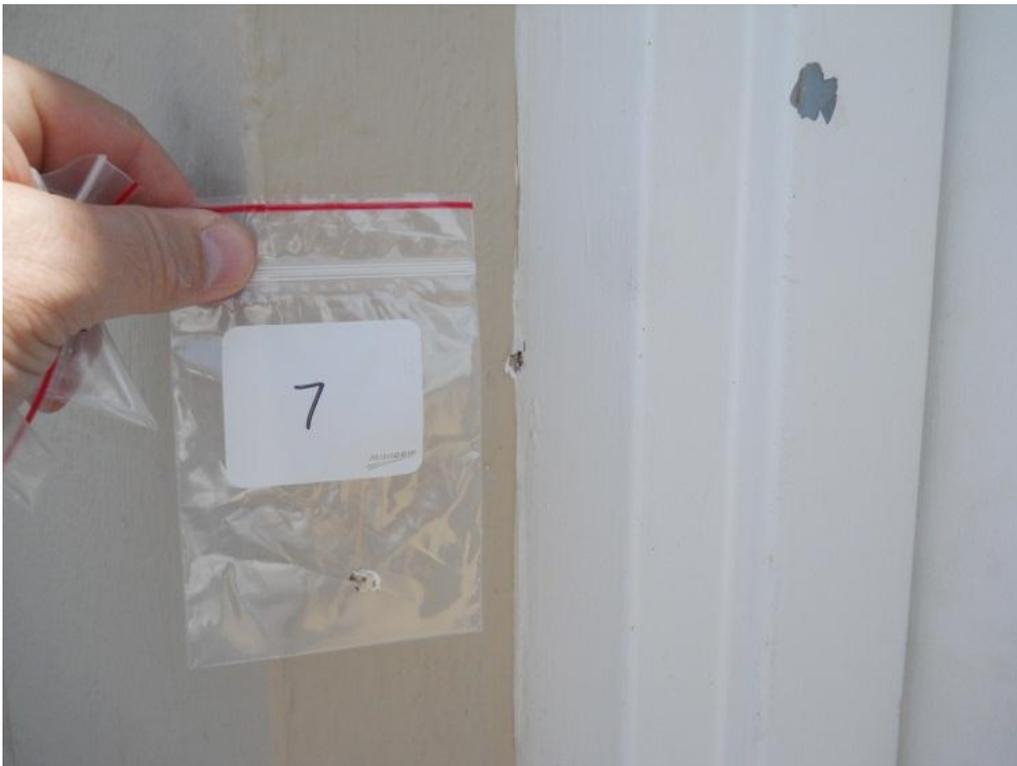
**View of exterior caulk.**

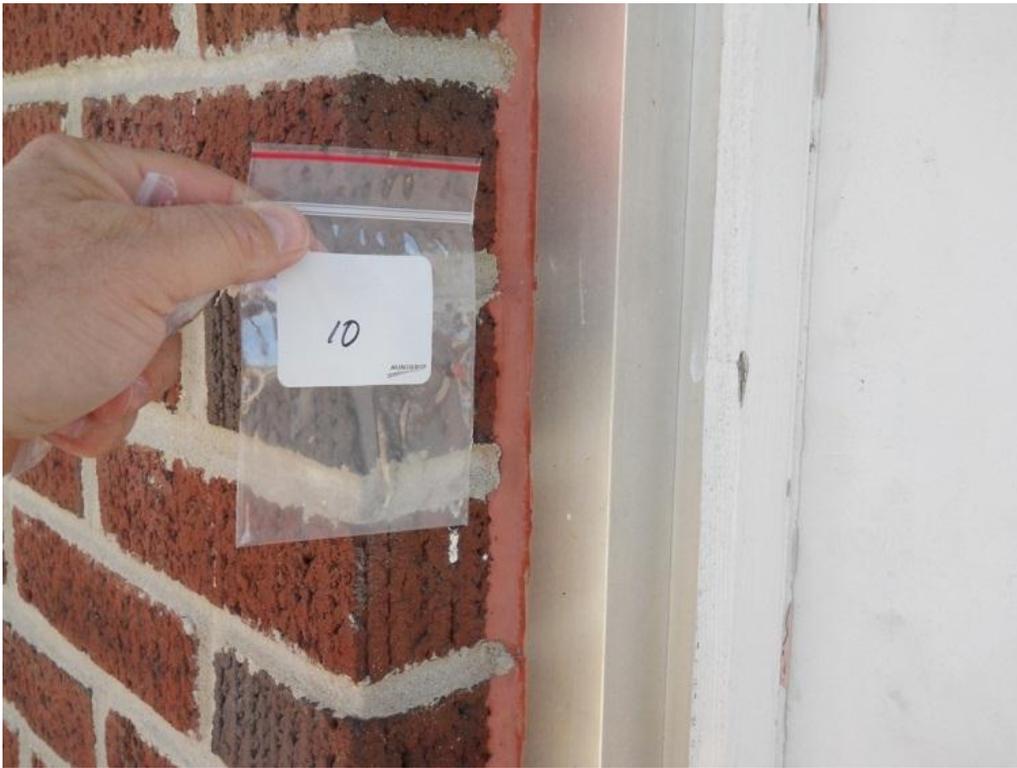
**View of exterior red caulk.**

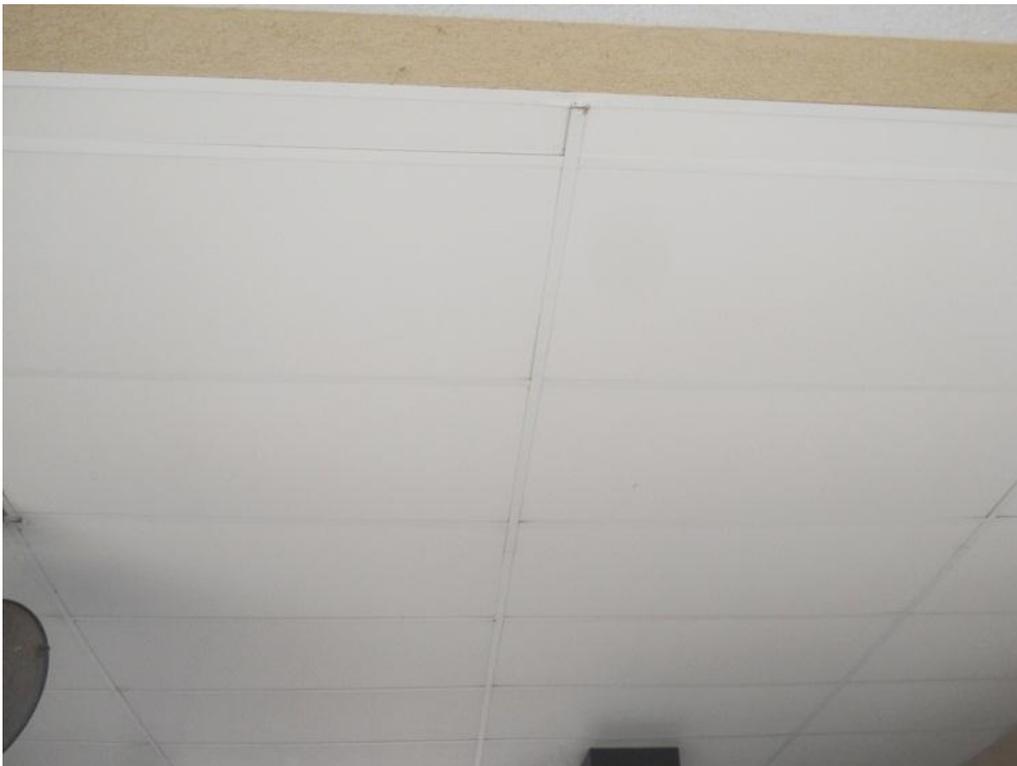
**View of exterior ceiling panels.**

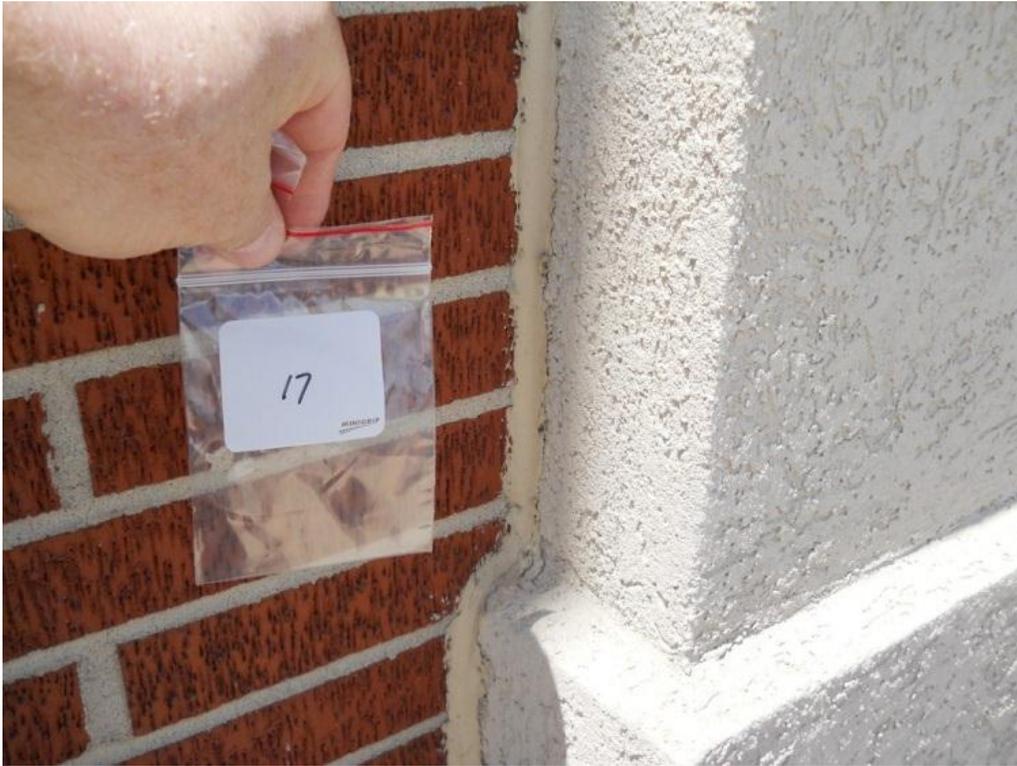
**View exterior tan caulk.**
