Re: Asbestos Sampling Report - Roof  
Site Name: Fifth Street  
Cost Center No. RFC025177  
423 First Capitol Drive  
St. Charles, Missouri  
Terracon Project No. 15177007

## **Asbestos Sampling Report--Roof**

Fifth Street RFC025177

423 First Capitol Drive ■ St. Charles, Missouri

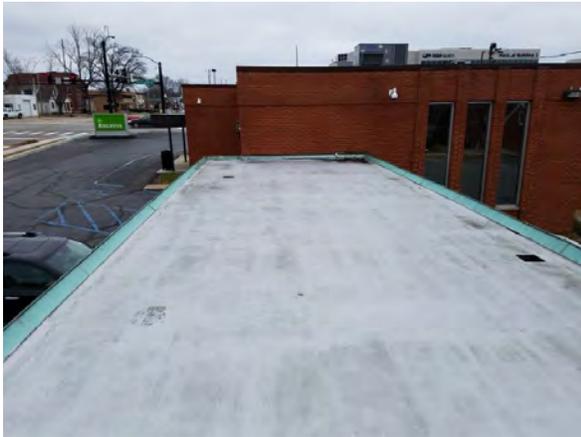
**Photo #1** Overview of roof south canopy.

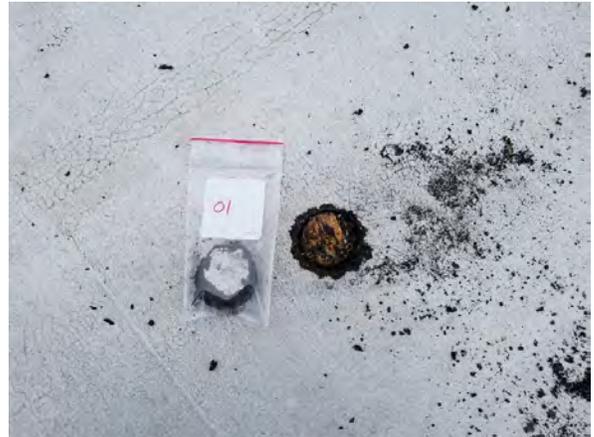
1. Silver painted built up roof over canopies – approximately 1,000 square feet.
2. Silver flashing along silver built up roof edges – approximately 350 linear feet
3. Sealant on condenser piping to roof penetrations – approximately 50 linear feet

**Photo #2** Sample 01, Roof Material, south canopy.

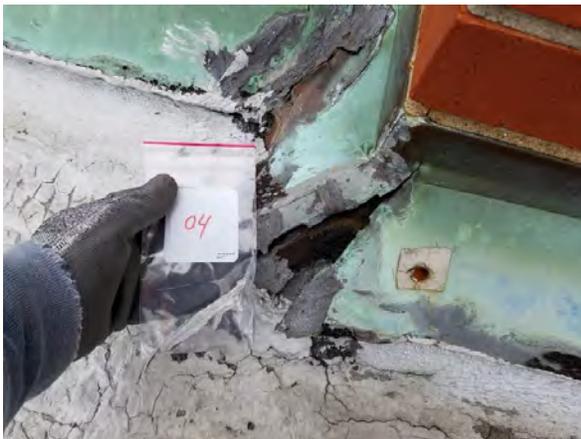
**Photo #3** Sample 04, silver paint and flashing, south canopy.

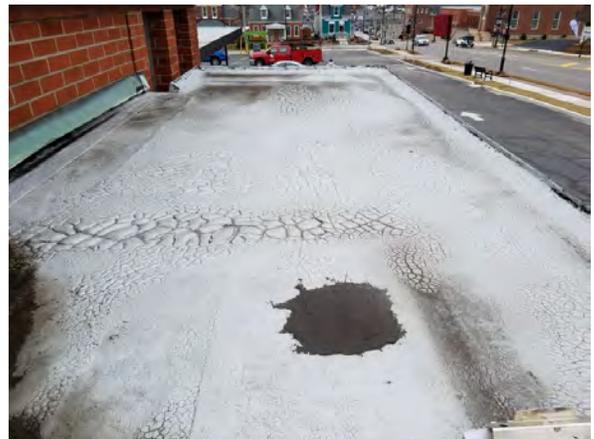
**Photo #4** Overview of west canopy.

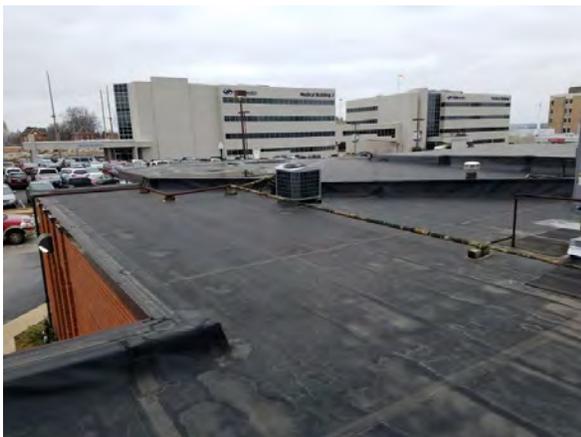
**Photo #5** Overview of main roof.

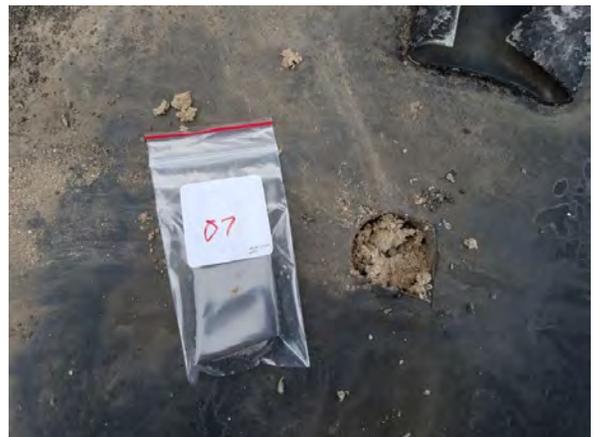
**Photo #6** Sample 07, EPDM roofing material, main roof.

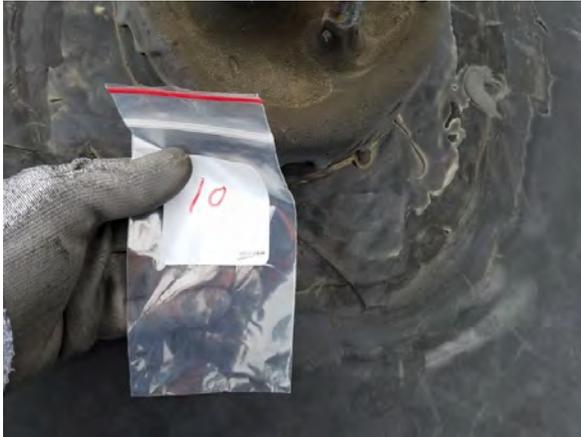
**Photo #7** Sample 10, roof caulk around condenser penetrations, main roof.

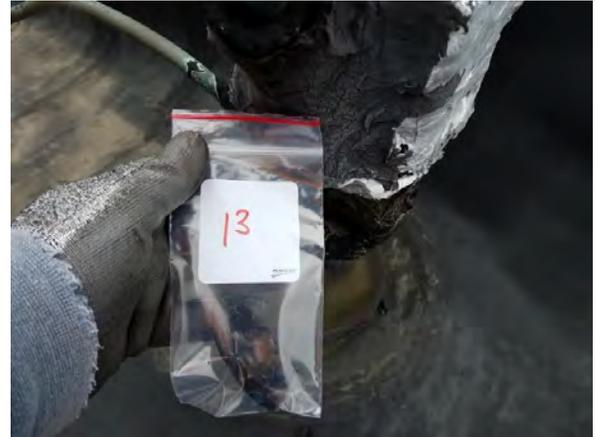
**Photo #8** Sample 13, sealant on condenser piping on main roof.
