Asbestos Survey Report

Centreville

162 W. Main Street

Terracon Project No. EB107106.007

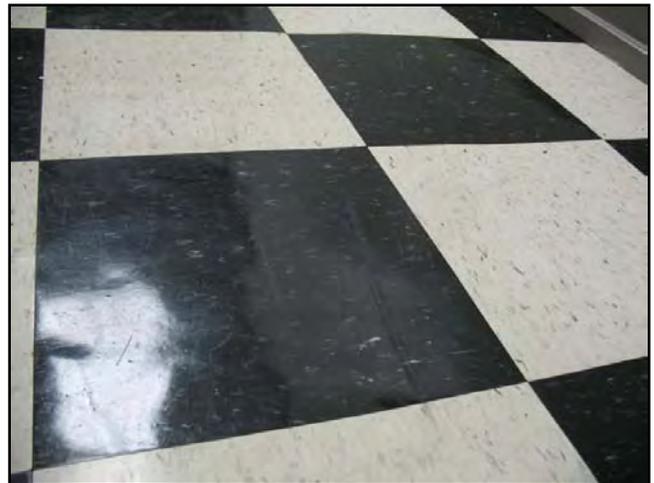
Photograph No. 4
View of black 12" x 12" floor tile (and associated
mastic beneath).

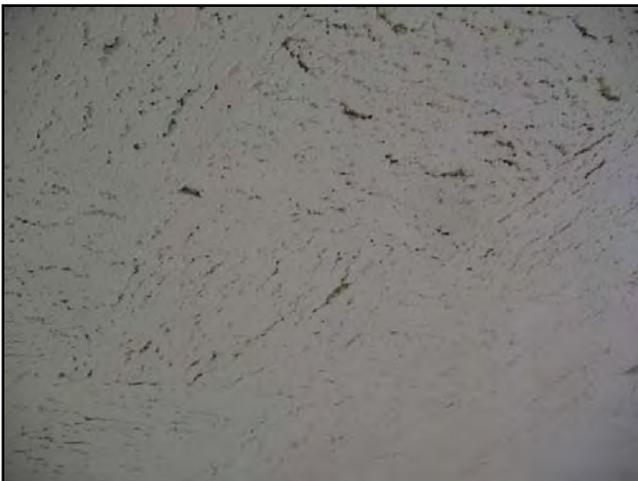
Photograph No. 5
View of white 12" x 12" floor tile (and associated
mastic beneath).

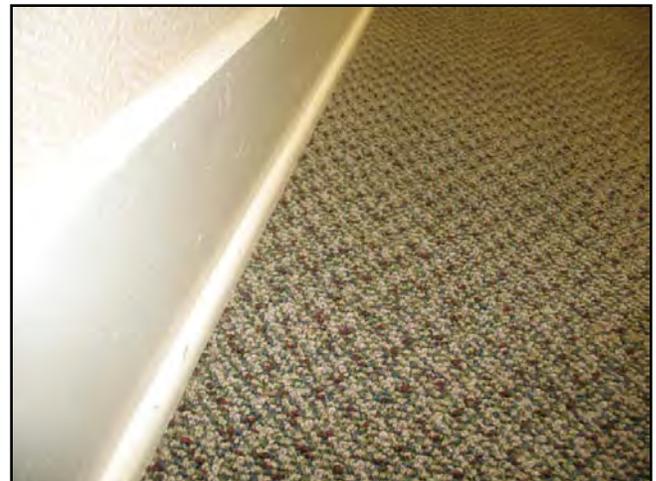
Photograph No. 6
View of carpet (and associated mastic beneath).

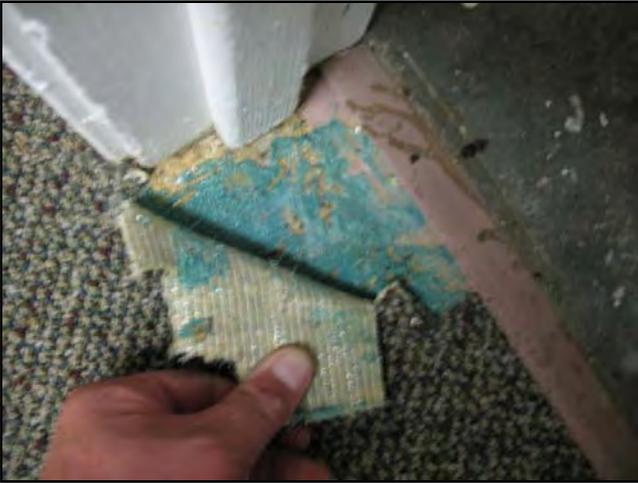
Photograph No. 7

View of carpet mastic and concrete beneath carpet.

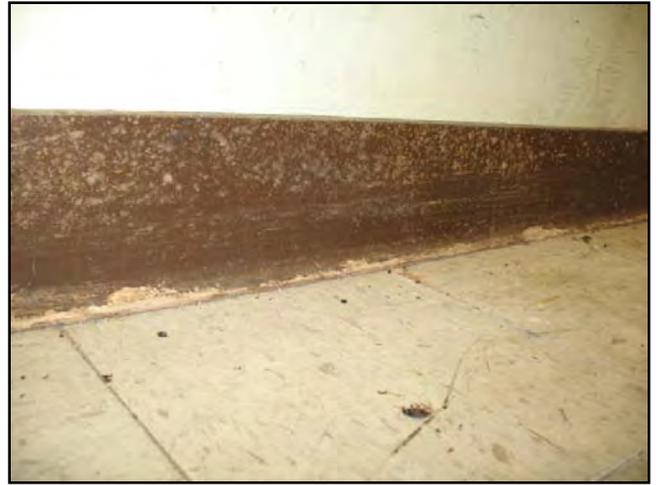
Photograph No. 8

The asbestos-containing tan floor tile and black mastic identified is located in a storage room and is considered a Category I non-friable ACM in good condition.

View of tan 9" x 9" floor tile (and associated mastic beneath), as well as brown cove base and brown mastic.

Terracon recommends that the identified ACM be removed and disposed of by a Mississippi-licensed asbestos abatement contractor prior to any renovation activity that will disturb the asbestos-containing materials identified.

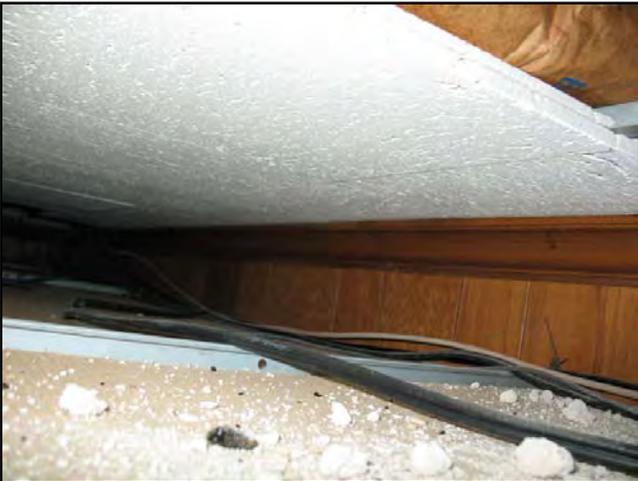
Photograph No. 9

View above ceiling tile.

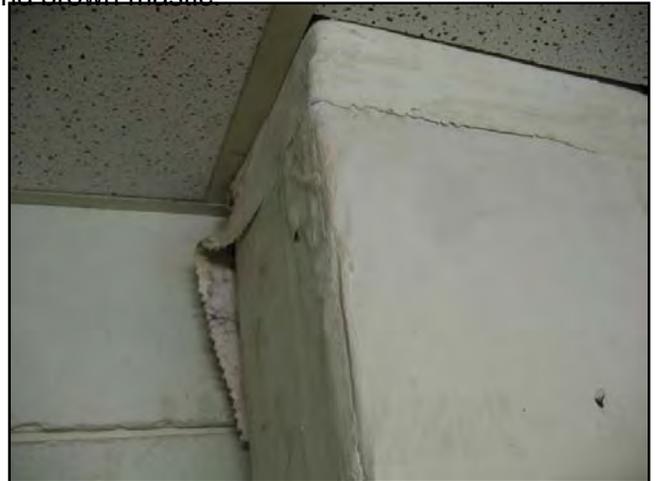
Photograph No. 10

View of HVAC ductwork mastic.

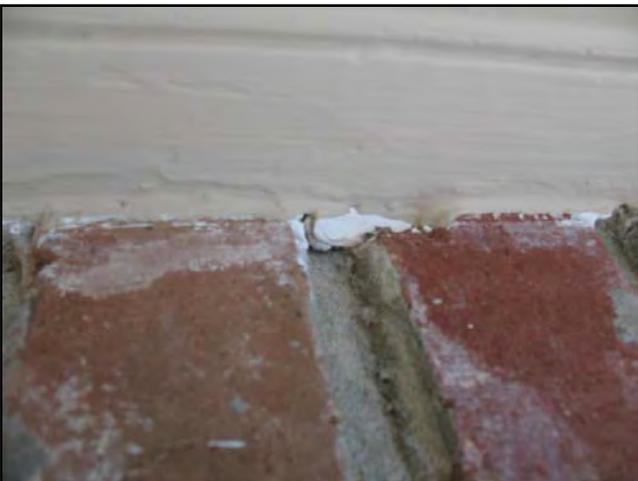
Photograph No. 11

View of exterior window caulk.

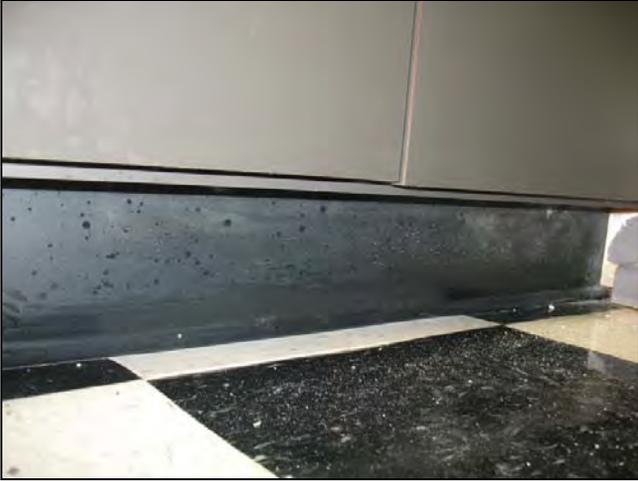
Photograph No. 7

View of black cove base and yellow mastic behind it.

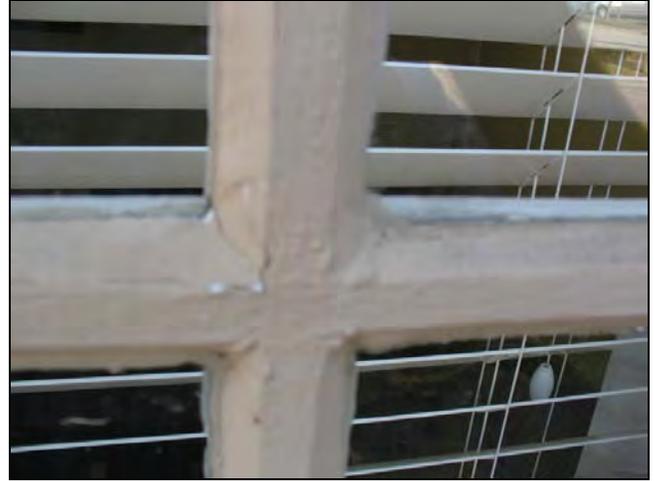
Photograph No. 8

View of window pane putty.
