ASBESTOS SURVEY REPORT

RIDGELY
COST CENTER NO. RFC#022722
124 SOUTH MAIN STREET
RIDGELY, TENNESSEE

Terracon Project No. 18097056
PO No. CA115610

October 21, 2009

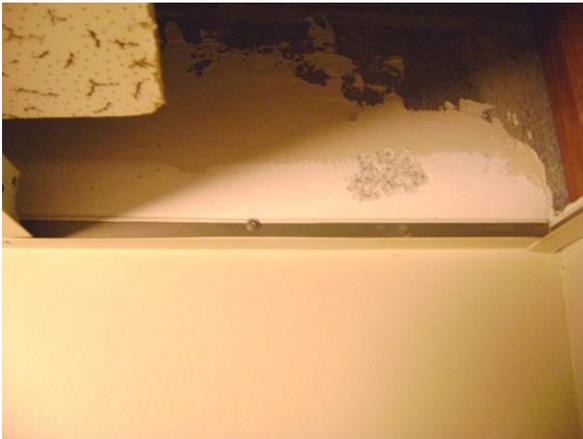
The gypsum wallboard and joint compound (white) is located in rooms 05, 06, 08, and 09 and is considered friable ACM in good condition.

The wall texture (white) on concrete block is located in rooms 05, 08, and 09 and is considered friable ACM in good condition.

Photo #3 Gypsum Wallboard and Joint Compound ACM (white) – HA 02 and Wall Texture ACM (white) on concrete block – HA 07

Terracon recommends that the friable and non-friable ACM be removed and disposed of by a TDEC-licensed asbestos abatement contractor prior to the renovation activity that will disturb the asbestos-containing materials identified.

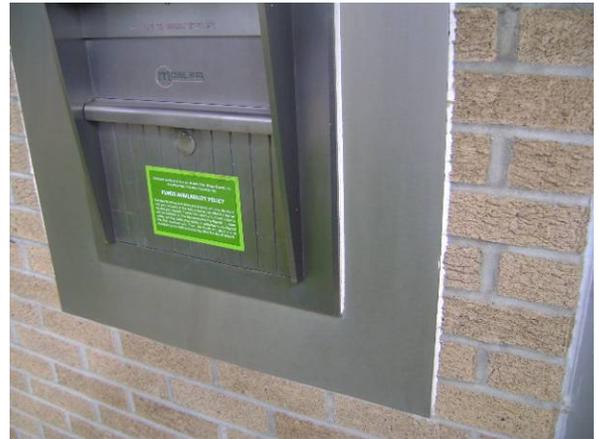
The caulk (white) is located on the exterior around the drop box and is considered Category II non-friable ACM in good condition.

Photo #4 Exterior Caulk ACM (white) around drop box – HA 08

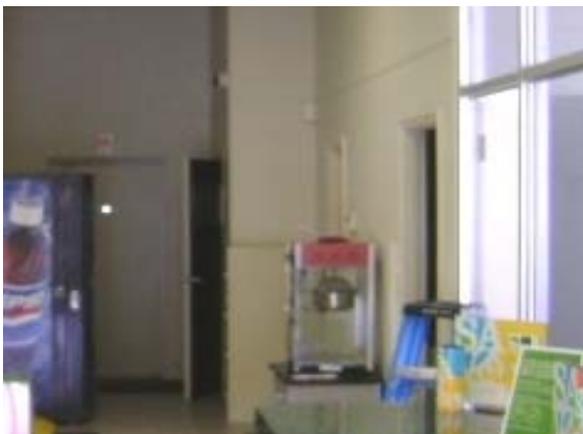
Terracon observed one (1) thermostat in room 01, the lobby, attached to a wood panel.

Photo #5 Thermostat on wood panel wall

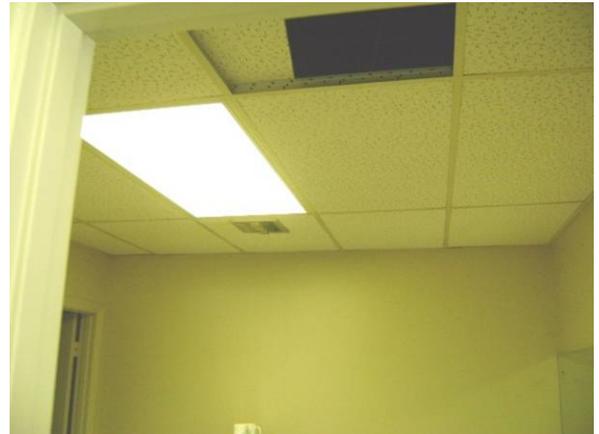
Photo #6 Lighting in 2'x4' drop ceiling tile (white, pinhole, fissure) – HA 03

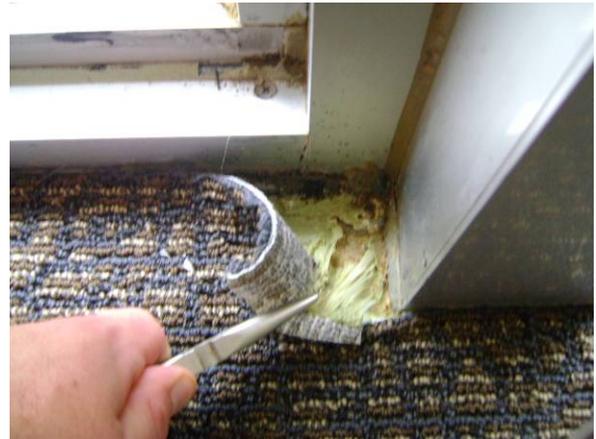
Photo #8 Carpet Mastic (green & tan) – HA 01

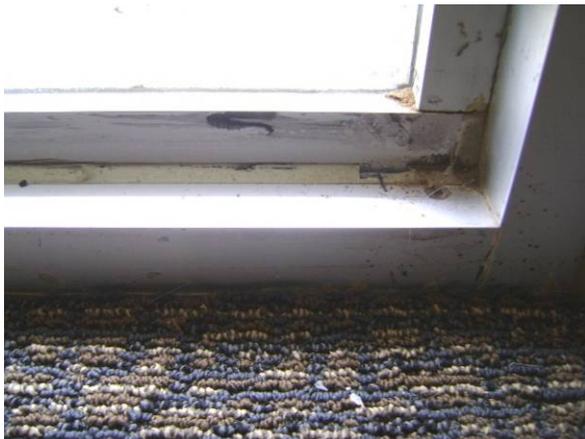
Photo #9 Window Caulk (gray) – HA 04

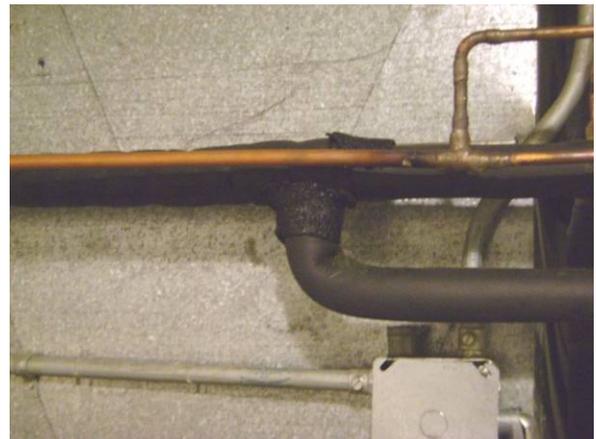
Photo #10 Asphalt Pipe Wrap (black) – HA 10

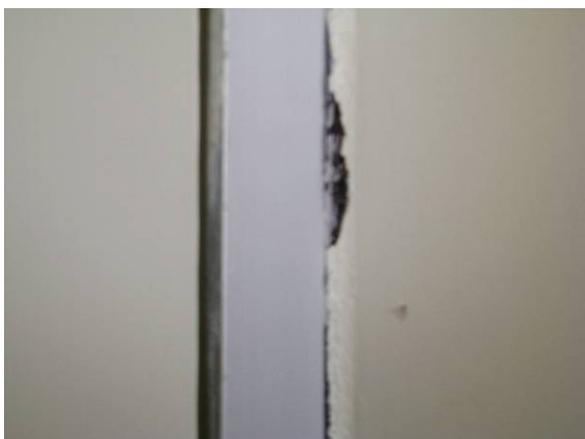
Photo #11 Door Caulk (black) – HA 06

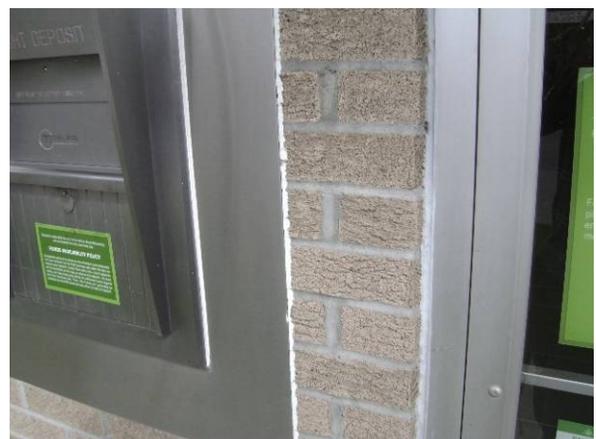
Photo #12 ACM HA 08
around drop box & exterior window
caulk (gray) – HA 09

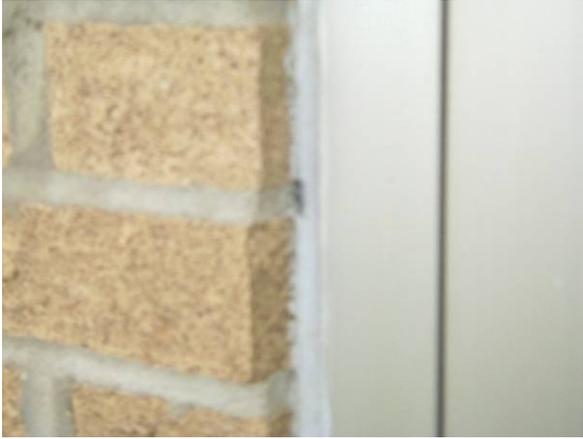
Photo #13 Exterior Caulk (white) around drive thru window – HA 10

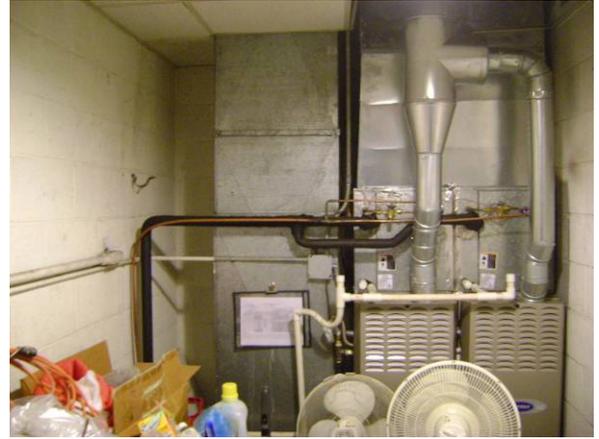
The building is a one-story, concrete brick structure constructed in 1968. The exterior consists of brick with metal frame windows and doors. Interior walls consist of gypsum wallboard, wood, glass, ceramic tile, concrete and concrete block. The floors are finished with ceramic tile, concrete and carpet. Ceilings throughout the approximately 3,500 square foot building are concrete, corrugated metal decking, and 2'x4' suspended ceiling tiles. The heating, ventilation and air conditioning (HVAC) system is located in room 07, the utility storage room. No suspect asbestos-containing materials were observed associated with the HVAC system.

Photo #14 General view of HVAC system in room 07

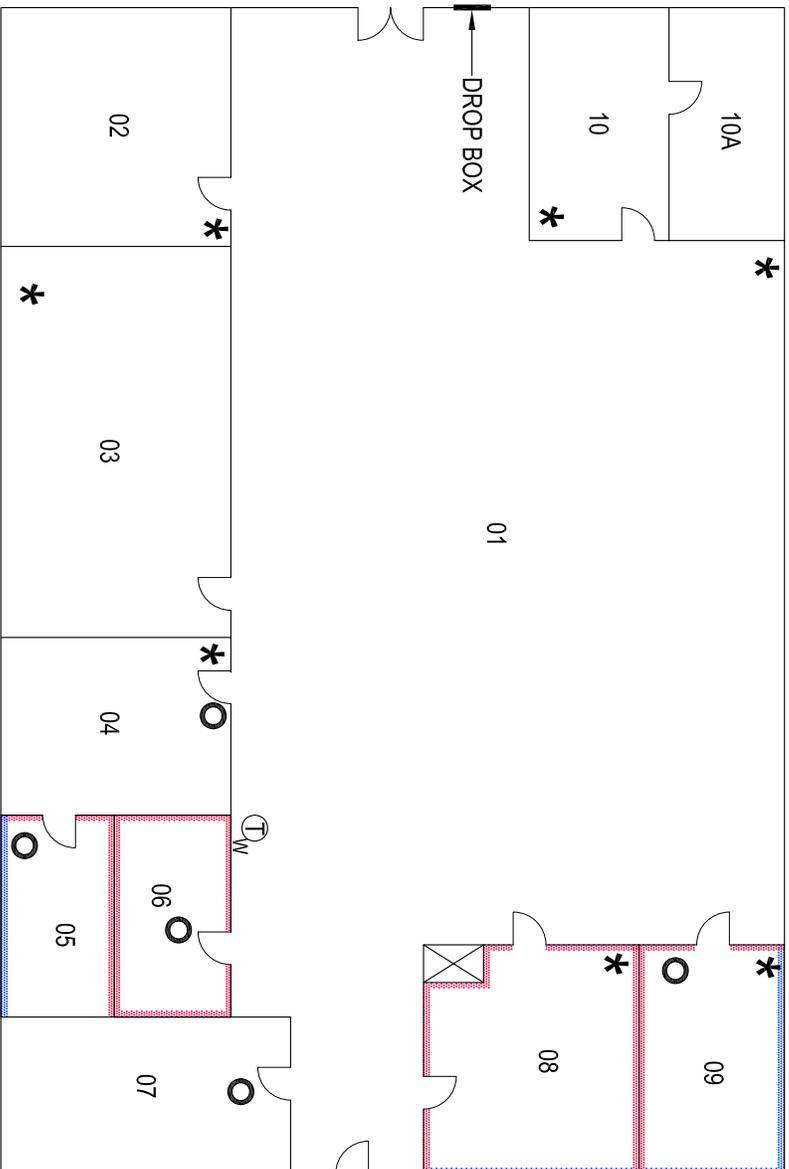
NOTE:
 ASBESTOS-CONTAINING EXTERIOR CAULK (WHITE) PRESENT
 ON DROP BOX AT WESTERN SIDE OF BUILDING.
