# Asbestos Survey Report

**Greenback**

**6705 Morganton Road**

Terracon Project No. 49107341

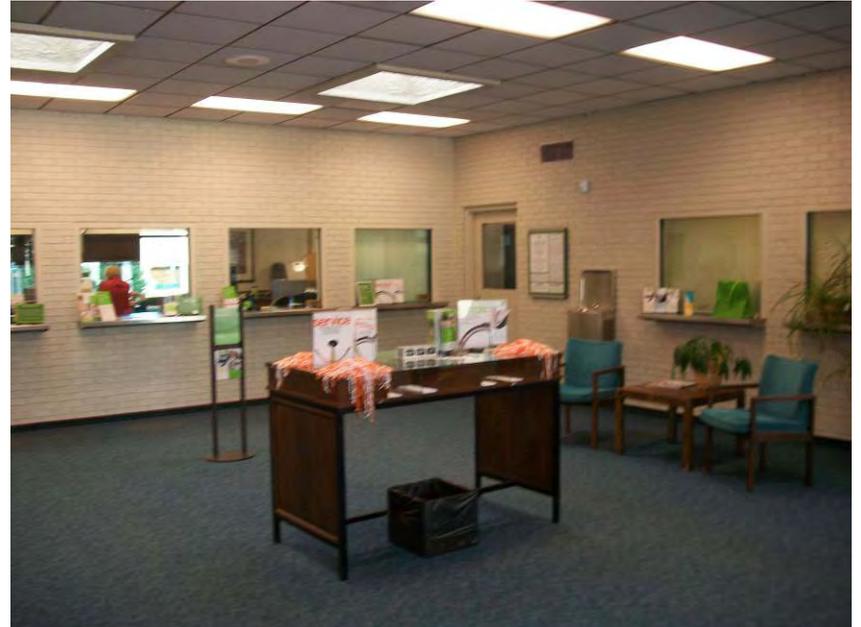
Carpet mastic is located in the stairwells, basement vault, and throughout the 1<sup>st</sup> floor areas. The mastic is considered Category I non-friable ACM in good condition.

**Photo 2:** View of the lobby with non-ACM 2'x2' ceiling tiles (HA 13), ACM carpet mastic (HA 9), and non-ACM texture brick paint (HA 12).

Terracon recommends that the identified ACM be removed and disposed of by a TN-licensed asbestos abatement contractor prior to the renovation activity that will disturb the asbestos-containing materials identified.

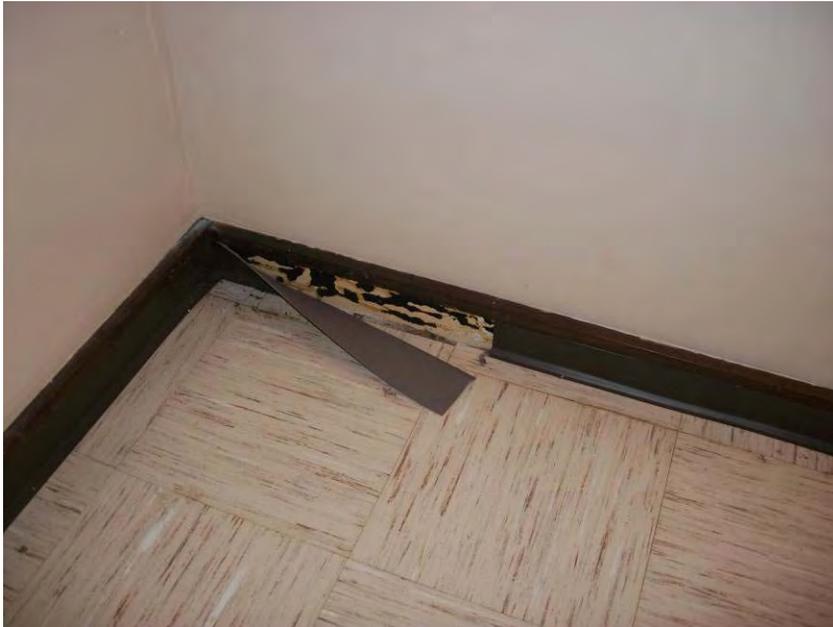
Black mastic associated with 12"x12" floor tiles (tan with streaks) is located throughout the majority of the basement areas and is considered Category I non-friable ACM in good condition.

**Photo 3:** View of the non-ACM 12"x12" floor tile with associated ACM black mastic (HA 1) and non-ACM cove base mastic (HA 2).

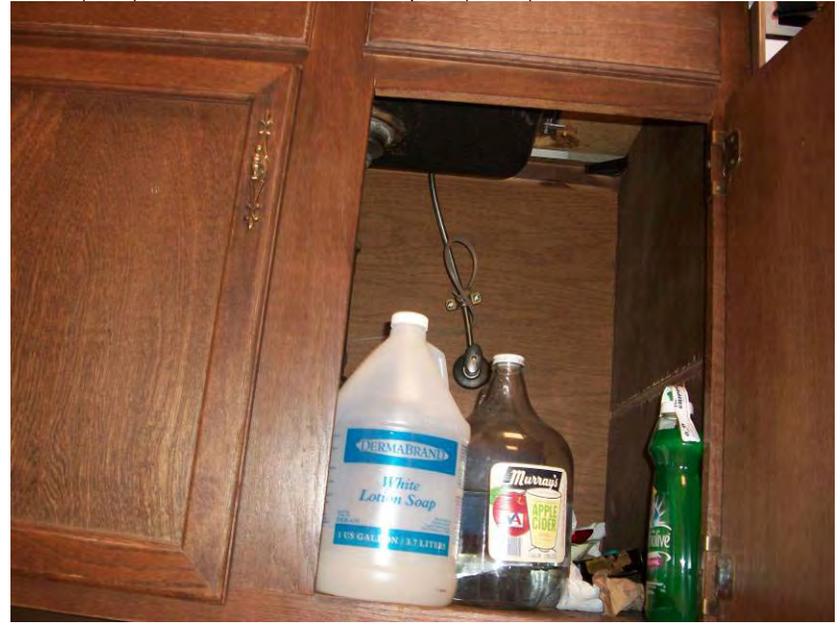
Sink undercoating is located in the basement break room and is considered Category II non-friable ACM in good condition.

**Photo 4:** View of the ACM sink undercoating (HA 3) located in the basement.

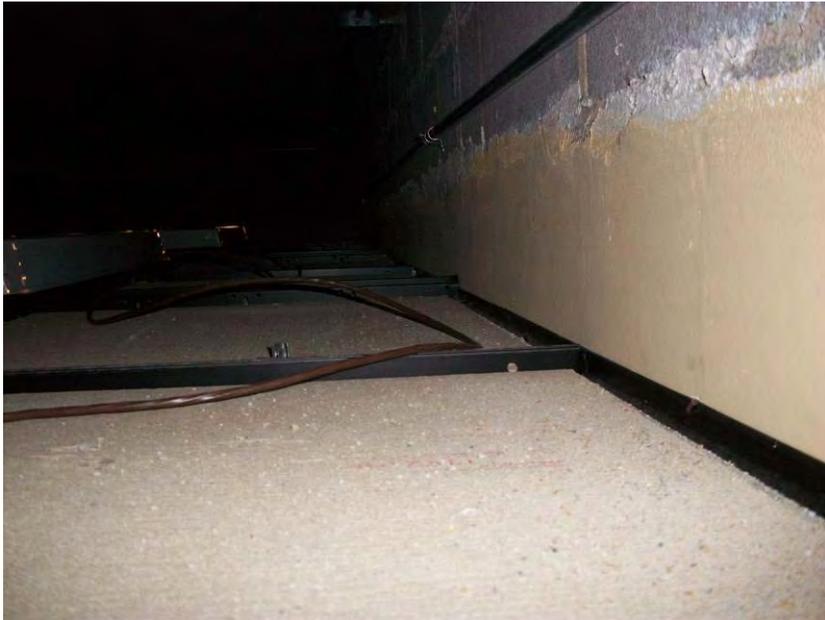
**Photo 5:** View of the non-ACM plaster walls (HA4).

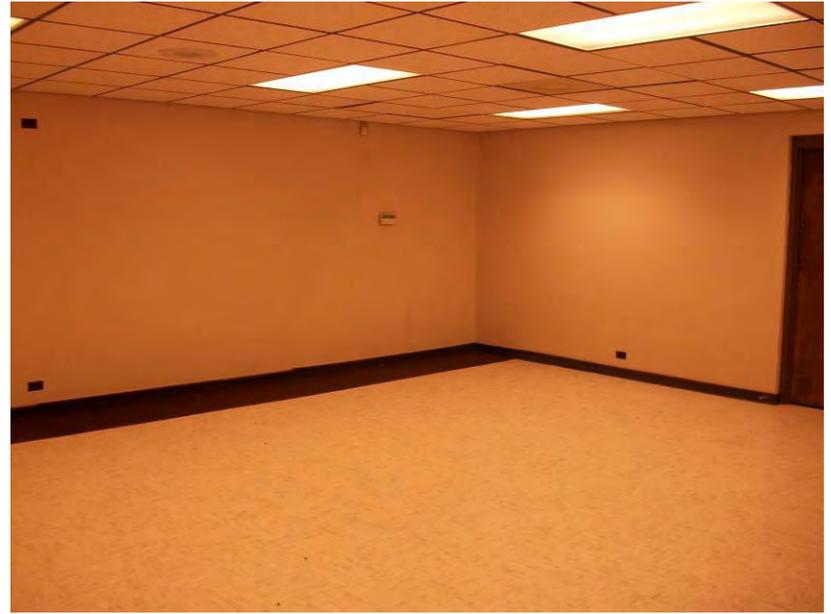
**Photo 6:** View of the non-ACM 2'x2' ceiling tiles (various styles HA 5-7) located in the basement.

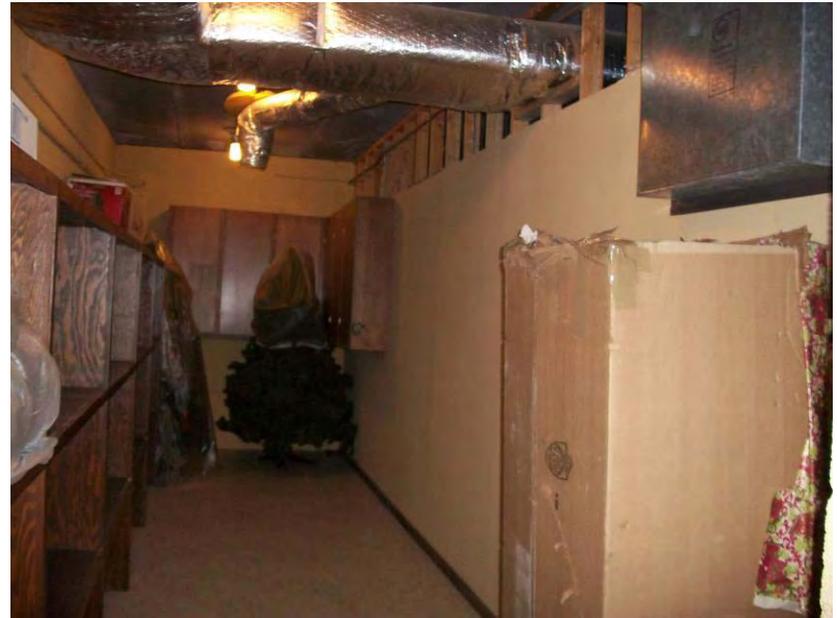
**Photo 8:** View of the non-ACM drywall/joint compound (HA10) located in the basement.

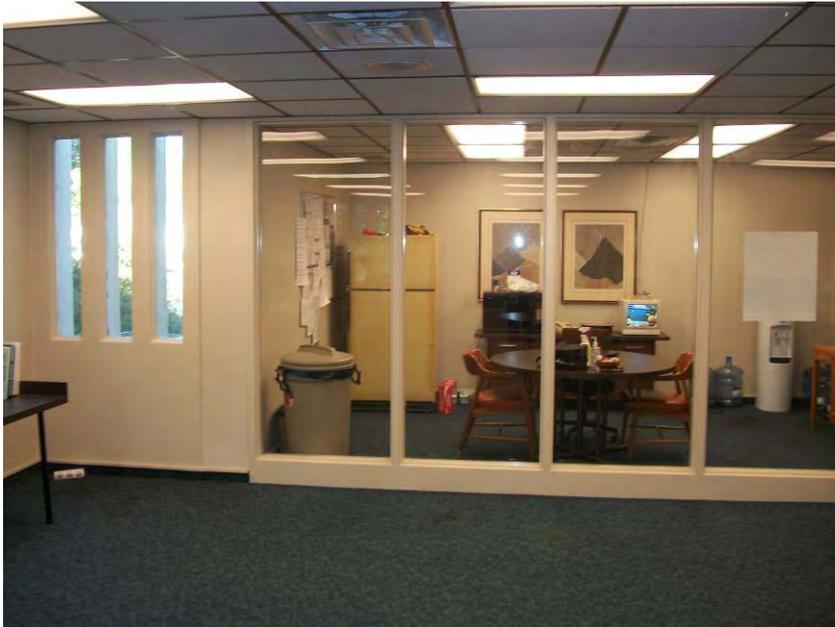
**Photo 9:** View of the non-ACM 2'x2' ceiling tiles (HA 6, 7 and 13), ACM carpet mastic (HA 9), and textured window paint (HA 11) located in the work area.

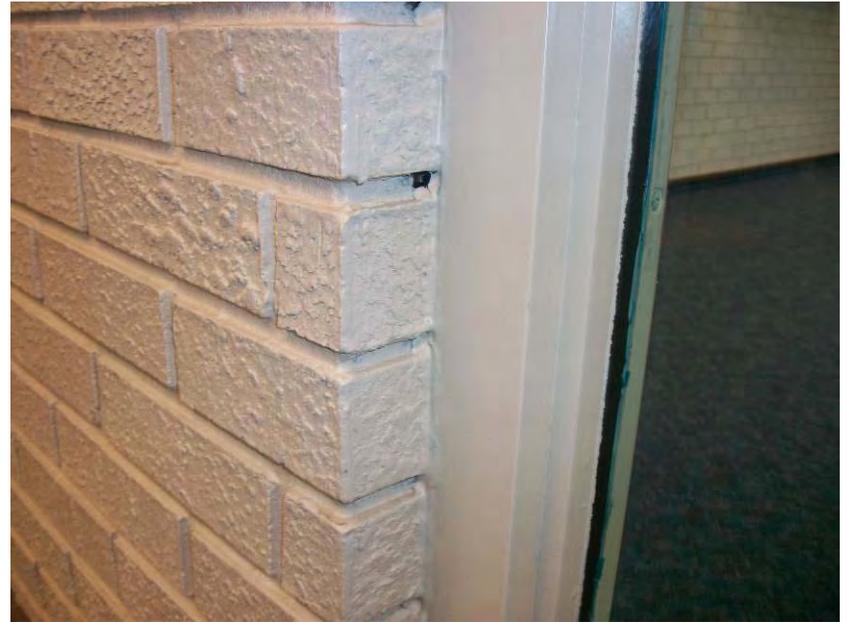
**Photo 10:** View of the non-ACM textured brick paint (HA 12) and interior window caulking (HA 14).

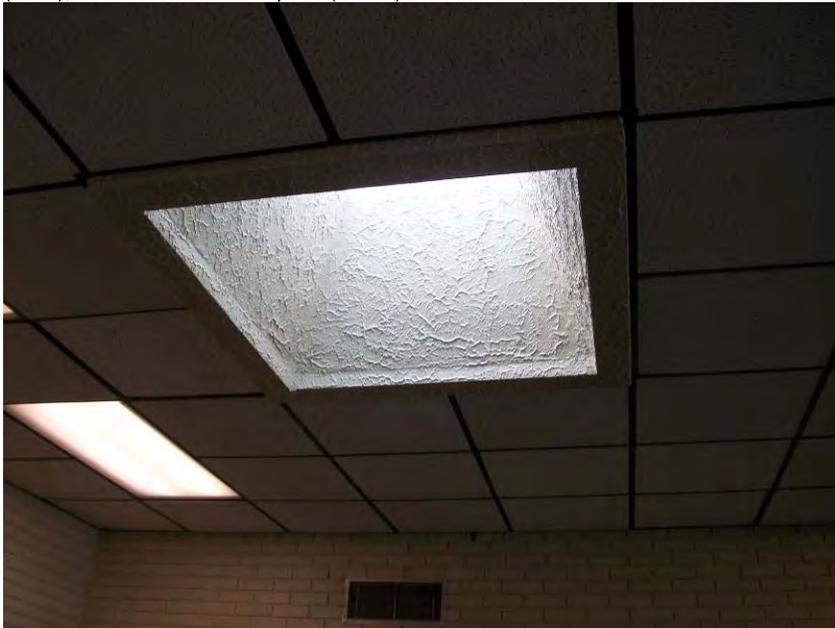
**Photo 11:** View of the non-ACM textured skylights (HA 15).

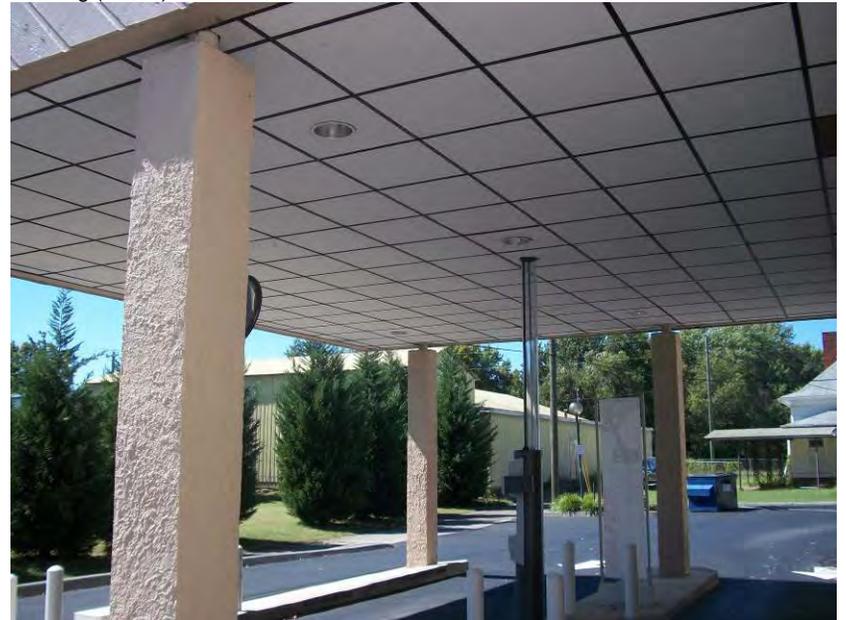
The 2'x2' cementitious ceiling tiles are associated with the overhangs at the entry and drive-thru areas are considered Category II non-friable ACM in good condition.

**Photo 12:** View of the ACM 2'x2' cementitious ceiling tiles (HA 16).

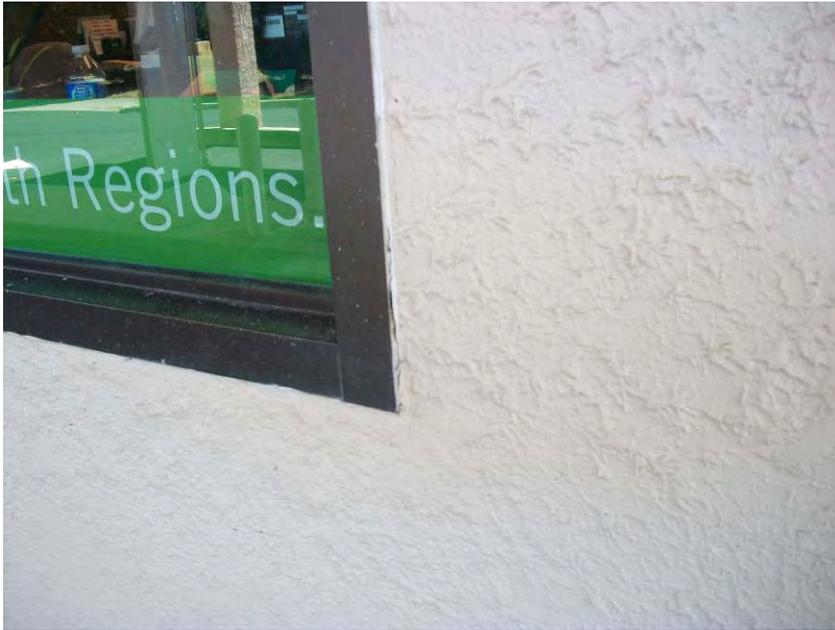
Photo 13: View of the non-ACM exterior texture (HA 19) and non-ACM teller window caulking (HA 20).

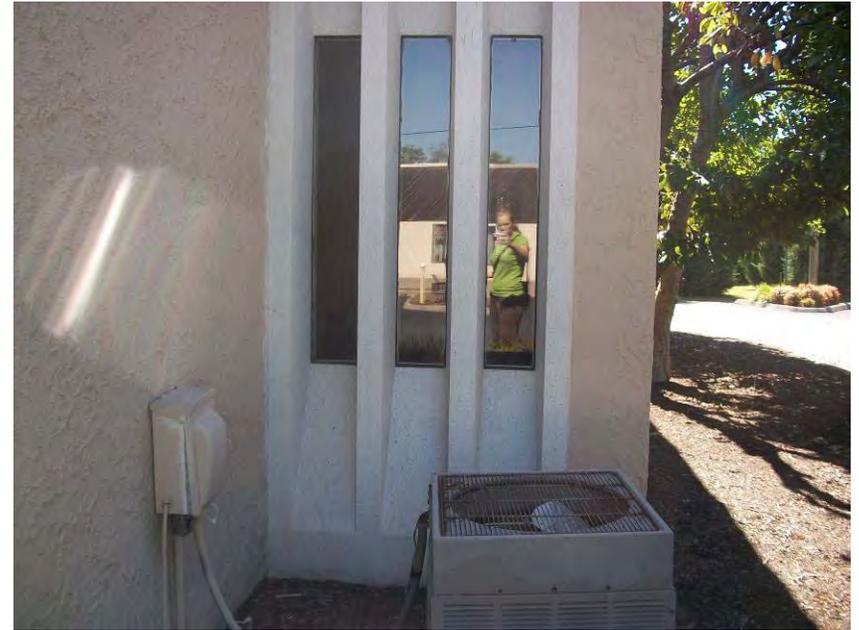
The window/door caulking and window caulking are located around the exterior windows and doors and are considered Category II non-friable ACM in good condition.

Photo 14: View of the ACM rectangular window caulking (HA 21).
