Asbestos Survey Report

North Gault

1718 Gault Avenue N

Terracon Project No. 49107374

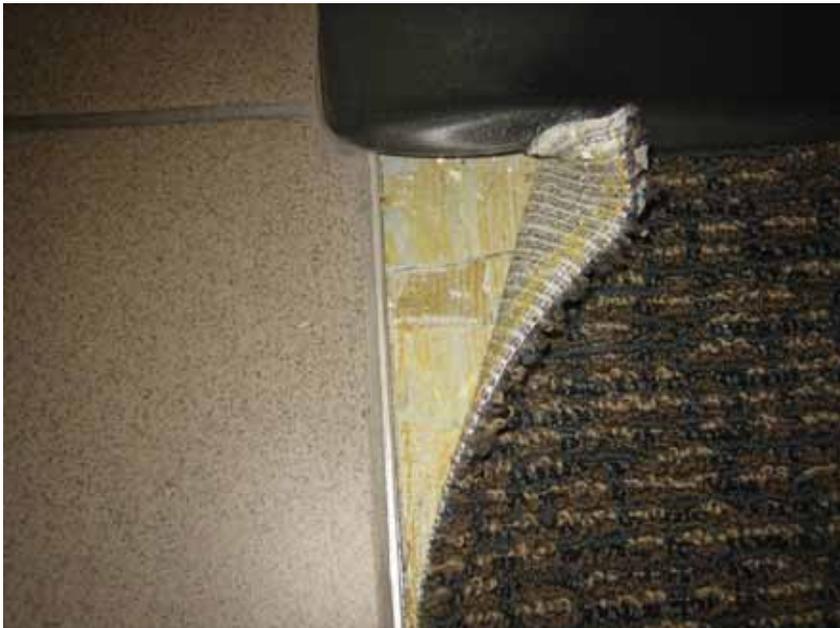
Photo 3: Non-ACM carpet mastic (HA 1) and non-ACM 2nd layer flooring and mastic (HA 10).

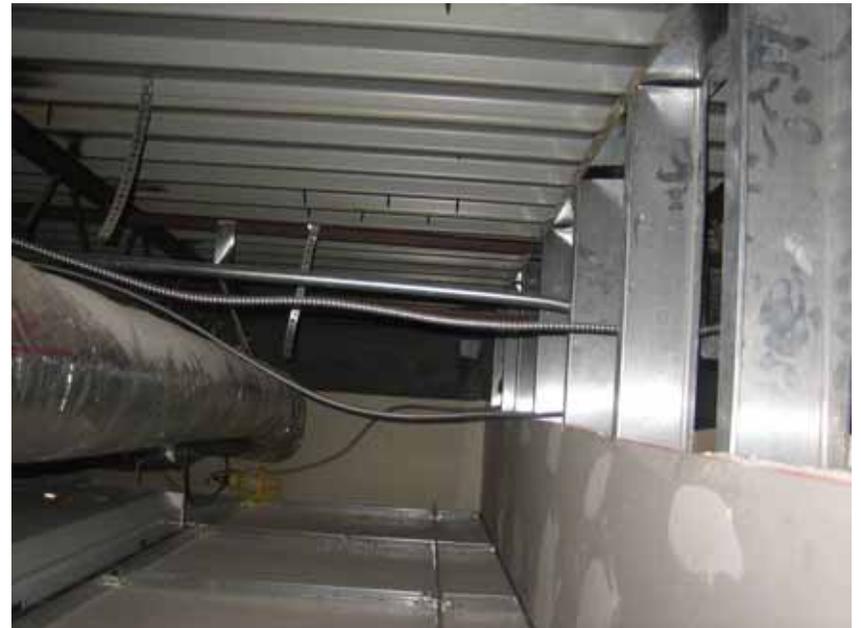
Photo 4: View above the non-ACM lay-in ceiling tile system (HA 3) and non-ACM drywall joint compound (HA 4).

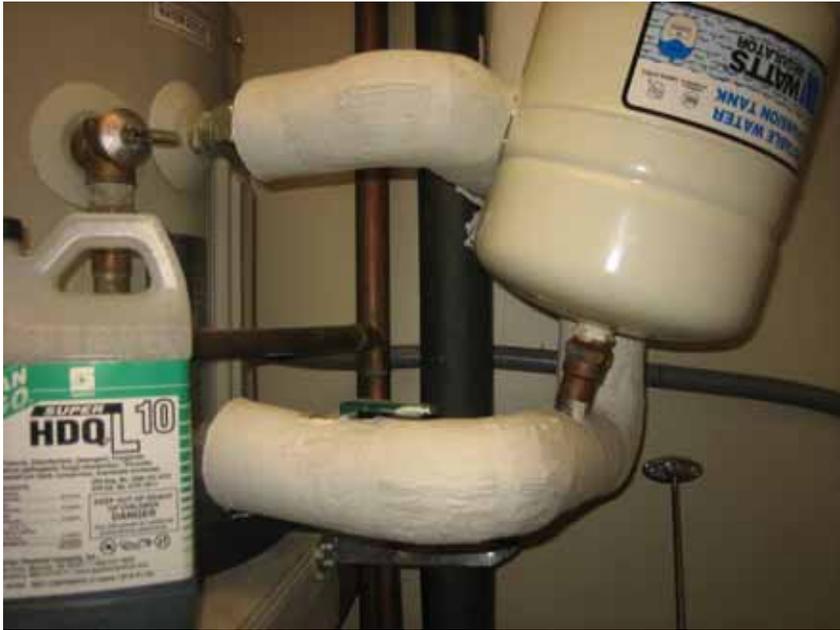
Photo 5: Non-ACM white pipe mastic (HA 5).

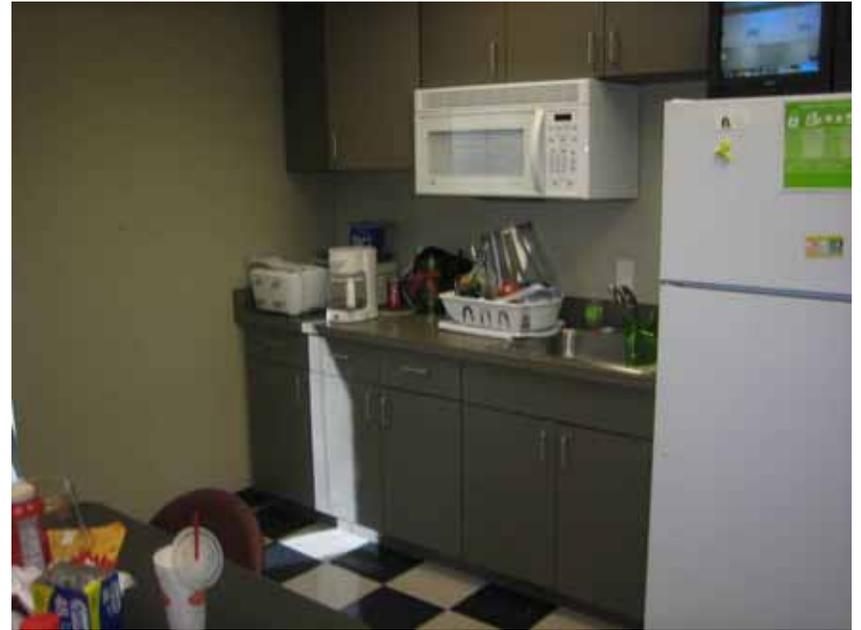
Photo 6: Non-ACM 12"x12" floor tile (HA 6 and HA 7).

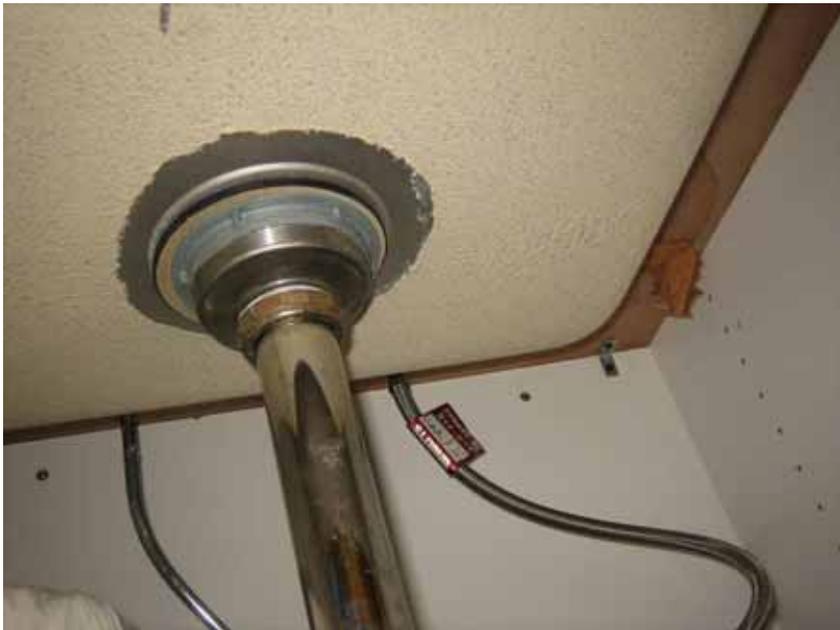
Photo 7: Non-ACM sink undercoating (HA 8).

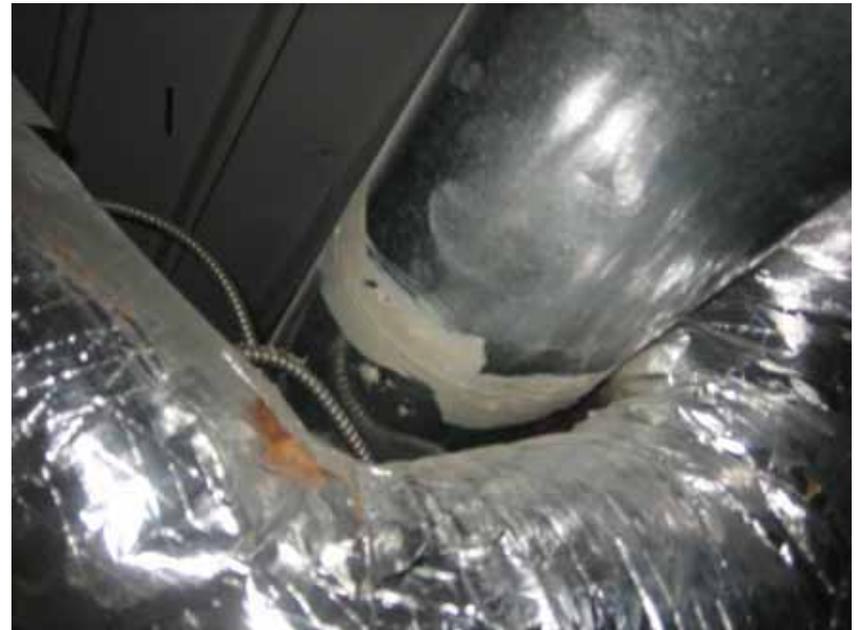
Photo 8: Non-ACM round duct mastic (HA 12).

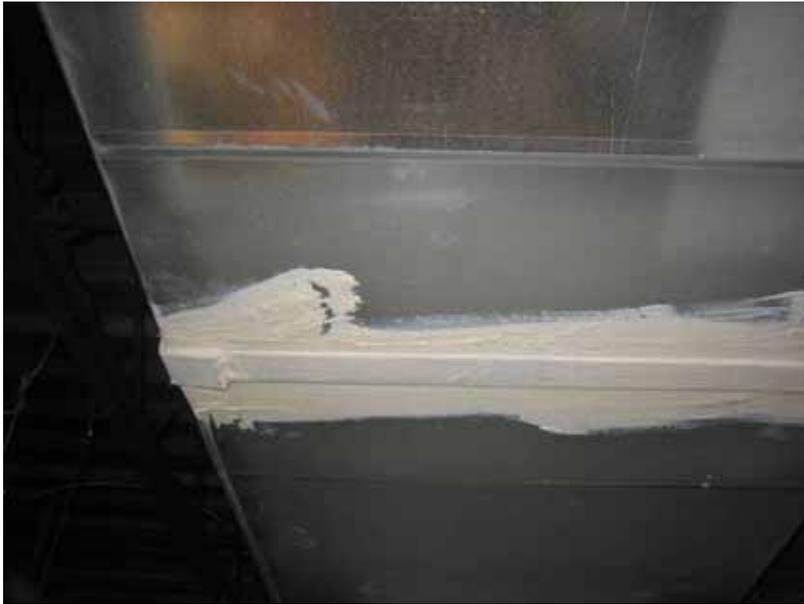
Photo 9: Non-ACM HVAC duct mastic (HA 13).

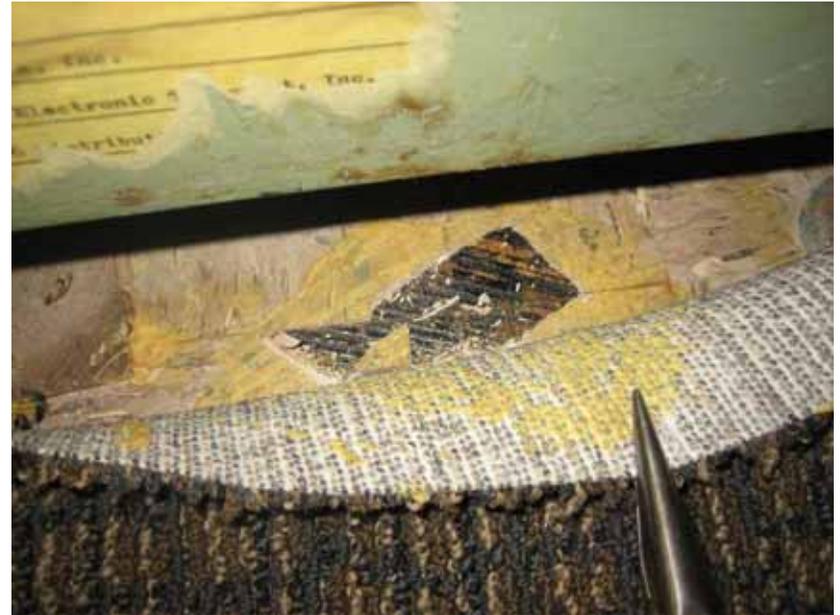
The black mastic was associated with non-ACM floor tile under carpet in the safety deposit vault. The black mastic is considered Category I non-friable ACM in good condition.

HA No.	Description	Material Location	Percent/Type Asbestos	NESHAP Classification	Condition	Estimated Quantity
14	Floor tile 2 nd layer	Under carpet in safety deposit vault	ND – floor tile 5%C – black mastic	Category I non-friable	Good	150 SF

Photo 10: Non-ACM floor tile under carpet with ACM black mastic (HA 14) in the safety deposit vault.

Terracon recommends that the identified ACM be removed and disposed of by an AL-licensed asbestos abatement contractor prior to renovation activity that will disturb the asbestos-containing materials identified.

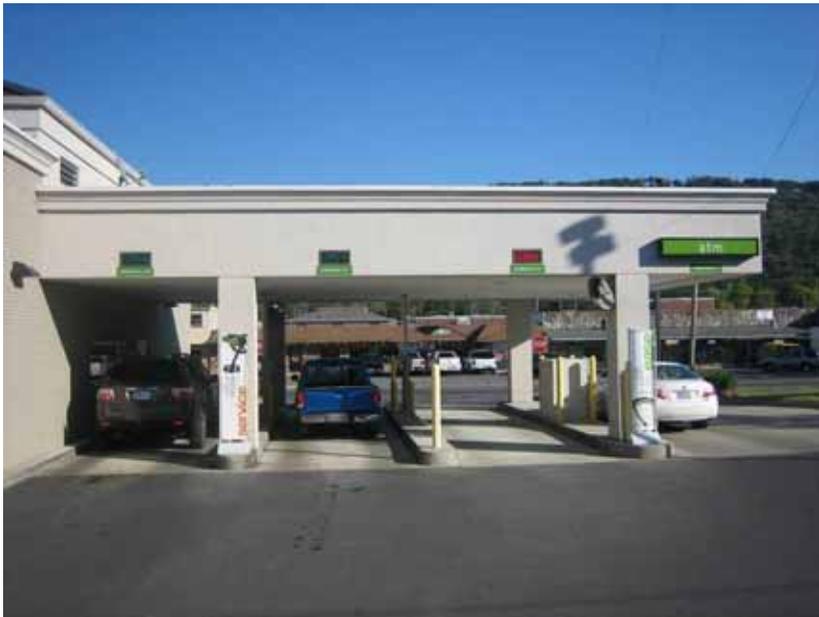
Photo 11: View of the drive-thru with non-ACM EIFS (HA 18).

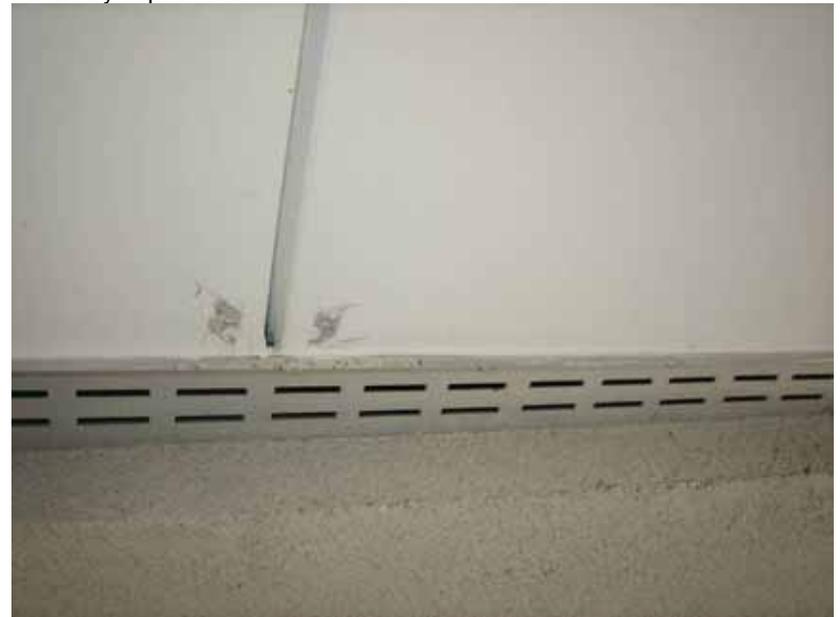
Photo 12: View of the drive-thru ceiling with non-ACM drywall / joint compound (HA 17).
