Asbestos Survey Report

West Rome

210-1 Shorter Avenue

Terracon Project No. 49107389-2

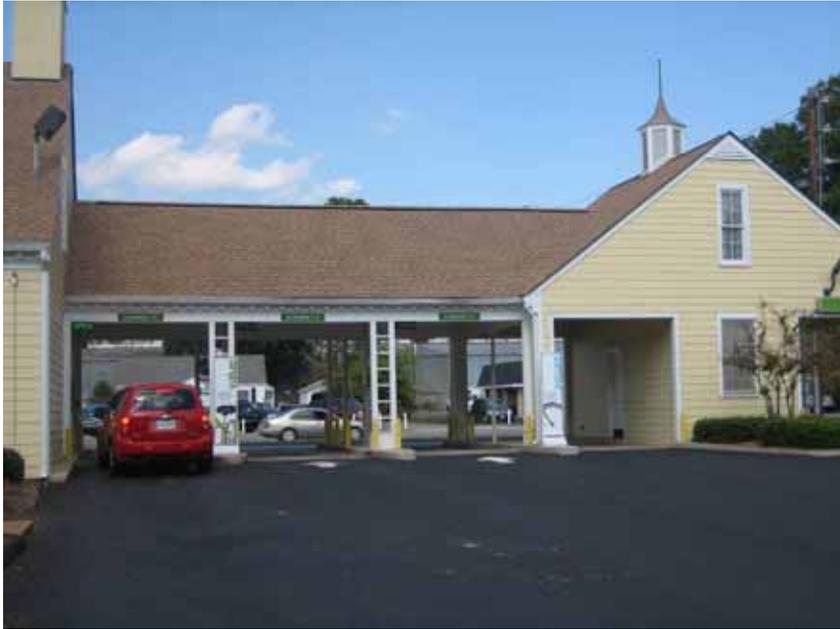
Photo 1: ATM/storage room at east end of drive –through lanes of West Rome.

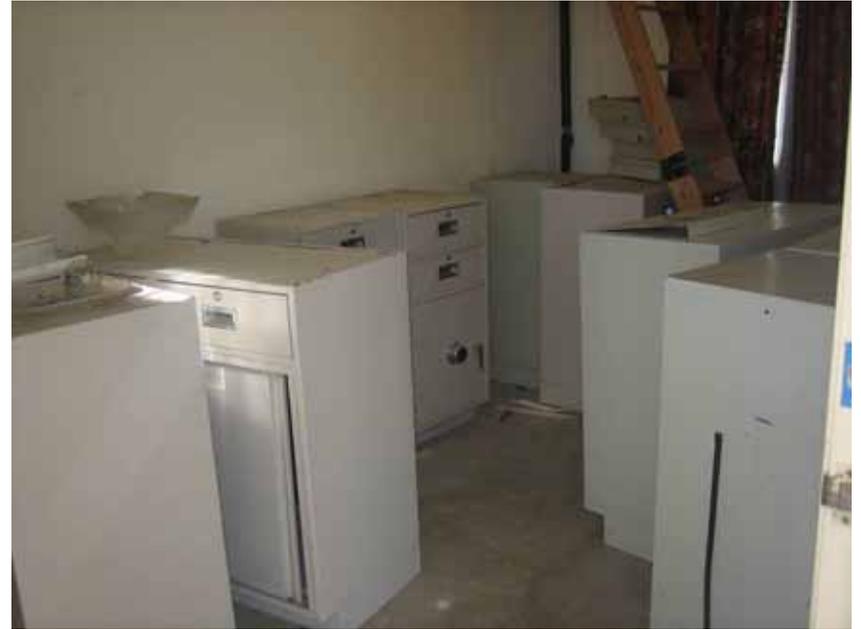
Photo 2: View of the storage portion of ATM/storage room.

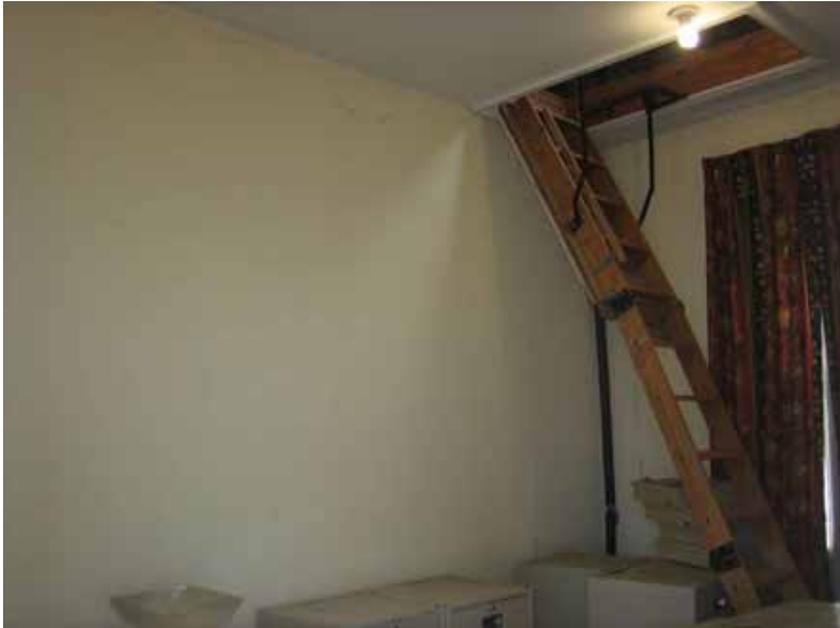
Photo 3: View of the storage portion of ATM/storage room.

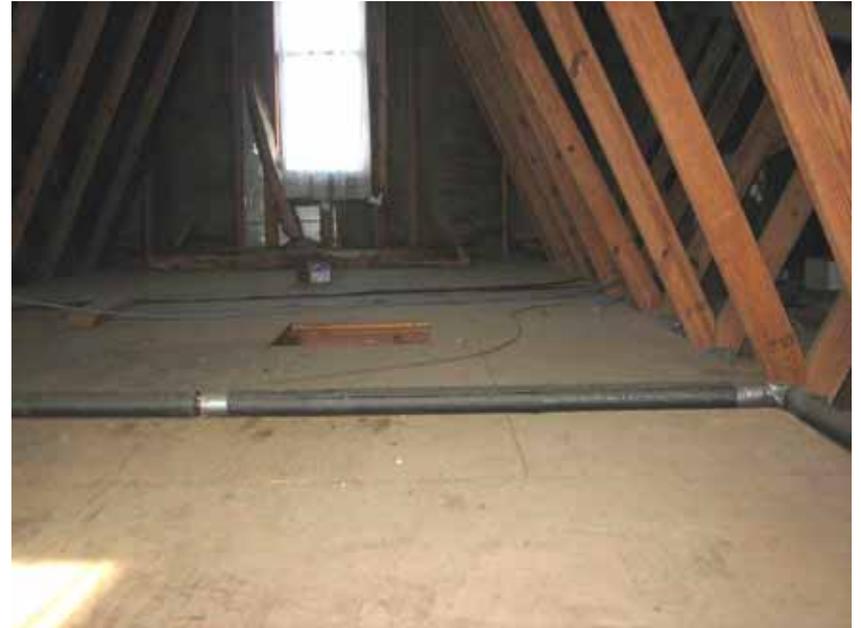
Photo 4: View of the attic space above ATM/storage room.

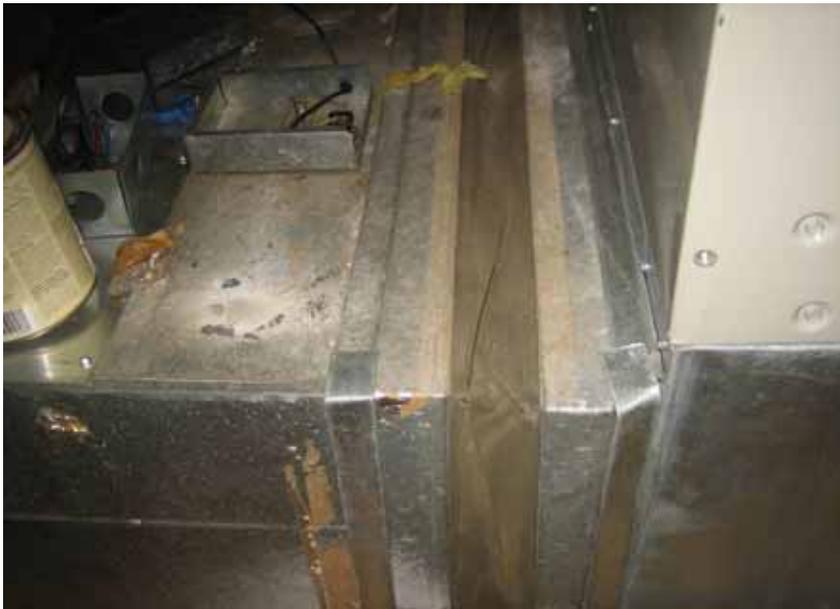
Photo 7: View of the non-ACM vibration dampener in attic.

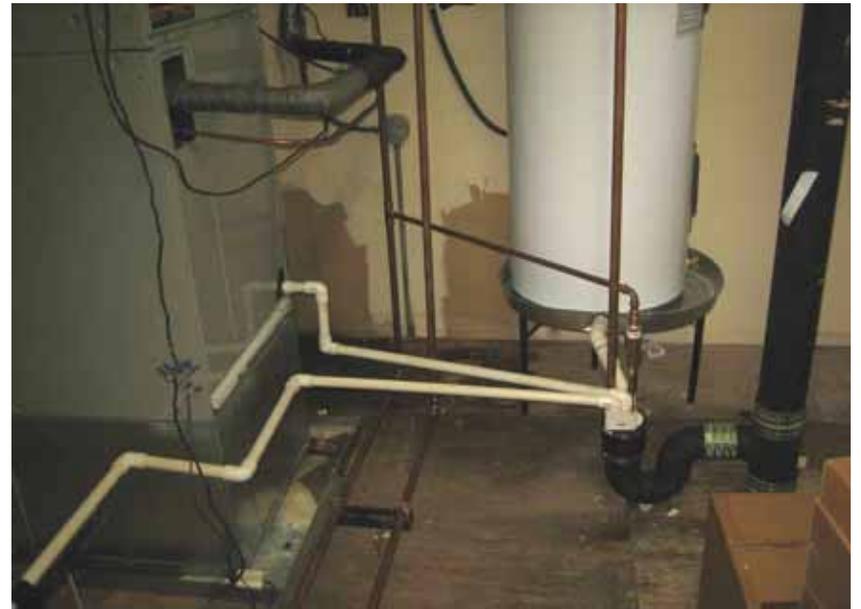
Photo 8: View of the mechanical systems in the attic.

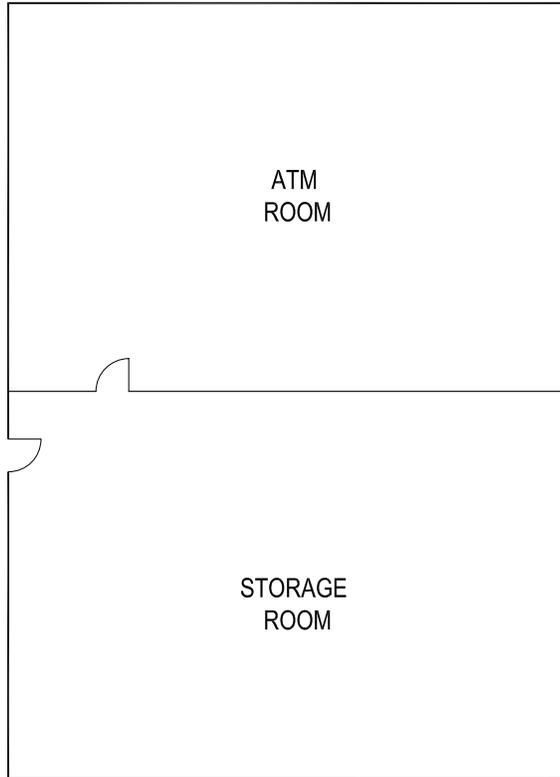
FIG. No. 1

THE BANK DOES NOT HAVE ACCESS TO THE ATM ROOM. TERRACON WAS ABLE TO ACCESS THE STORAGE ROOM PORTION OF THE ATM/STORAGE ROOM.

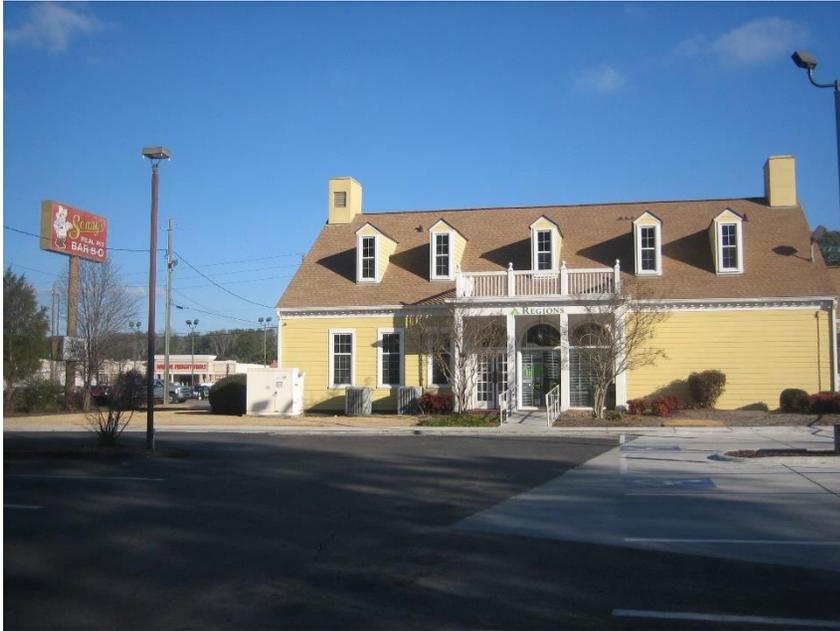
Photo 1: Exterior of West Rome branch.

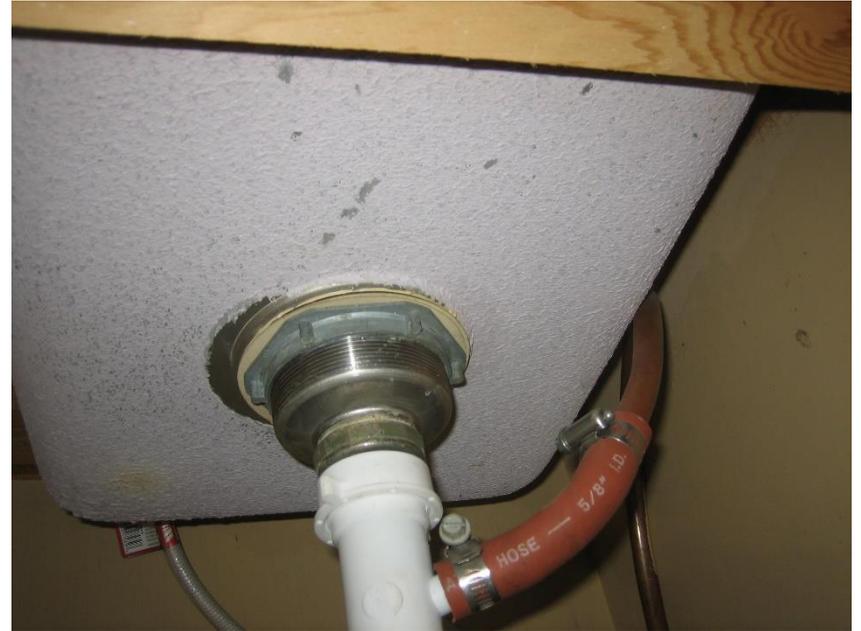
On January 30, 2018 Terracon performed an interior re-assessment of the facility. The white sink undercoating listed in the Terracon ACM survey conducted in 2010 was observed in the breakroom and is in good condition. The remaining non-ACM materials identified in the previous surveys were observed in good condition.

Photo 2: ACM Sink Undercoating in the Breakroom.

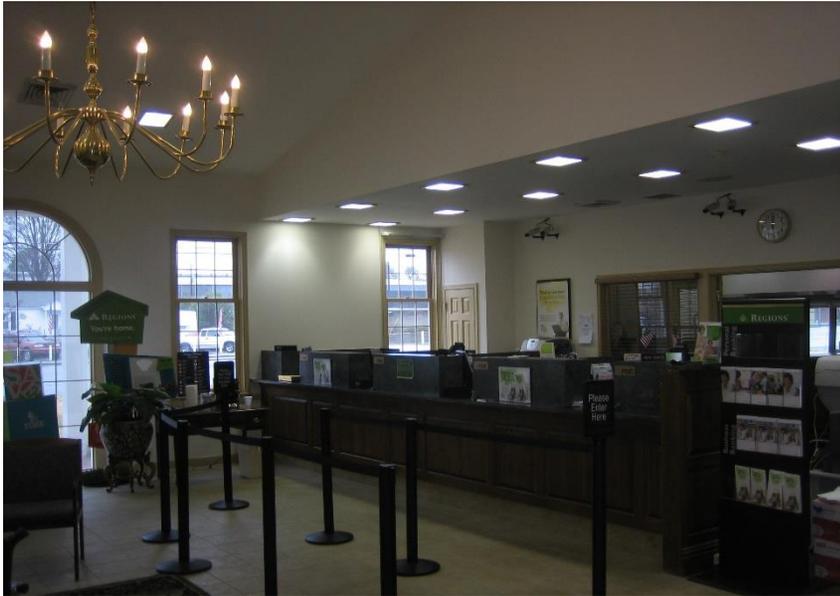
Photo 3: View of Lobby.
