3221 Pineridge Dr  
Chesapeake VA 23321

2/17/2020

Burke Inspection Service dba HouseMaster - VA #3380001054  
109-G Gainsborough Sq.  
#165  
(757)822-4839

Single Family

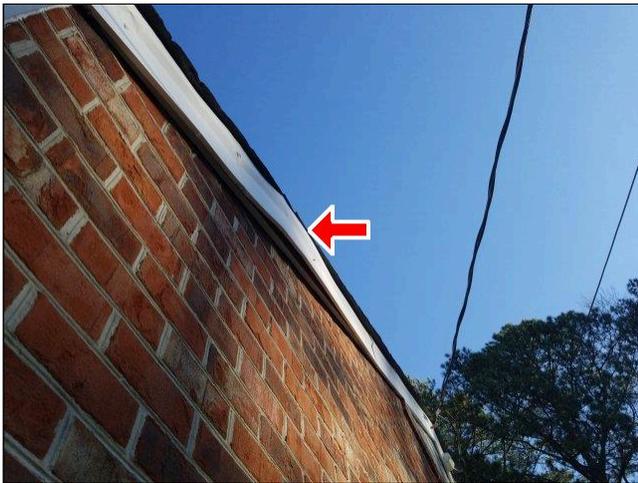
1.8 FASCIA / SOFFITS Photo 1

Loose fascia capping noted at the left side of the home, correct and maintain as needed.

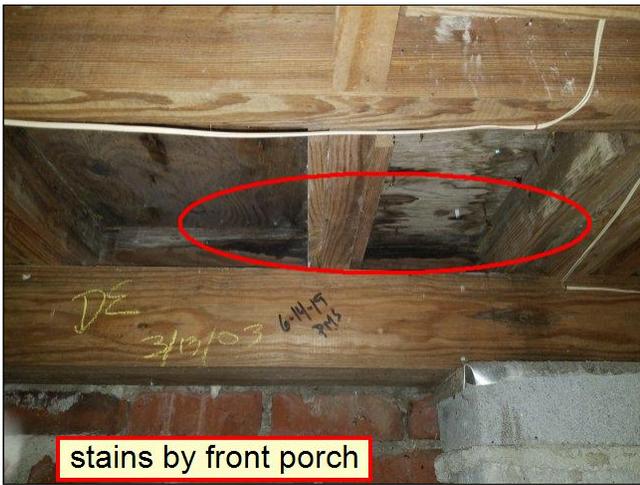
9.2(2) FLOOR FRAMING Photo 2

stains by front porch

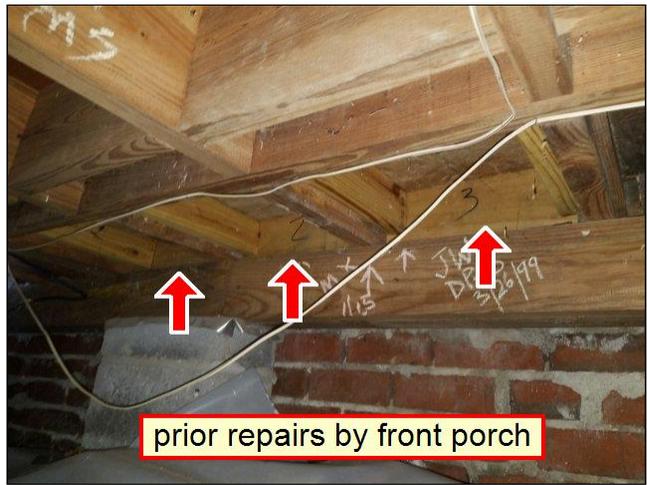
9.2(2) FLOOR FRAMING Photo 3

prior repairs by front porch

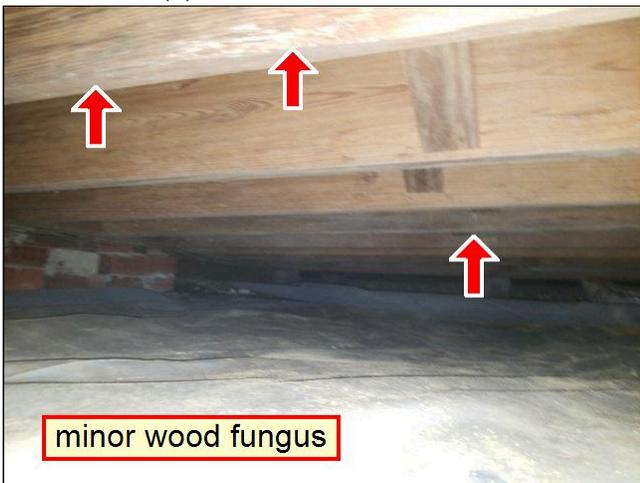
9.2(3) FLOOR FRAMING Photo 1

minor wood fungus

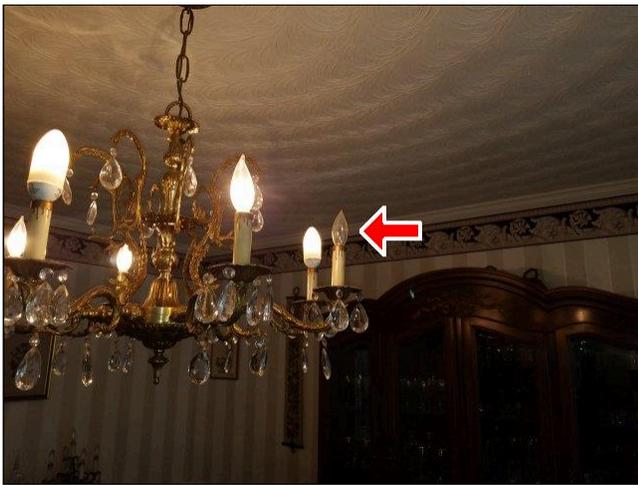
10.5(1) DEVICES Photo 1

●					<b>10.5 DEVICES</b>  (1) Inoperable light fixtures noted, replace bulbs as needed and verify proper operation of all fixtures prior to closing.  (2) Light fixtures with exposed bulbs are no longer permitted in clothes closets, consider replacing / upgrading.
