422 Crawford St  
Portsmouth VA 23704

3/17/2020

Burke Inspection Service dba HouseMaster - VA #3380001054

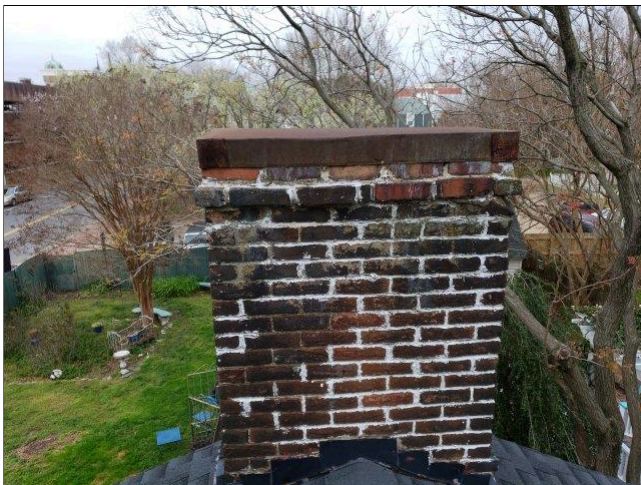
1.2 Photo 1

The chimney at the rear of the Slave Quarters appears to have been re-pointed with an improper type of mortar and/or caulk, which can lead to additional cracking and damage; the metal cap that was used to seal that chimney is rusting; and the parge coating that was added to the other two chimneys has cracked in a few locations. Inspection was limited to readily accessible and visible components. Recommend having more intrusive "Level 2" inspections performed by a (CSIA) Certified Chimney Sweep prior to the sale of the property.

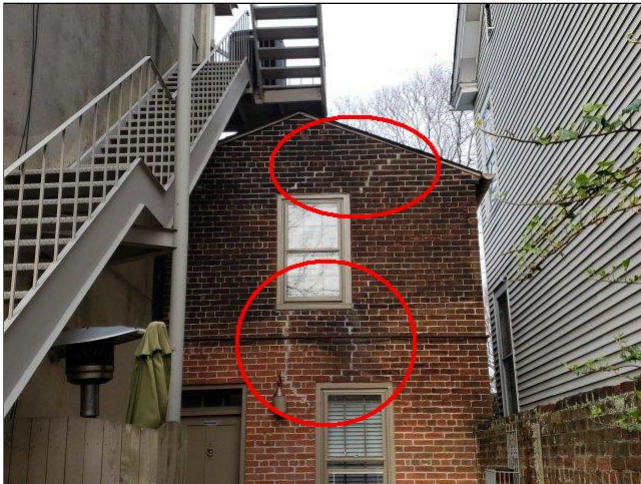
2.0 Photo 1

Settlement cracking is evident in the brick walls in a few locations, a few damaged bricks were noted as well. This is a relatively normal condition for a structure of this age. Have checked and re-pointed as needed by a licensed Masonry Contractor and anticipate periodic re-pointing needs.

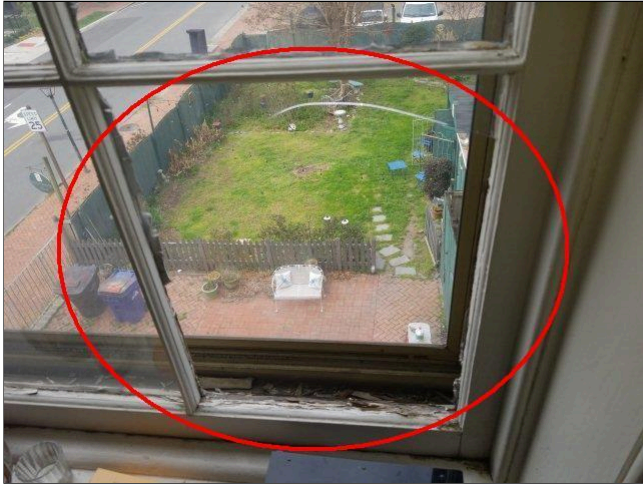
2.2 Photo 1

Cracked panes were noted at multiple windows, as was deteriorated paint and glazing; in particular, a portion of a pane is missing from a window at the rear 3rd Fl BR; minor decay was found in the wood exterior trim in a few locations as well; and the sash cords are missing from many of the windows, making them inoperable. Have all of the windows checked and corrected as needed by a licensed Contractor.

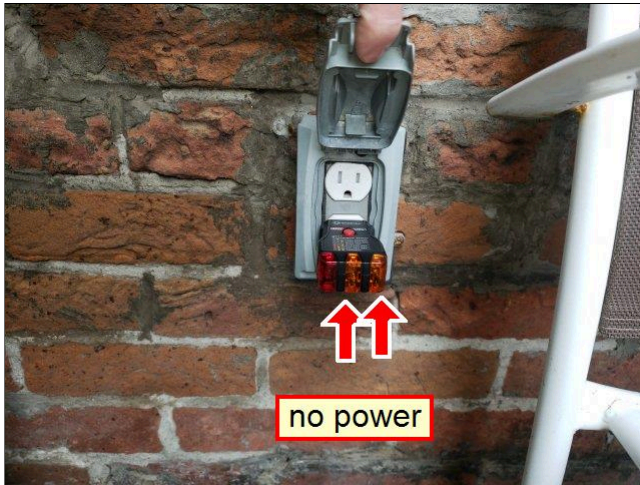
2.8 Photo 1

No power was detected at the receptacle outlet on the front of the Slave Quarters; the GFCI on the rear of the main house is defective / will not test; the receptacle outlets in the Sheds and in the Electrical Rm are not GFCI protected; and improperly exposed cabling was noted in those locations as well. Have checked and corrected as needed by a licensed Electrical Contractor.

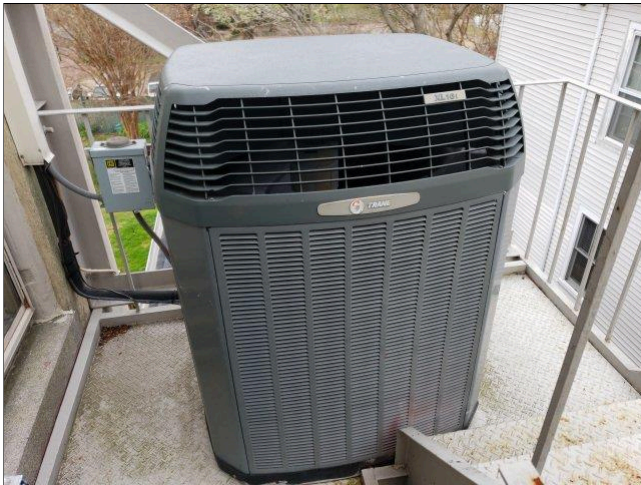
2.10 Photo 1

The fire escape appears to be in generally good condition, but the landings at the 3rd & 4th floors are obstructed by the presence of Heat Pump condensing units. Recommend having the Heat Pumps relocated to ground level to allow for proper and safe egress.

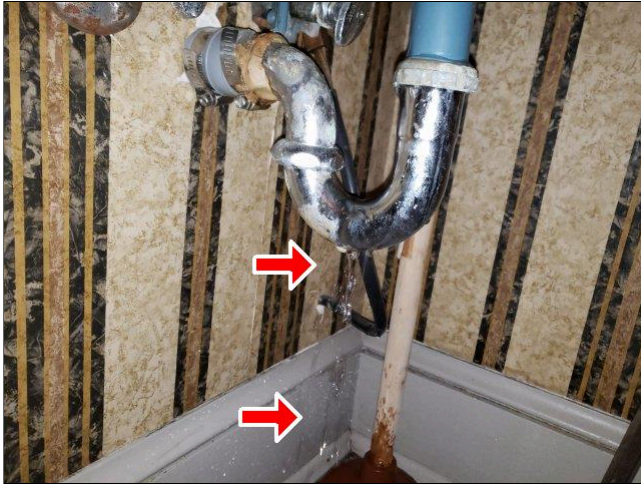
5.0.A Photo 1

The drain was clogged and significant leakage was observed at the drain piping, have checked and corrected as needed by a licensed Plumbing Contractor.

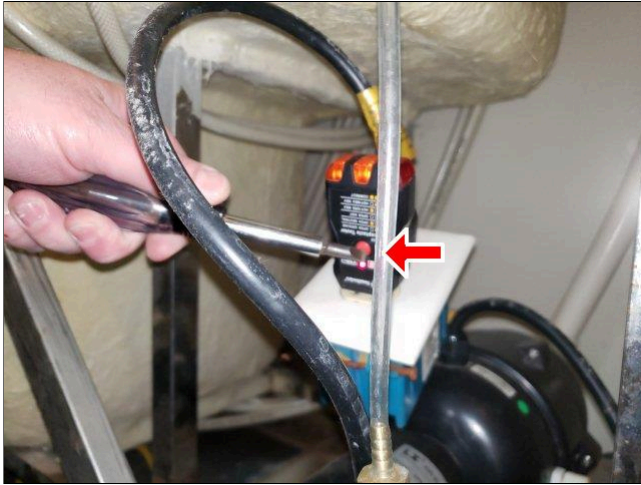
5.7.B Photo 1

The circuit for the Jetted Tub is not GFCI protected, have checked and corrected as needed by a licensed Electrical Contractor to ensure safety.

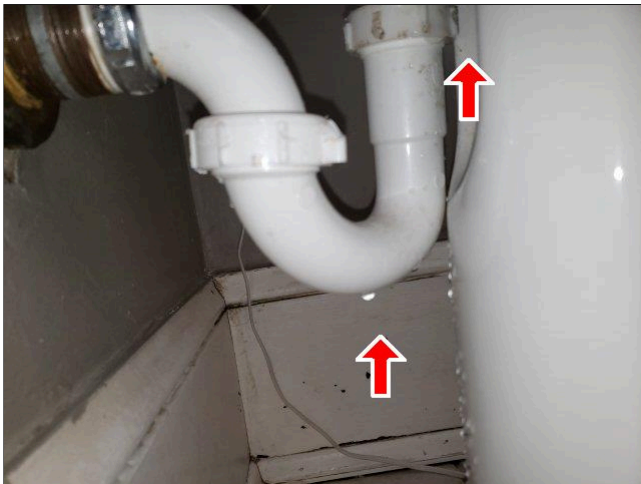
5.0.D Photo 1

Leakage was observed at the drain piping below the sink, have checked and corrected as needed by a licensed Plumbing Contractor.

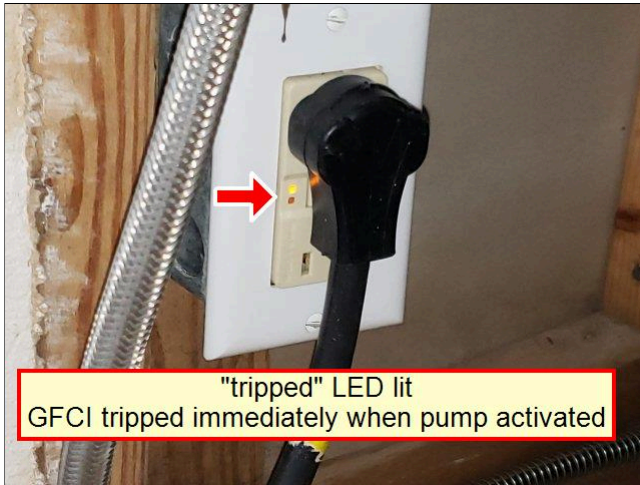
5.2.D Photo 1

The Jet Pump caused it's GFCI outlet to trip when powered on, have checked and corrected as needed by a licensed Plumbing Contractor.

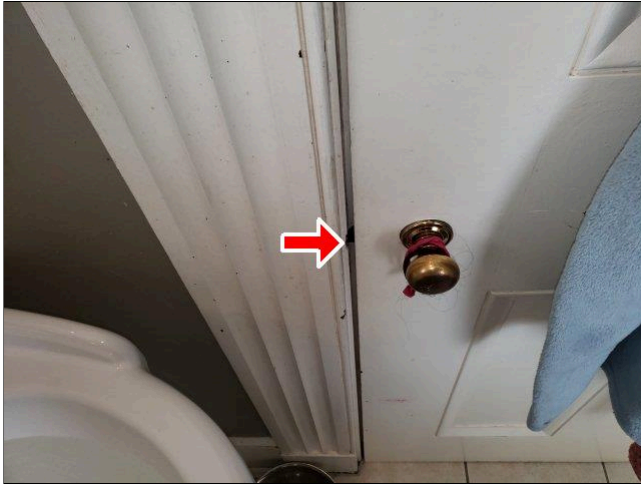
5.5.D Photo 1

Door does not latch properly, correct as required. (adjust striker, and/or replace the missing striker plate at the jamb)

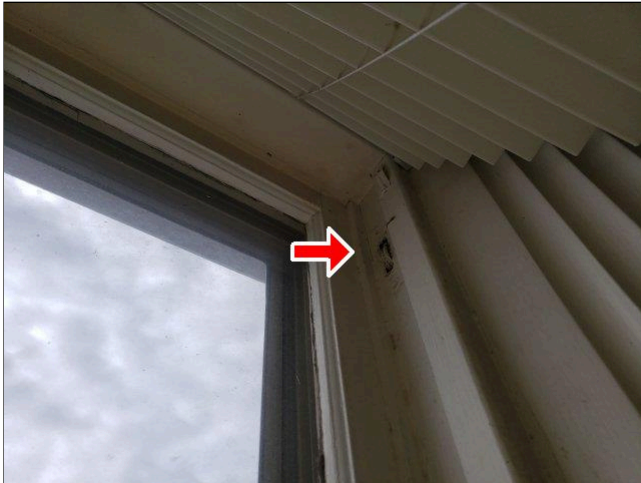
5.6.D Photo 1

Window is the only source of ventilation, and it could not be opened due to missing sash cords. Have the window repaired as needed and consider installing an exhaust fan.

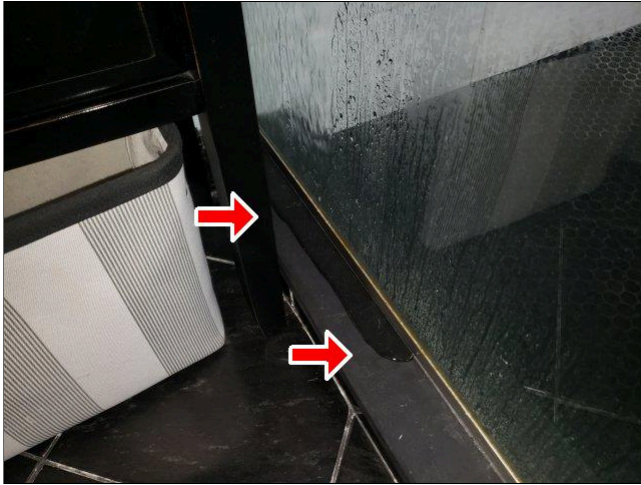
5.3.E Photo 1

Leakage occurred at the bottom of the glass wall surround, re-seal and maintain as needed.

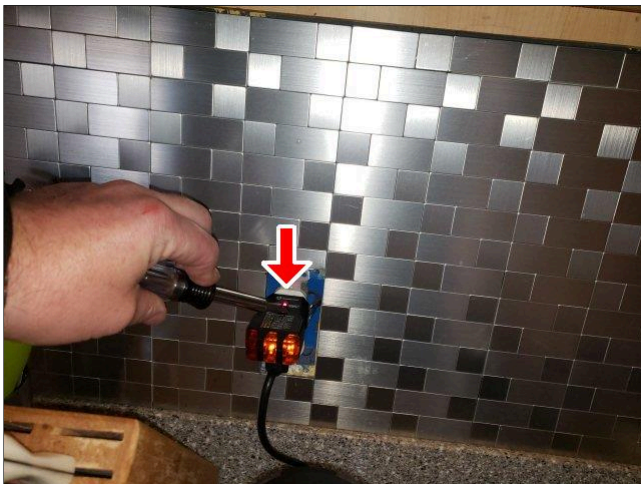
6.3.A (1) GFCI test failed at counter accessible outlets, and no GFCI units were observed in the Kitchen. (structure predates current requirements) Consider installing GFCI units for additional safety.

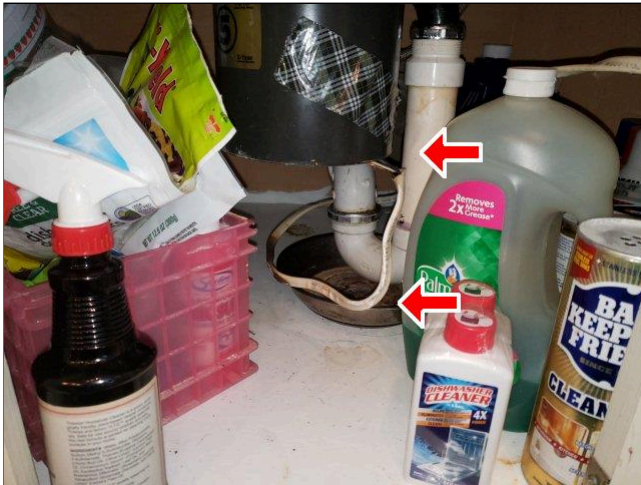
6.6.A Photo 1

NM (aka Romex) solid wire cabling is improperly exposed, and it is not properly secured to the unit. Have cabling secured and placed within a proper protective conduit, or replace with a flexible appliance cord and install a receptacle outlet as needed to reduce the potential for accidental damage.

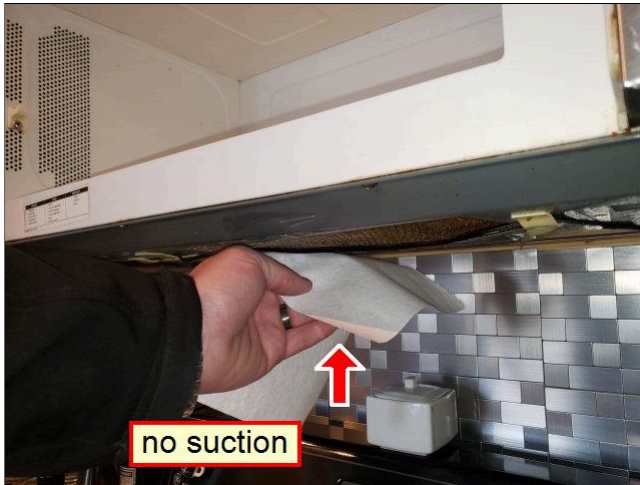
6.7.A Photo 1

Ventilator in microwave is not properly configured. Modern microwaves are designed to vent to the exterior via outlets on the rear or top of the unit, or to recirculate air back into room through the grate over the door. When these units are installed, they usually have to be modified by removing metal plate(s) over the desired opening and/or changing the position of the blower fan. This unit does not appear to have been properly configured, as it is drawing in and discharging very little air when fan is set to high. Recommend having unit checked by an appliance specialist and properly configured.

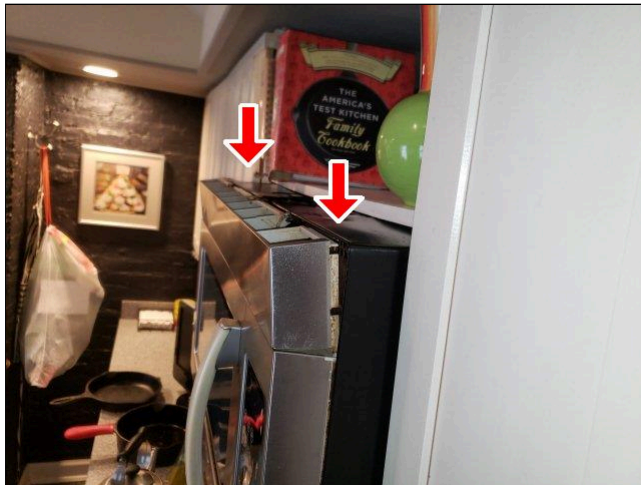
6.10.A (1) In addition to the concerns with the recirculating fan noted above, the vent panel above the door is loose / damaged as well, correct and maintain as needed.

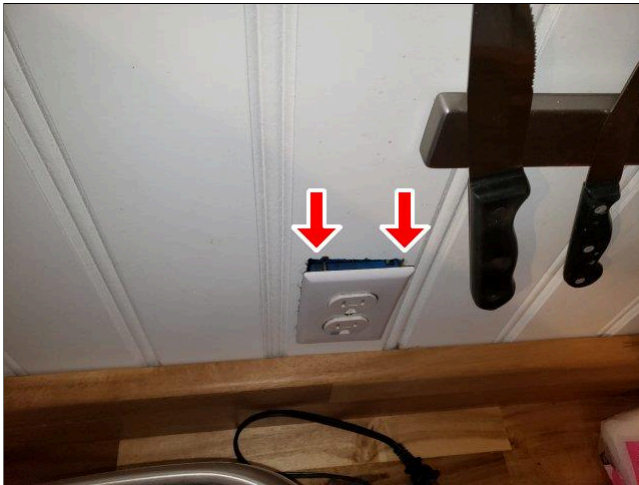
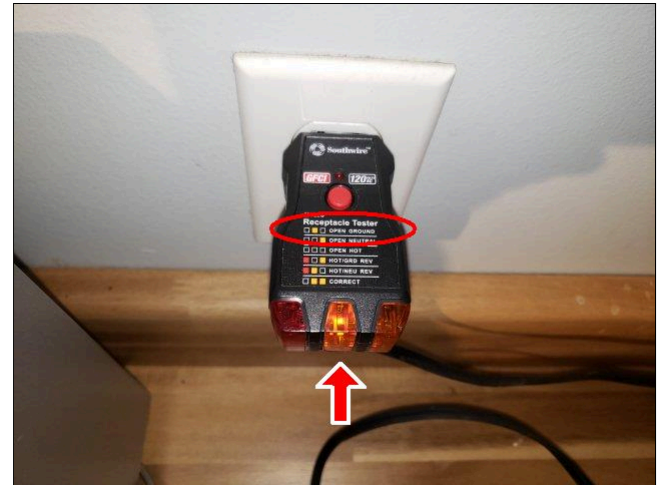
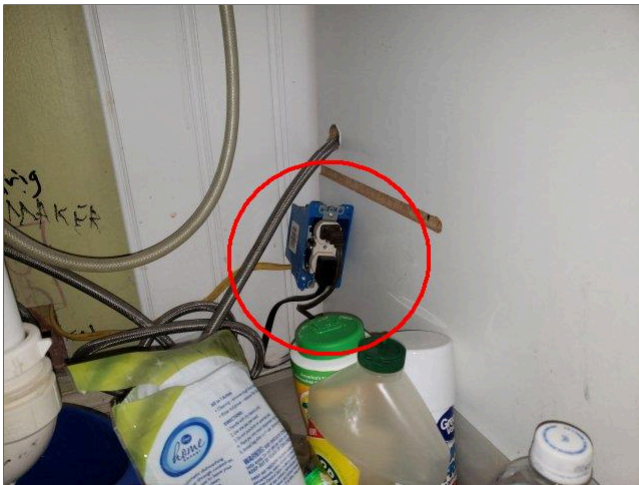
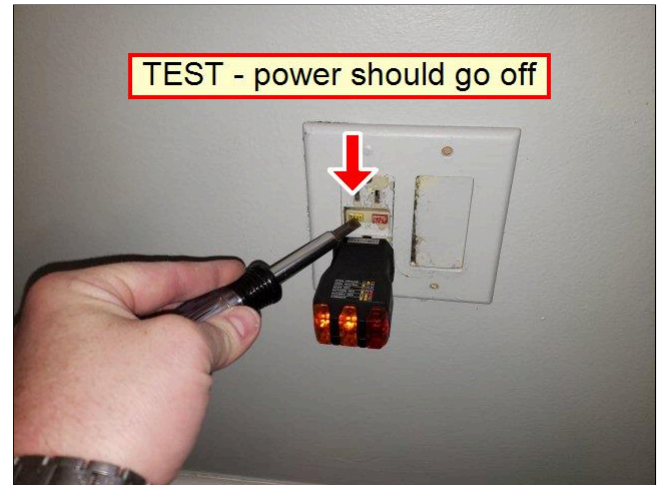
6.3.B (1) The receptacle outlet that is to the right of the Range is loose at the wall; an open ground connection was detected at the counter accessible receptacle on the opposite wall; the cover plate is missing from the receptacle below the sink; and the GFCI outlet by the window is defective / will not test. Have these concerns checked and corrected as needed by a licensed Electrical Contractor.

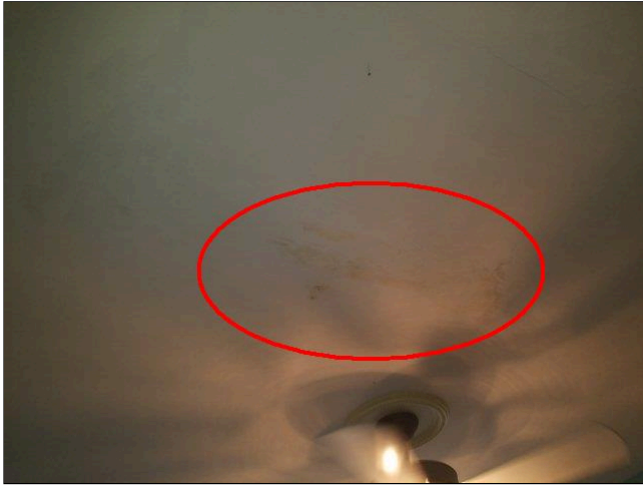
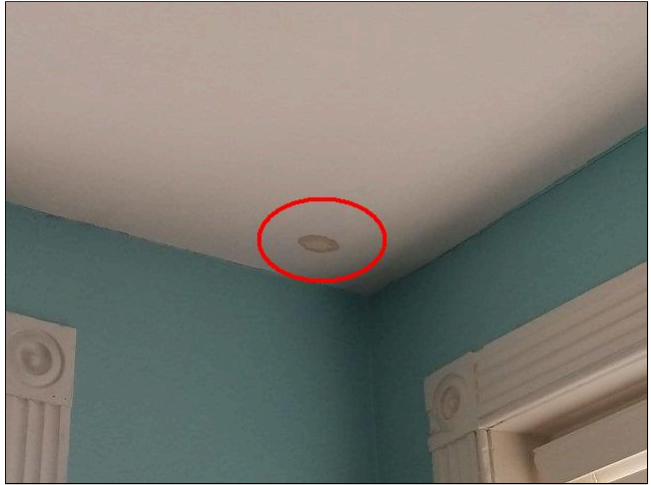
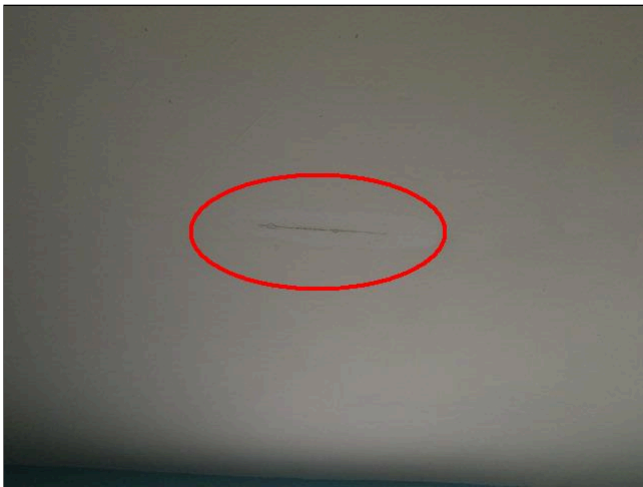
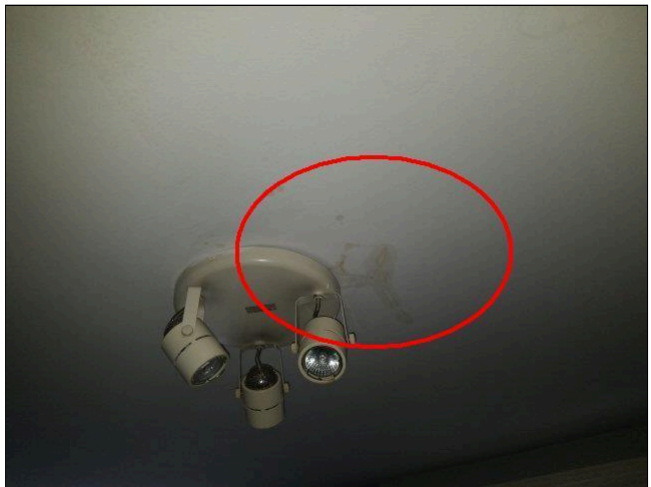
7.0 (1) Stains and minor damage noted in the 3rd FI rear BR and 1st FI Laundry Rm. Have conditions evaluated further and corrected as required by a licensed Contractor.

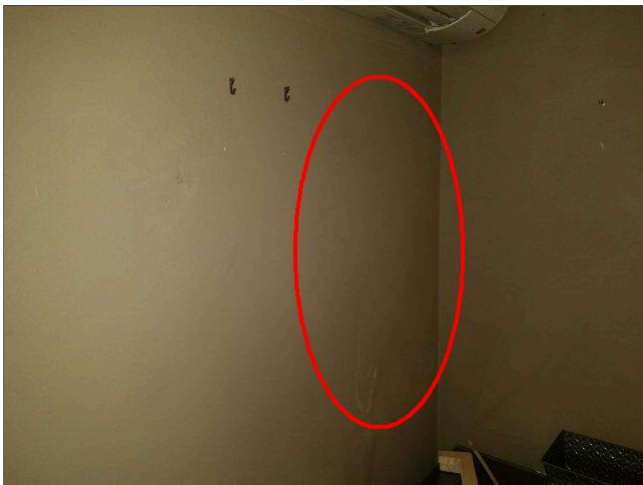
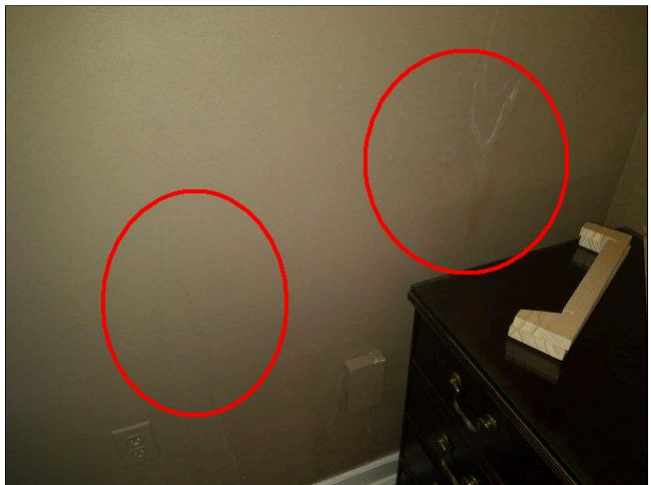
7.1 (1) Moisture stains noted in the 2nd floor Office below one of the HVAC wall units. Though this tested dry at the time of inspection, it is likely from condensation in the unit running down the wall. Recommend having conditions evaluated further and corrected as needed by a licensed HVAC Contractor.

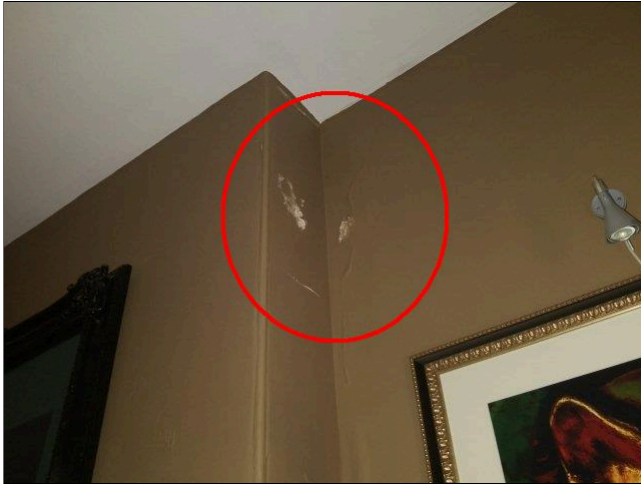
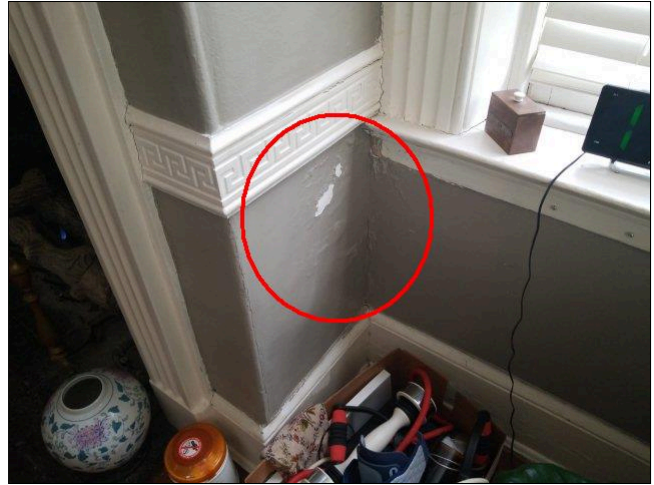
7.1 (2) Minor damage from prior leakage noted in the 2nd Floor Family Rm and 3rd FI front BR, have checked and corrected as required by a licensed Contractor.

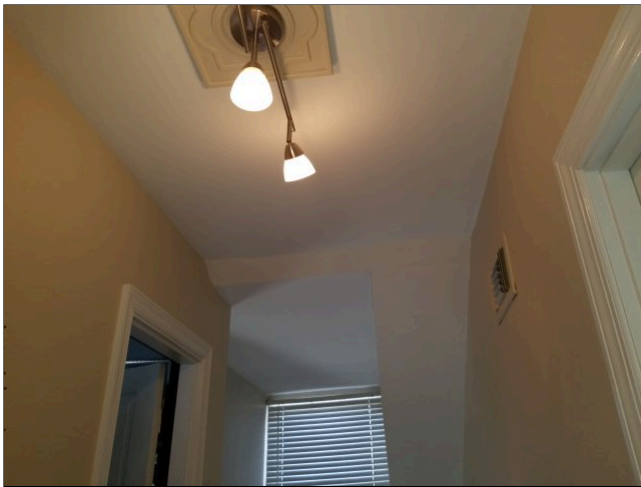
7.8 (1) 4th Floor smoke detector is missing, replace as required.

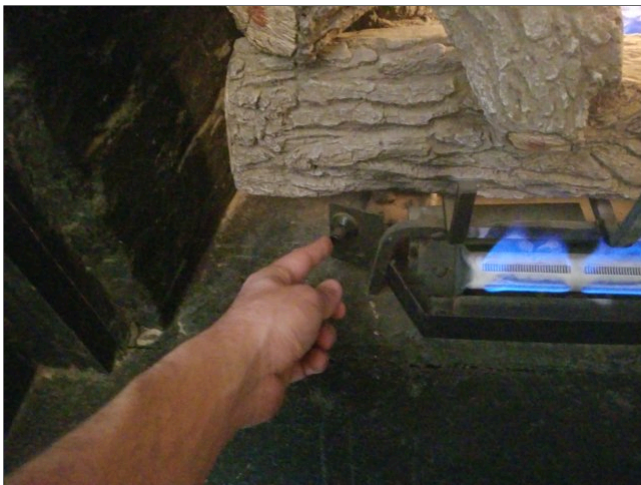
7.10 (1) The piezoelectric ignitor was inoperable at the logs in the Dining Rm at the time of inspection. Have corrected as needed by a qualified gas appliance specialist.

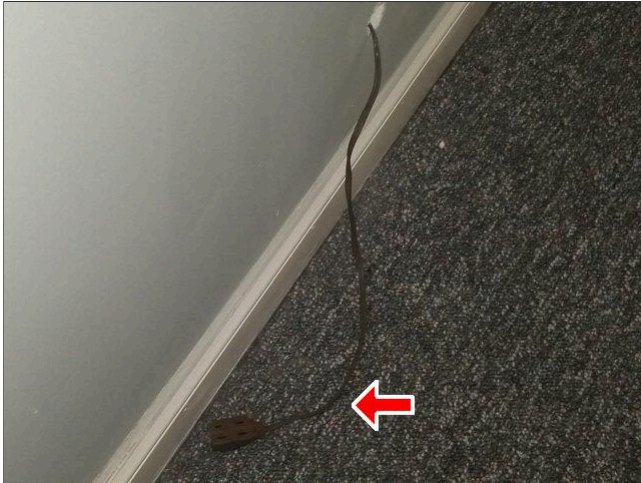
8.4 (1) An extension cord is being used as a permanent receptacle at the 1st FI Storage Rm. Have corrected as required by a licensed Electrical Contractor.

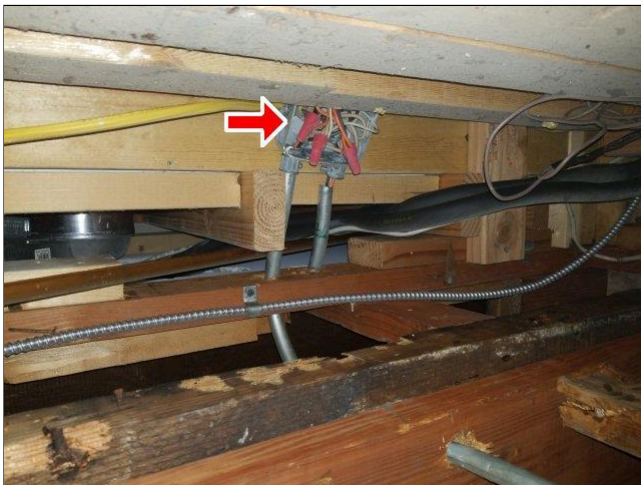
8.4 (2) Exposed wiring splices were found in the space above the 1st FI MBA; enclose in properly covered junction box(es) as required for safety.

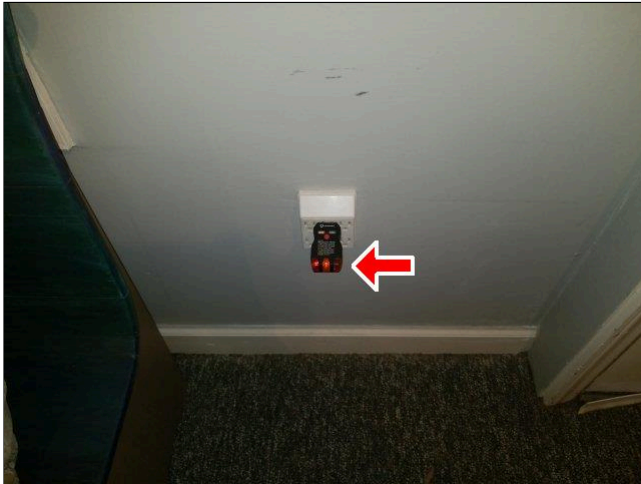
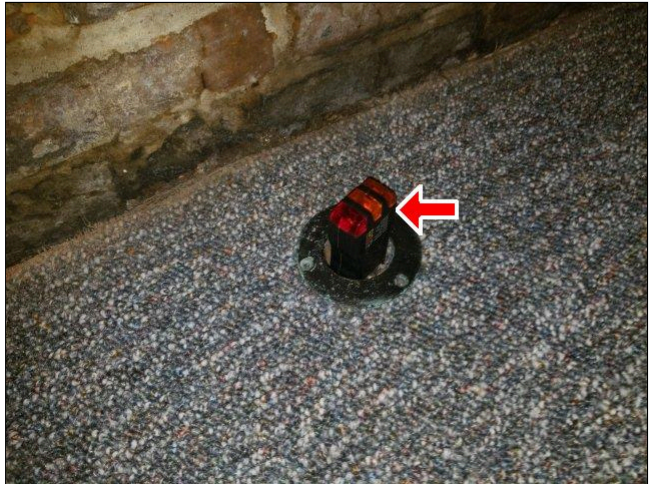
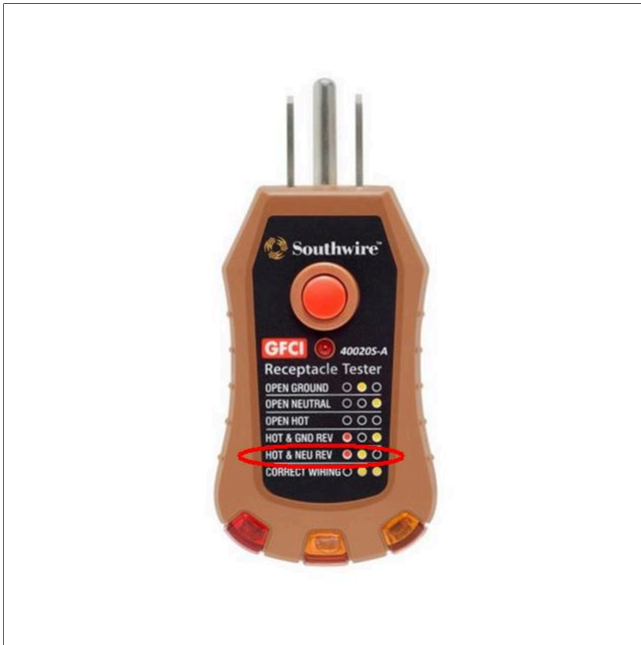
8.5 (1) Reverse polarity (hot & neutral wires crossed) was found at a receptacle outlet at the 1st FI Laundry Rm and MBR; rewire properly.

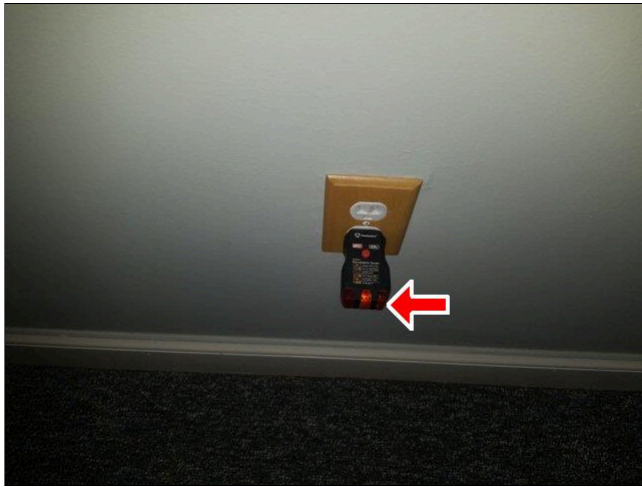
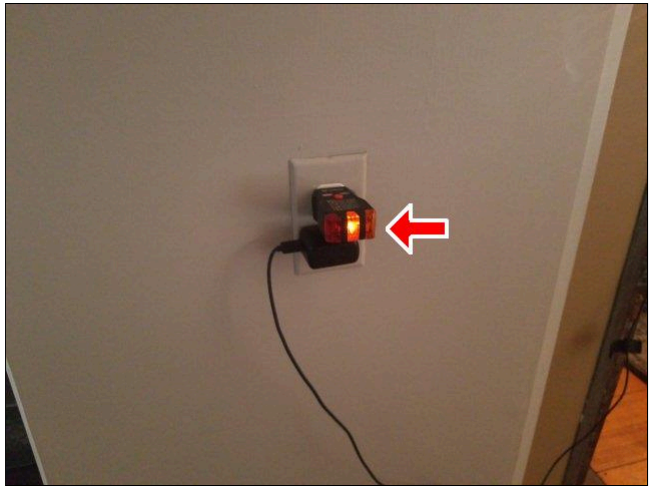
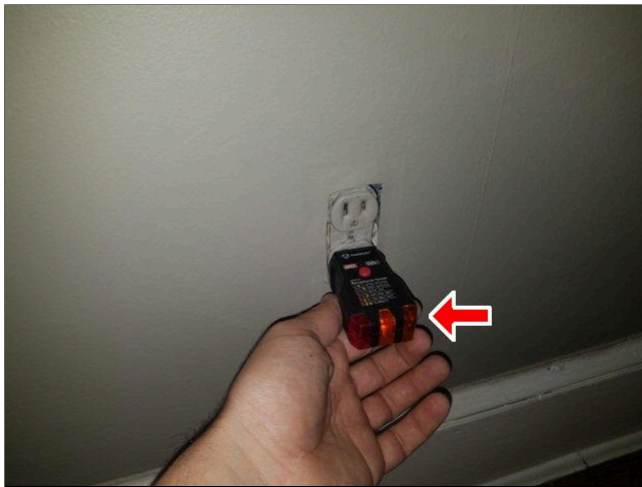
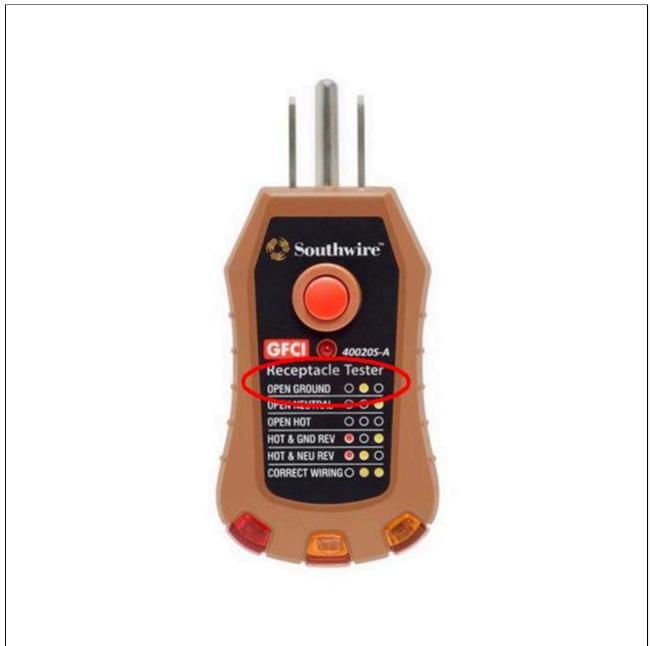
8.5 (2) Outlets with open ground connections were found in multiple locations throughout the home, suggesting that 2-prong receptacles were replaced with 3-prong units without connecting a ground wire. Much of the original circuits are wired with ungrounded cable. The third receptacle slot implies a false impression of safety when a ground is not present, and these receptacles should be replaced with 2-prong units or with GFCI units that are labeled as having "No Equipment Ground". Installing GFCI breakers on these circuits in the service panel would be acceptable as well, provided each of the receptacles is labeled as being "GFCI Protected" and having "No Equipment Ground". Have checked and correct as required by a licensed Electrical Contractor prior to closing.

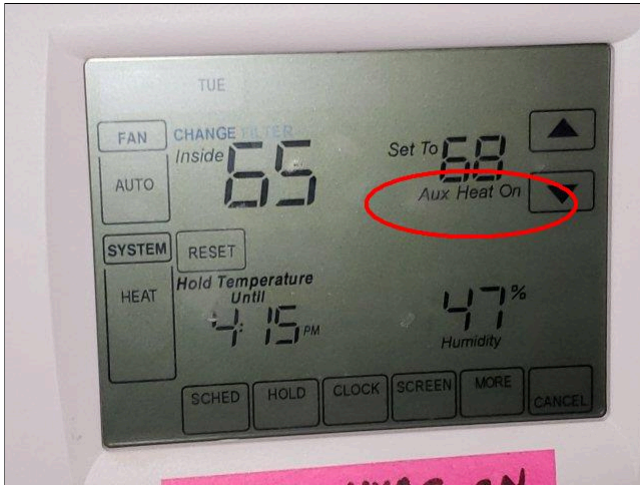
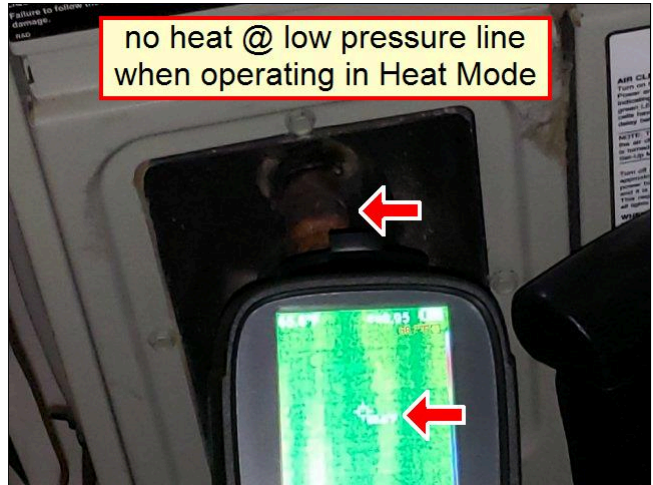
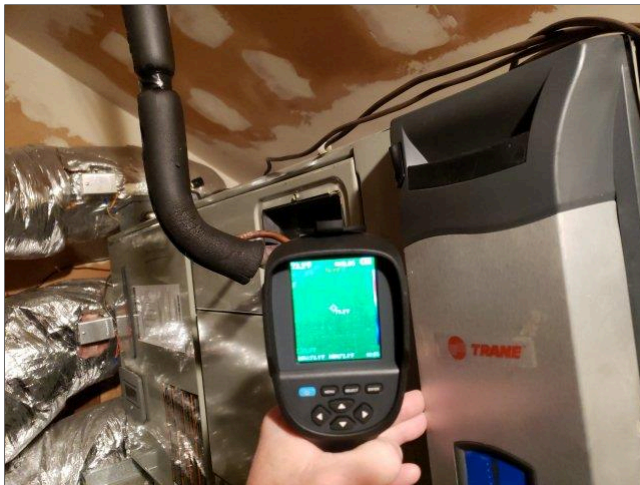
9.0 (1) Most of the systems were inoperable and/or defective at the time of inspection. Only the main system for the 2nd FI appeared to be functioning as intended. No temperature differential was detected between the high and low pressure refrigerant lines for the Basement and 3rd & 4th FI systems, the wall mounted Air Handler in the 1st FI BR was noisy at the time of inspection, as was the condenser for the main 1st FI system, and the cover was falling off the Air Handler in the main Kitchen. That system could not be operated as well, as the remote control for it was missing. Additionally, the cover panel to access the wiring compartment was off the outdoor unit for the 3rd & 4th FI system. All of the equipment appears to be at or near the end of it's intended service life as well. Have evaluated, serviced, and repaired as needed by a licensed HVAC Contractor, and plan for replacements.

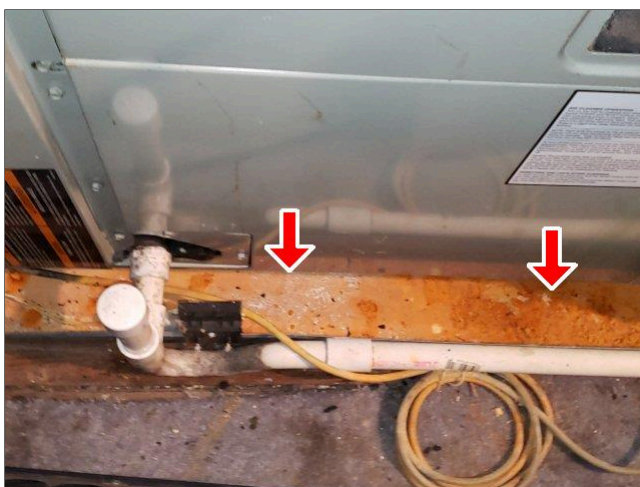
9.3 Photo 1

Evidence of prior backups in the primary drain line for the main 2nd FI system, resulting in leaks noted at the overflow pan below the Air Handler. (rust found in the pan) Recommend having checked and corrected as needed by a licensed HVAC Contractor prior to the start of the Cooling Season.

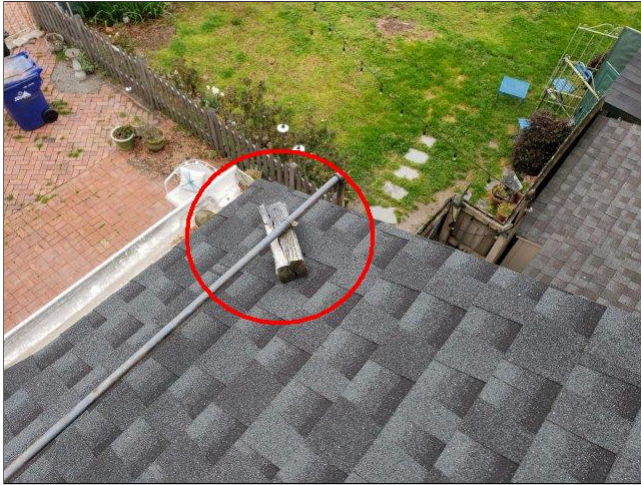
10.5 (1) The wood blocks that support the gas line on the roof of the Slave Quarters part of the building are decaying, and the straps have come loose, re-secure and maintain as needed.
