Report ID: 20033980-A / Asset Management

1.1 ROOFING #2

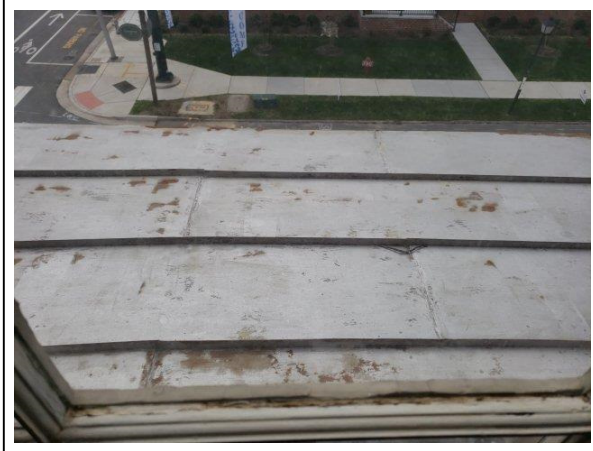
1.1 Photo 1

The metal roofing on both of the porches are aging. Metal roofing of this type can have a very long service life, but it must be re-sealed / coated with an appropriate fiber reinforced sealant. Have checked and re-sealed as needed by a licensed Roofing Contractor every 3-5 yrs.

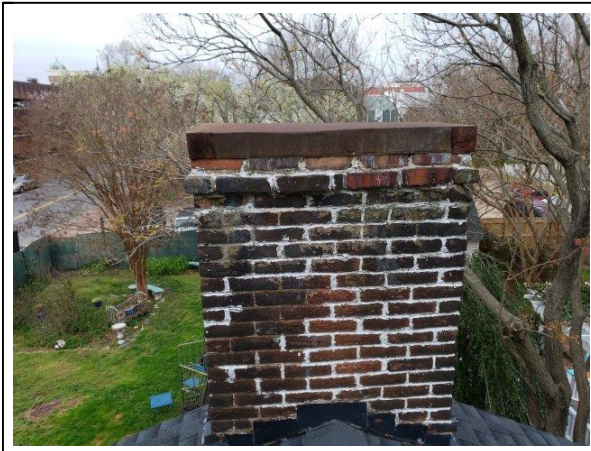
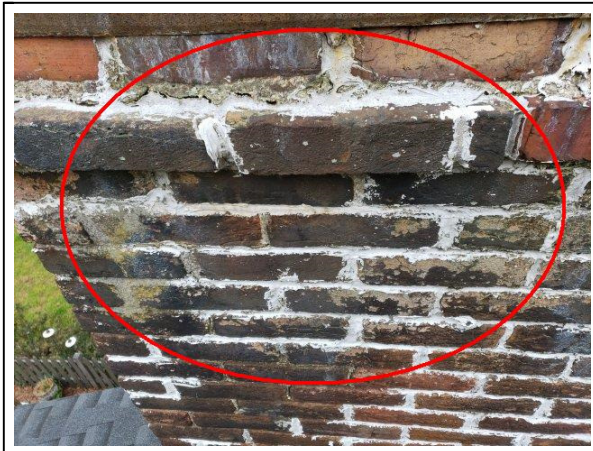
The chimney at the rear of the Slave Quarters appears to have been re-pointed with an improper type of mortar and/or caulk, which can lead to additional cracking and damage; the metal cap that was used to seal that chimney is rusting; and the parge coating that was added to the other two chimneys has cracked in a few locations. Inspection was limited to readily accessible and visible components. Recommend having more intrusive "Level 2" inspections performed by a (CSIA) Certified Chimney Sweep prior to the sale of the property.

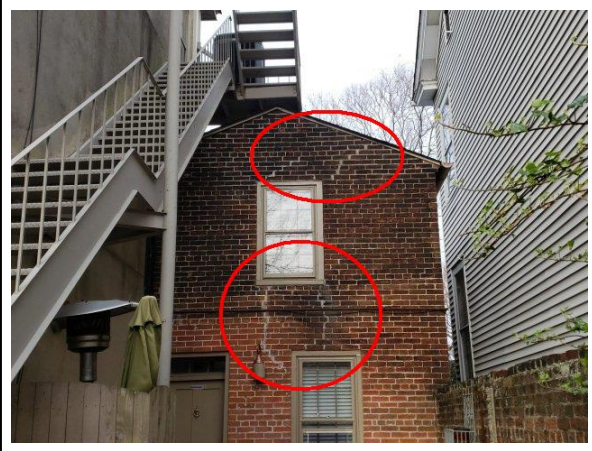
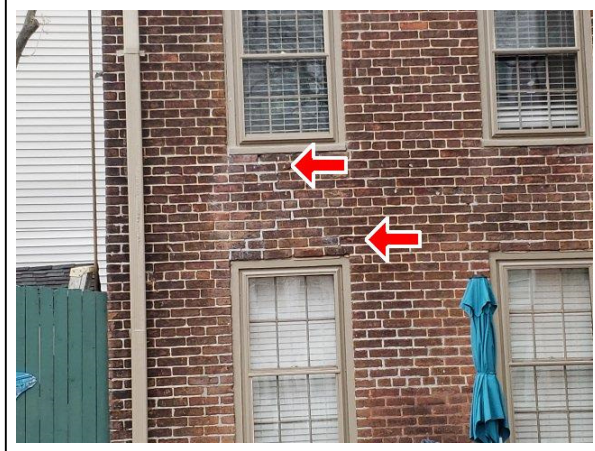
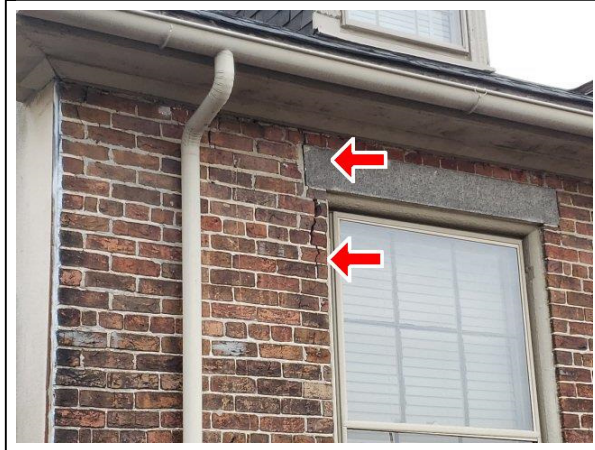
Settlement cracking is evident in the brick walls in a few locations, a few damaged bricks were noted as well. This is a relatively normal condition for a structure of this age. Have checked and re-pointed as needed by a licensed Masonry Contractor and anticipate periodic re-pointing needs.

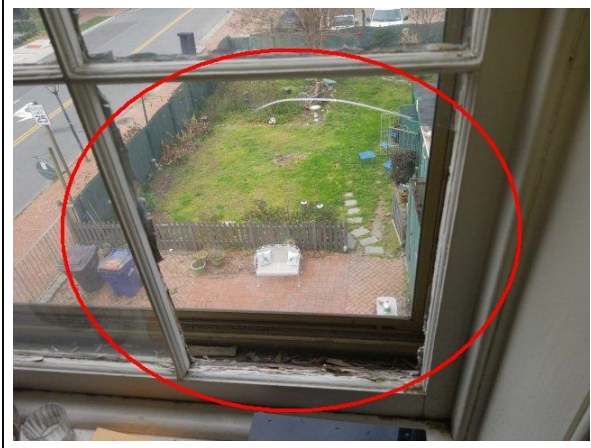
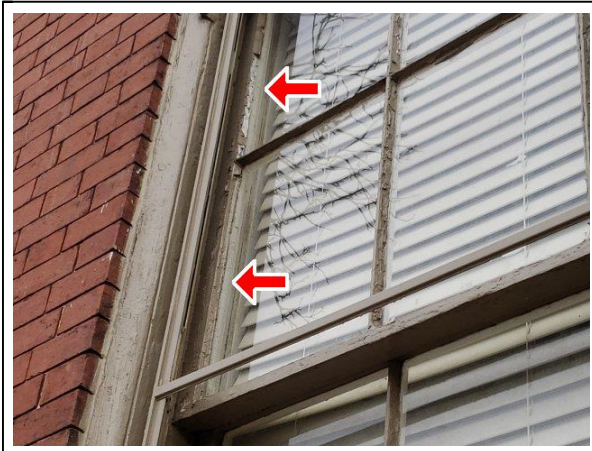
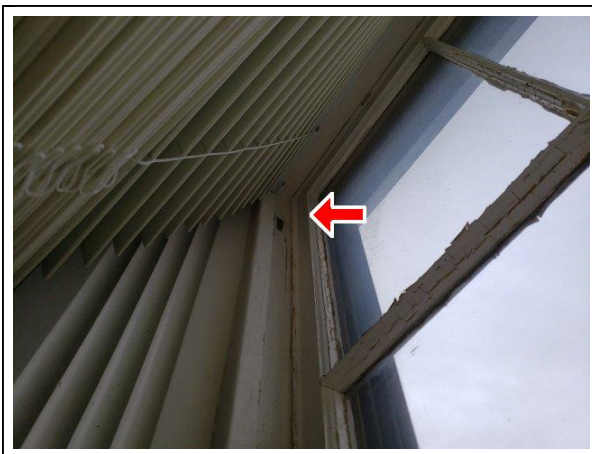
Cracked panes were noted at multiple windows, as was deteriorated paint and glazing; in particular, a portion of a pane is missing from a window at the rear 3rd FI BR; minor decay was found in the wood exterior trim in a few locations as well; and the sash cords are missing from many of the windows, making them inoperable. Have all of the windows checked and corrected as needed by a licensed Contractor.

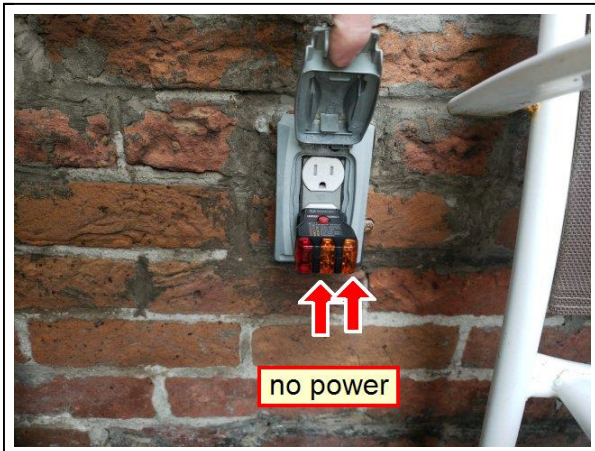
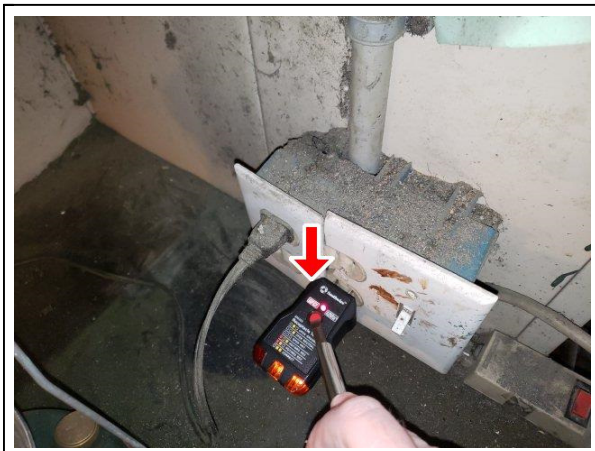
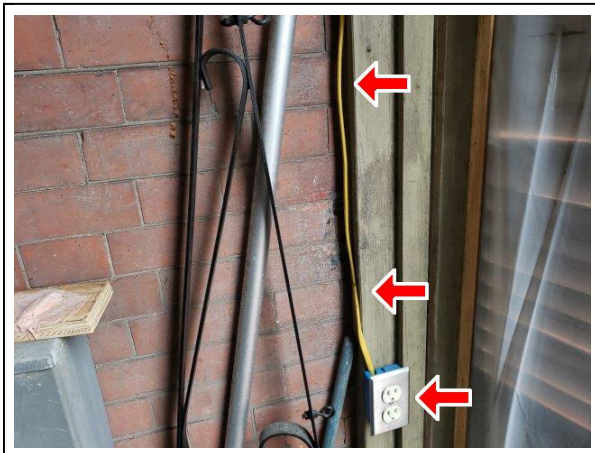
No power was detected at the receptacle outlet on the front of the Slave Quarters; the GFCI on the rear of the main house is defective / will not test; the receptacle outlets in the Sheds and in the Electrical Rm are not GFCI protected; and improperly exposed cabling was noted in those locations as well. Have checked and corrected as needed by a licensed Electrical Contractor.

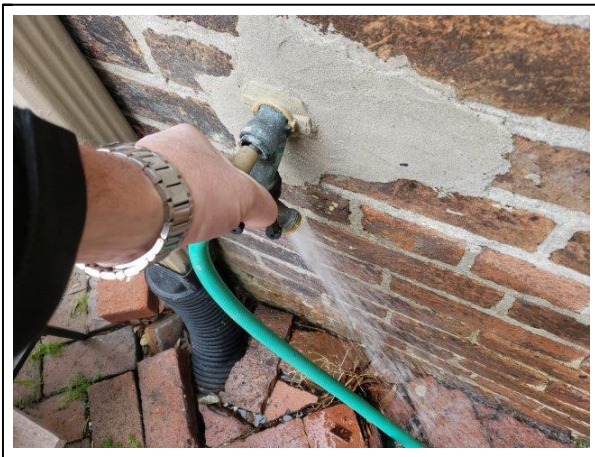
2.9 (1) The hose bib is defective / will not close, (water was being contained by the valves on the adapter that was added) have checked and corrected as needed by a licensed Plumbing Contractor.

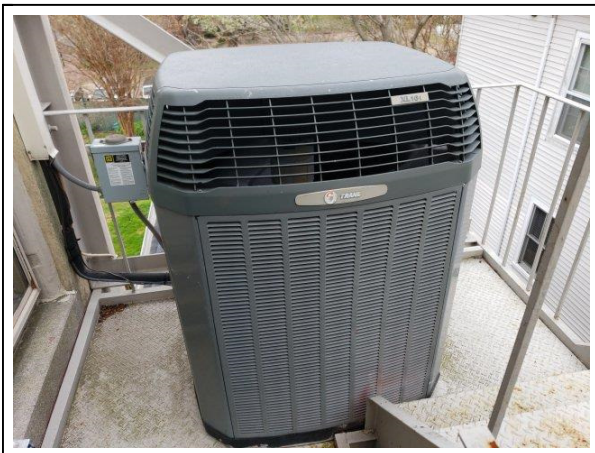
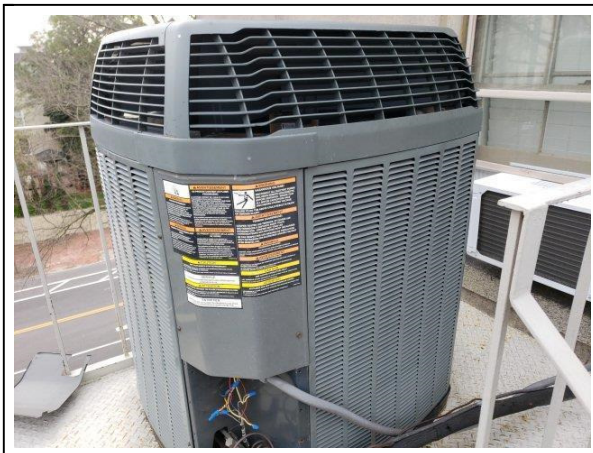
The fire escape appears to be in generally good condition, but the landings at the 3rd & 4th floors are obstructed by the presence of Heat Pump condensing units. Recommend having the Heat Pumps relocated to ground level to allow for proper and safe egress.

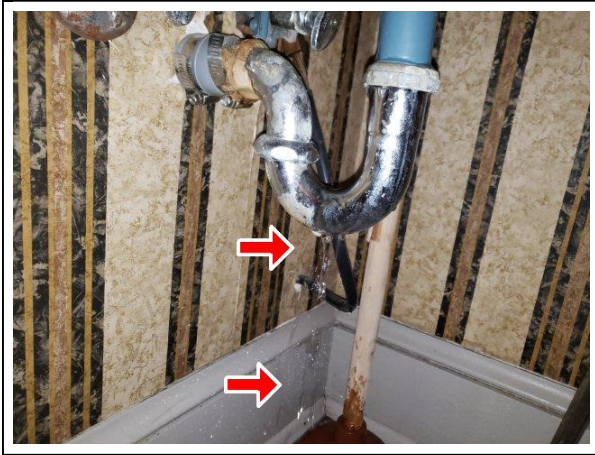
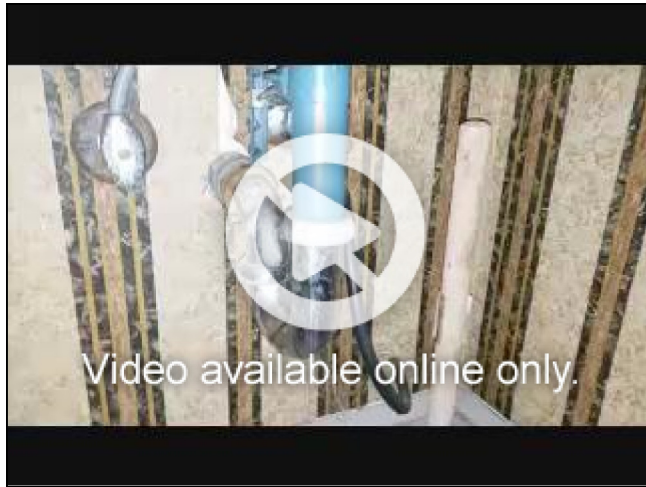
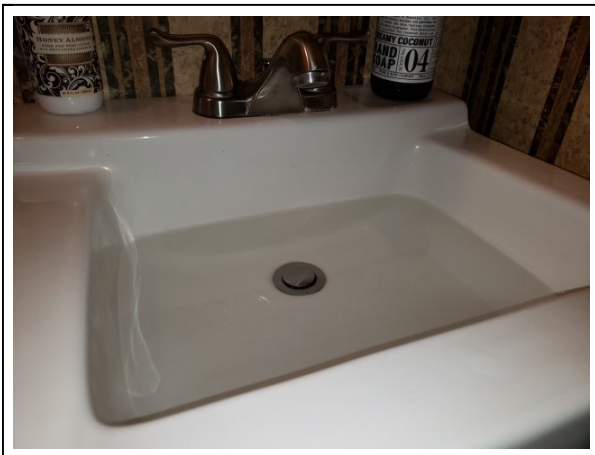
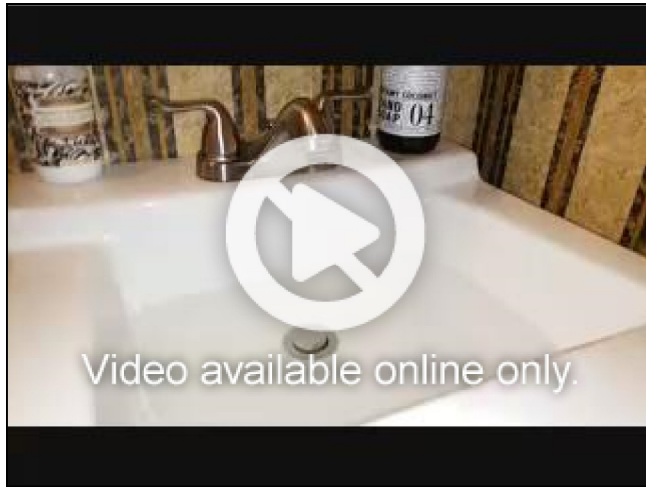
The drain was clogged and significant leakage was observed at the drain piping, have checked and corrected as needed by a licensed Plumbing Contractor.

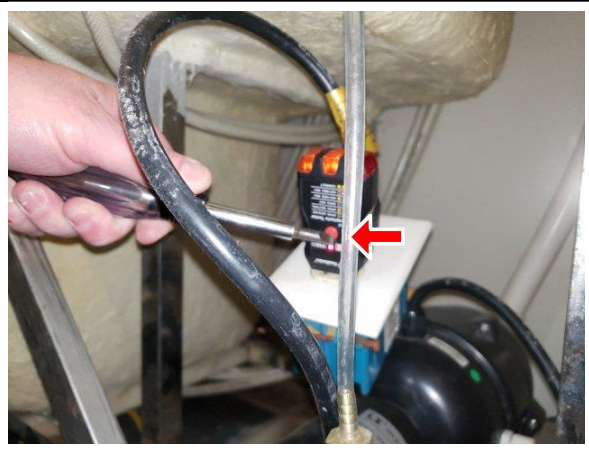
5.7.B Photo 1

The circuit for the Jetted Tub is not GFCI protected, have checked and corrected as needed by a licensed Electrical Contractor to ensure safety.

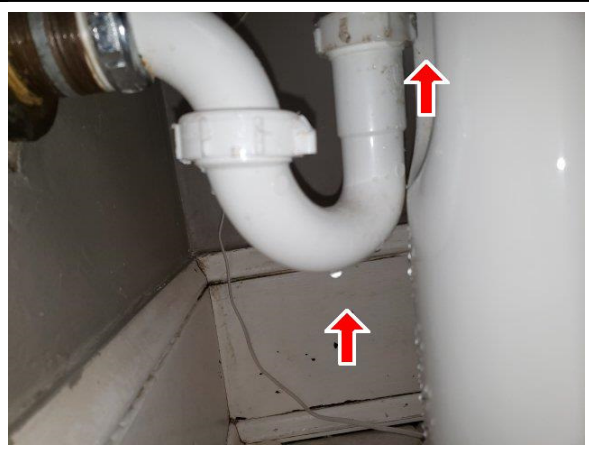
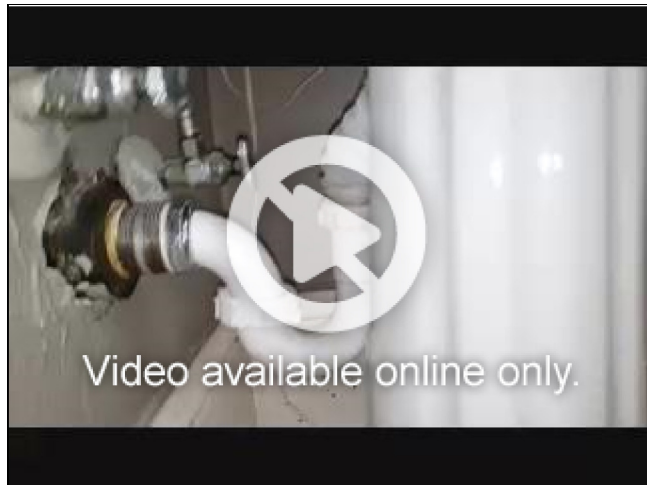
Leakage was observed at the drain piping below the sink, have checked and corrected as needed by a licensed Plumbing Contractor.

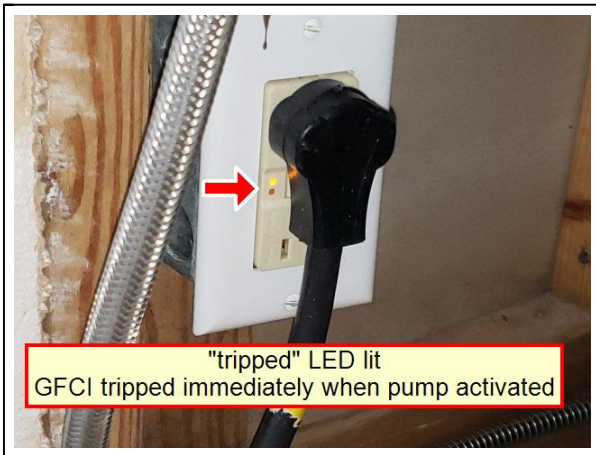
5.2.D Photo 1

The Jet Pump caused it's GFCI outlet to trip when powered on, have checked and corrected as needed by a licensed Plumbing Contractor.

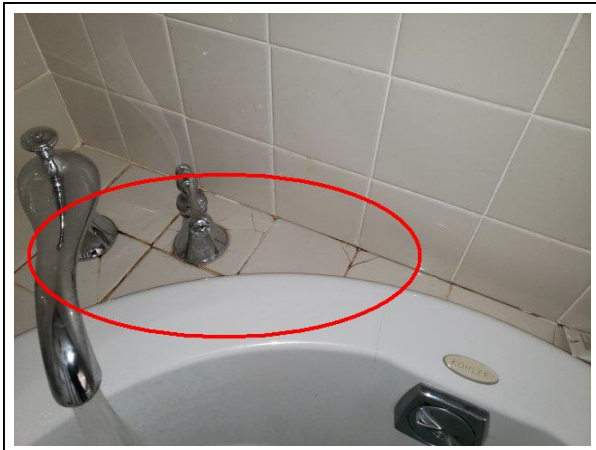
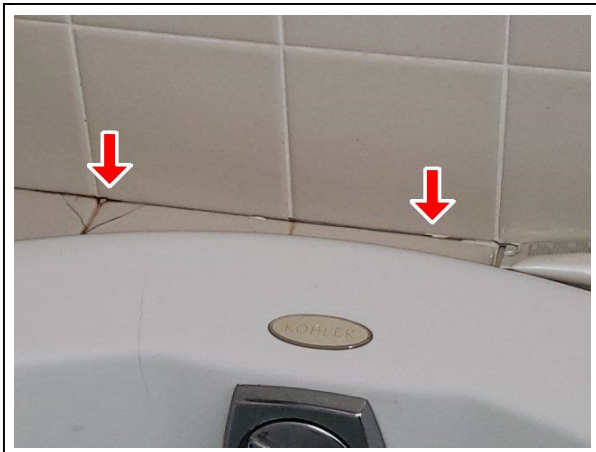
Cracked and damaged tiles and grout were noted, correct and maintain as needed to prevent water intrusion into the walls and ceiling below.

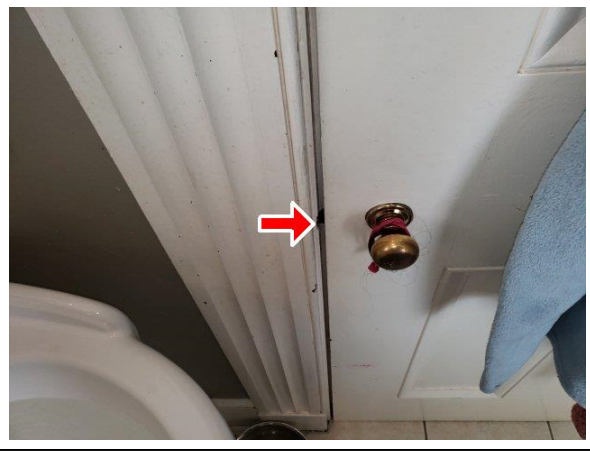
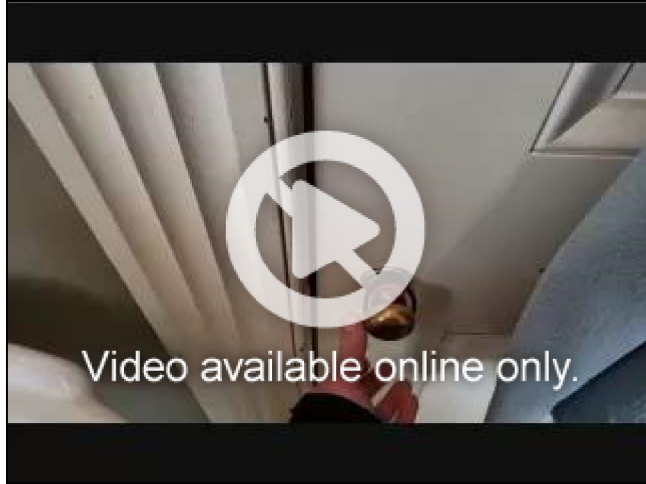
Door does not latch properly, correct as required. (adjust striker, and/or replace the missing striker plate at the jamb)

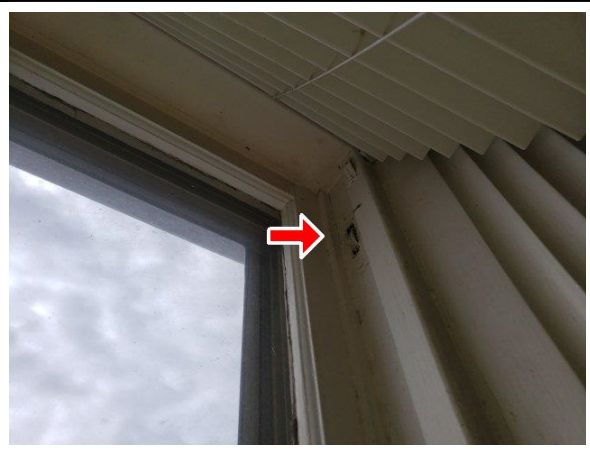
5.6.D Photo 1

Window is the only source of ventilation, and it could not be opened due to missing sash cords. Have the window repaired as needed and consider installing an exhaust fan.

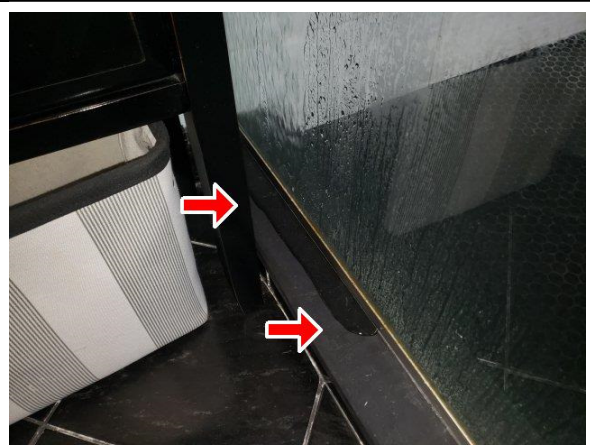
5.3.E Photo 1

Leakage occurred at the bottom of the glass wall surround, re-seal and maintain as needed.

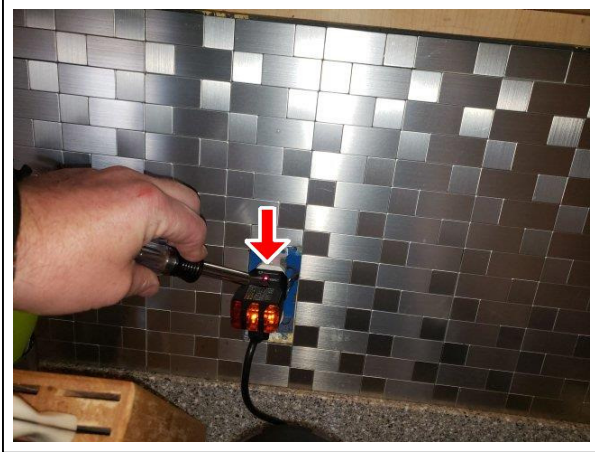
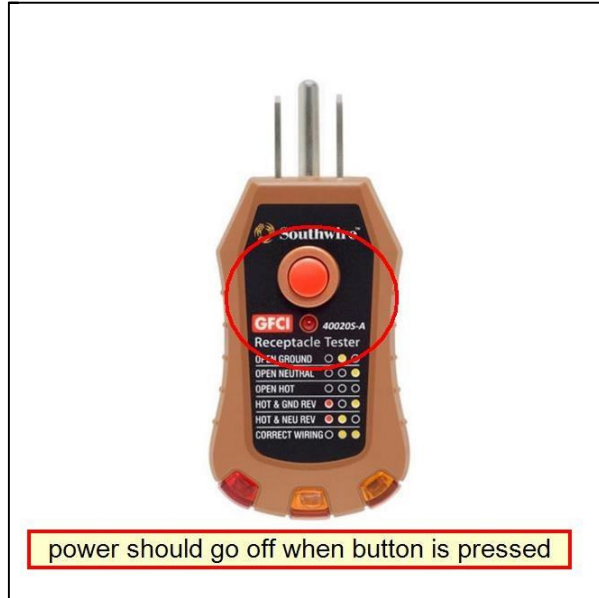
6.3.A (1) GFCI test failed at counter accessible outlets, and no GFCI units were observed in the Kitchen. (structure predates current requirements) Consider installing GFCI units for additional safety.

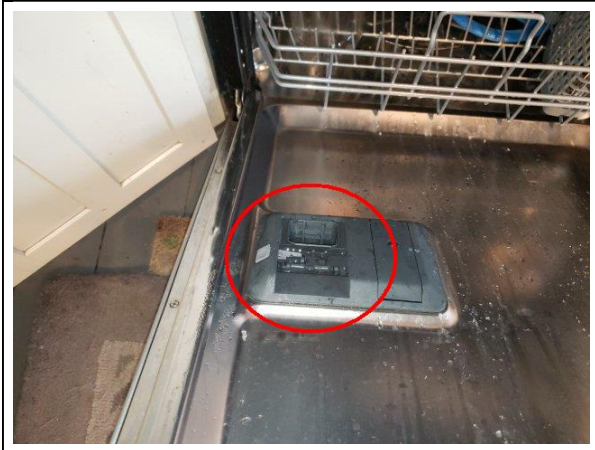
6.5.A (1) The soap dispenser compartment door is missing, replace as needed.

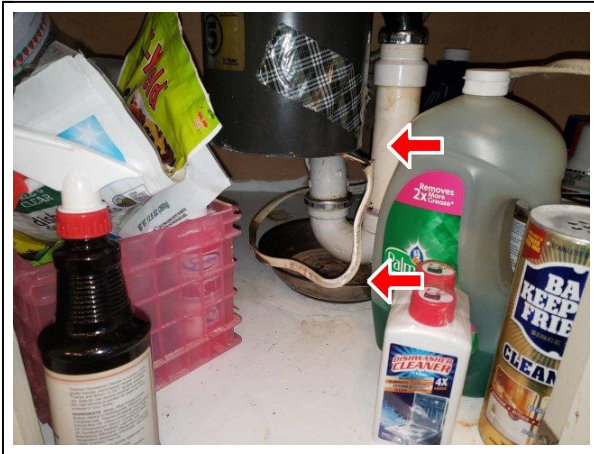
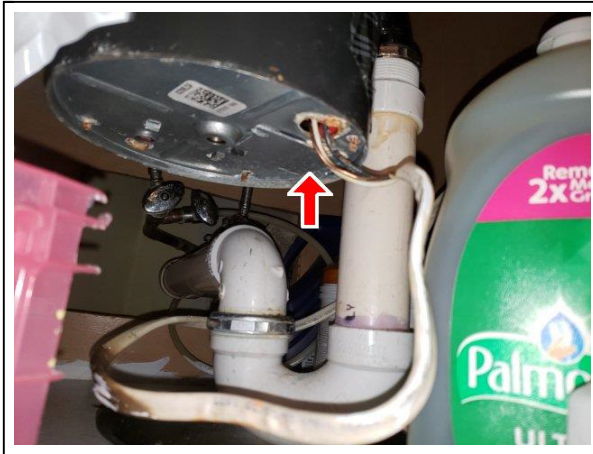
NM (aka Romex) solid wire cabling is improperly exposed, and it is not properly secured to the unit. Have cabling secured and placed within a proper protective conduit, or replace with a flexible appliance cord and install a receptacle outlet as needed to reduce the potential for accidental damage.

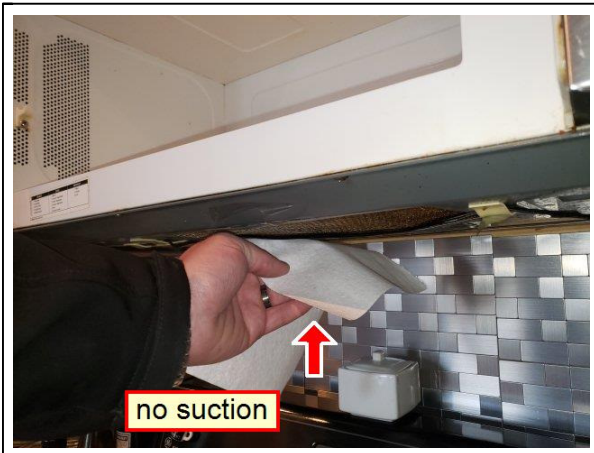
6.7.A Photo 1

Ventilator in microwave is not properly configured. Modern microwaves are designed to vent to the exterior via outlets on the rear or top of the unit, or to recirculate air back into room through the grate over the door. When these units are installed, they usually have to be modified by removing metal plate(s) over the desired opening and/or changing the position of the blower fan. This unit does not appear to have been properly configured, as it is drawing in and discharging very little air when fan is set to high. Recommend having unit checked by an appliance specialist and properly configured.

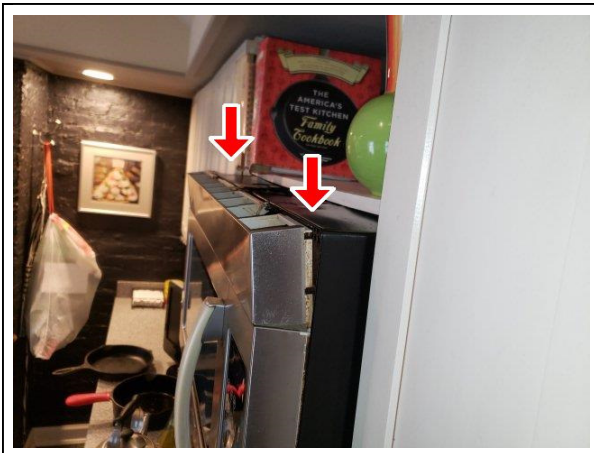
6.10.A (1) In addition to the concerns with the recirculating fan noted above, the vent panel above the door is loose / damaged as well, correct and maintain as needed.

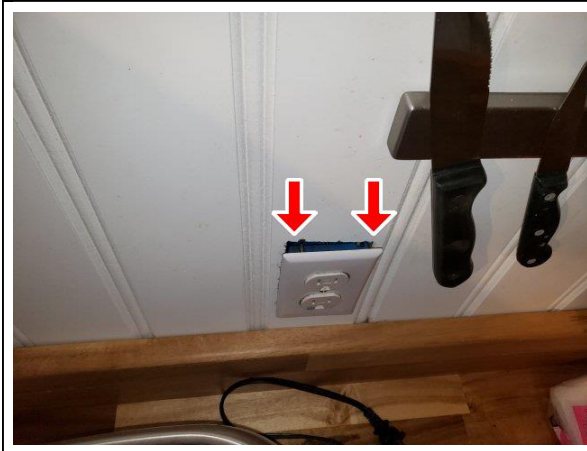
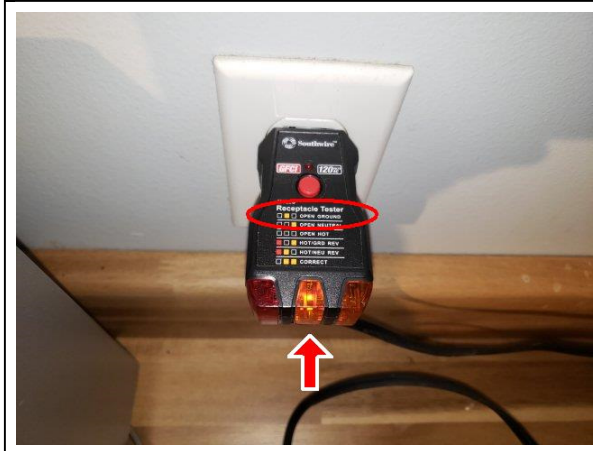
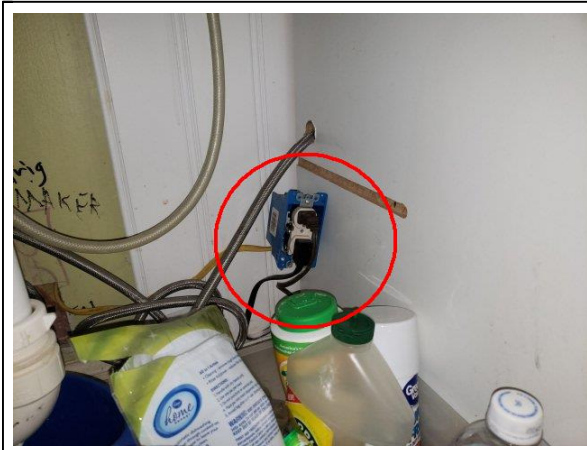
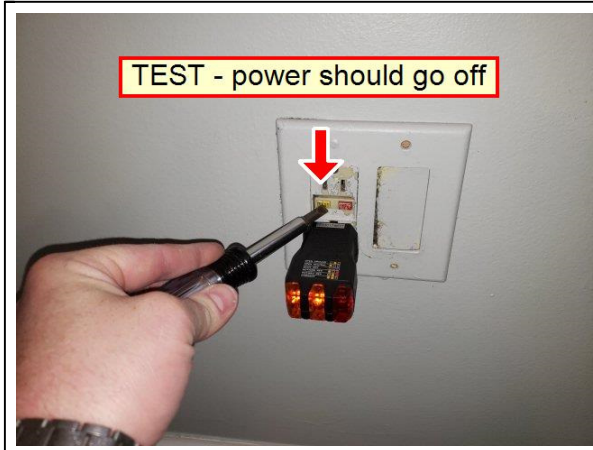
6.3.B (1) The receptacle outlet that is to the right of the Range is loose at the wall; an open ground connection was detected at the counter accessible receptacle on the opposite wall; the cover plate is missing from the receptacle below the sink; and the GFCI outlet by the window is defective / will not test. Have these concerns checked and corrected as needed by a licensed Electrical Contractor.

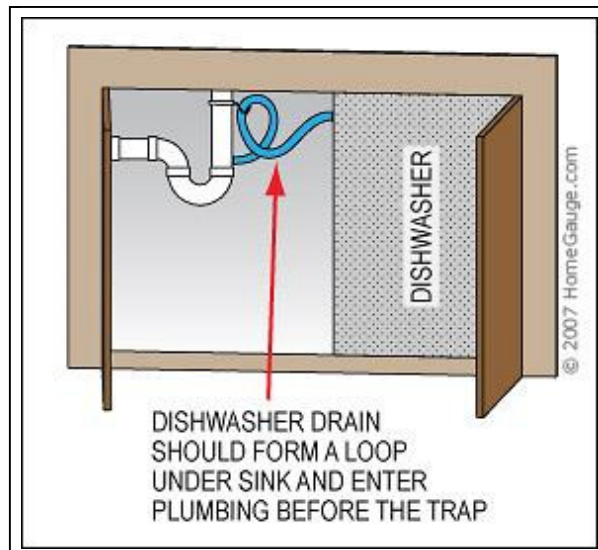
6.5.B (1) A "high loop" is not visible in the drain hose below sink. Having the dishwasher drain hose extend above the level of the sink drain forms a trap, and prevents sink waste from entering unit. Correct (move or strap hose) as required.

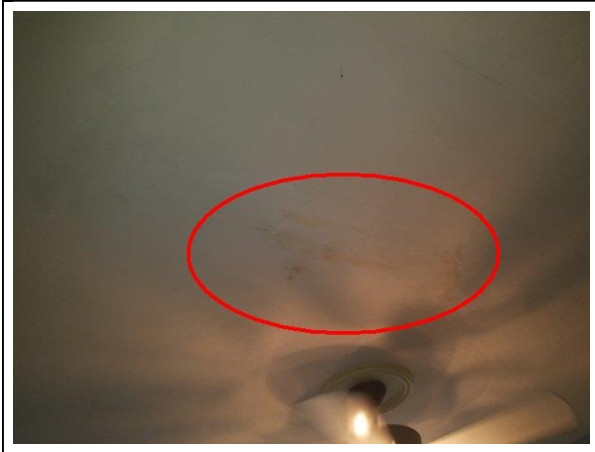
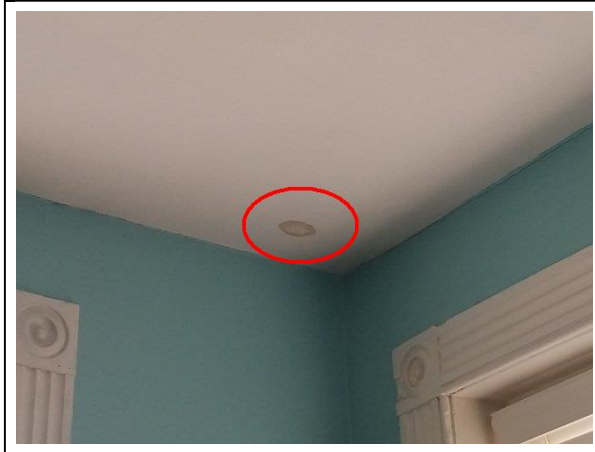
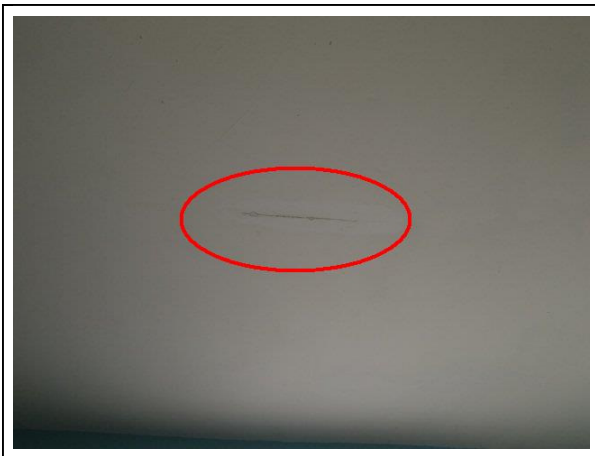
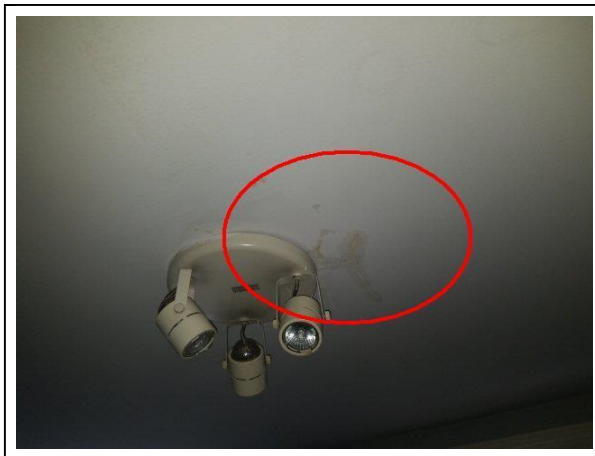
7.0 (1) Stains and minor damage noted in the 3rd FI rear BR and 1st FI Laundry Rm. Have conditions evaluated further and corrected as required by a licensed Contractor.

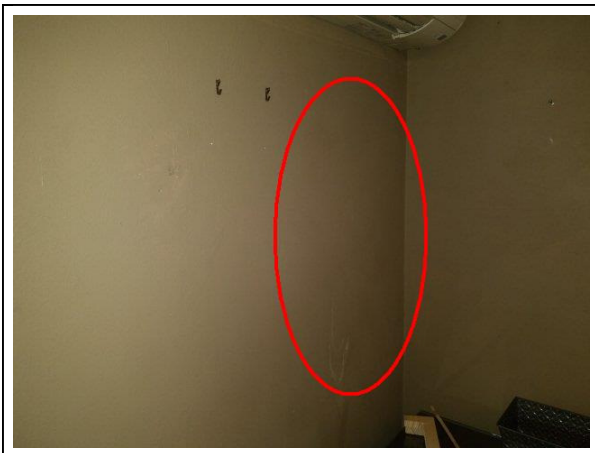
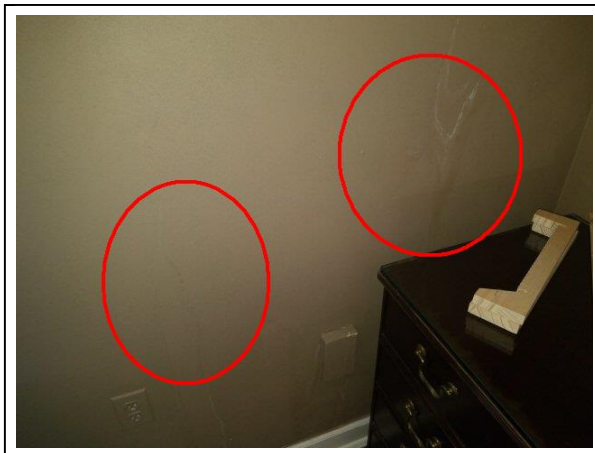
7.1 (1) Moisture stains noted in the 2nd floor Office below one of the HVAC wall units. Though this tested dry at the time of inspection, it is likely from condensation in the unit running down the wall. Recommend having conditions evaluated further and corrected as needed by a licensed HVAC Contractor.

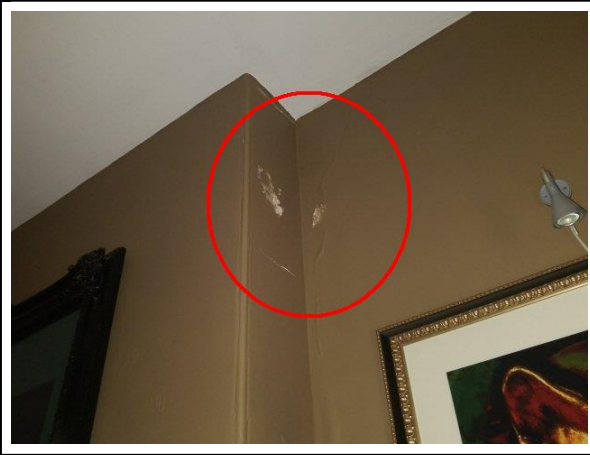
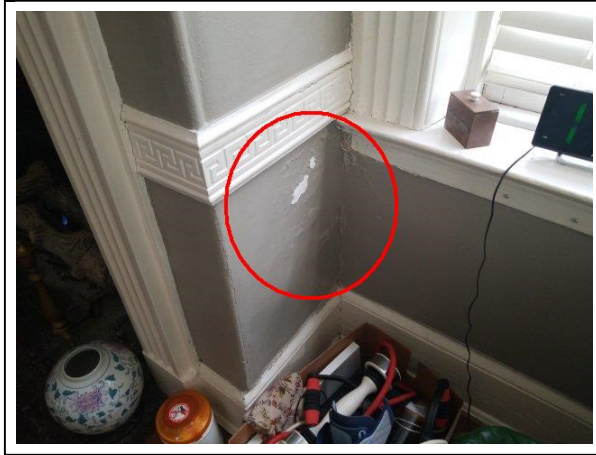
7.1 (2) Minor damage from prior leakage noted in the 2nd Floor Family Rm and 3rd Fl front BR, have checked and corrected as required by a licensed Contractor.

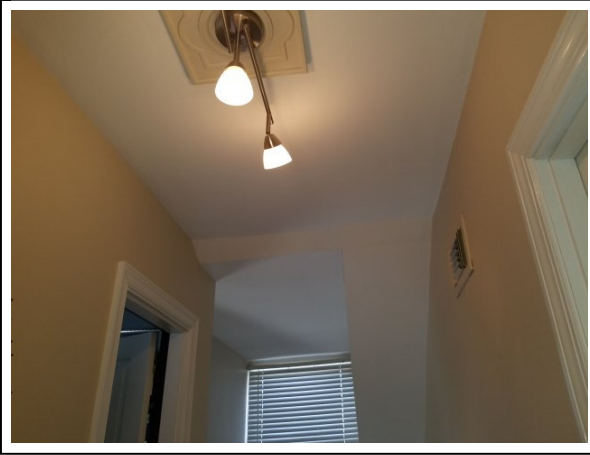
7.8 (1) 4th Floor smoke detector is missing, replace as required.

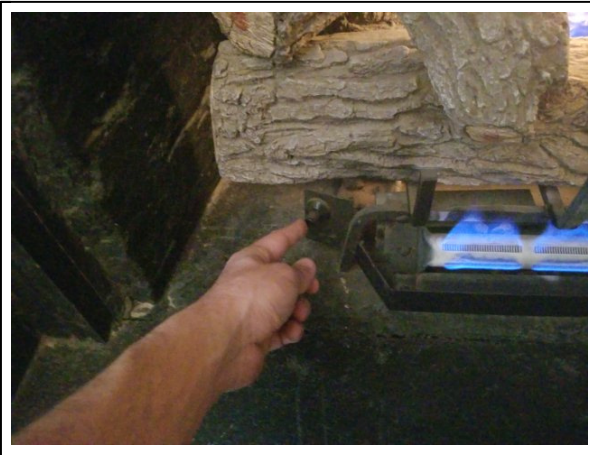
7.10 (1) The piezoelectric ignitor was inoperable at the logs in the Dining Rm at the time of inspection. Have corrected as needed by a qualified gas appliance specialist.

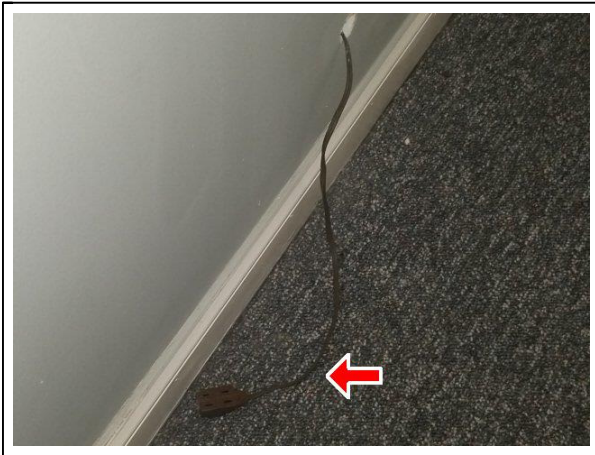
8.4 (1) An extension cord is being used as a permanent receptacle at the 1st FI Storage Rm. Have corrected as required by a licensed Electrical Contractor.

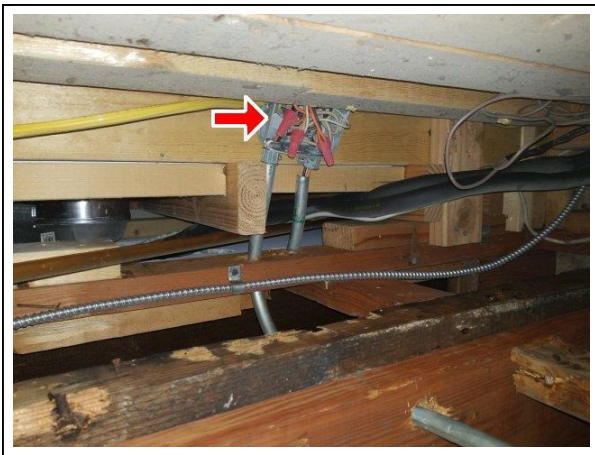
8.4 (2) Exposed wiring splices were found in the space above the 1st FI MBA; enclose in properly covered junction box(es) as required for safety.

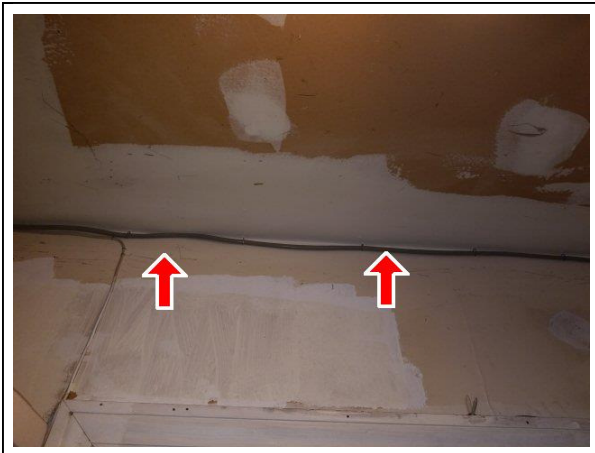
8.4 (3) Improperly exposed NM (aka RomeX) wiring noted in the Utility Rm, in the Sheds, and in the Electrical Rm. Have placed in a protective conduit to reduce the potential for accidental damage by a licensed Electrical Contractor.

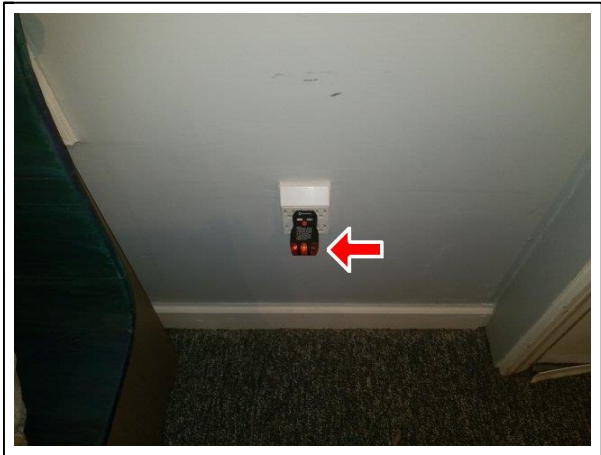
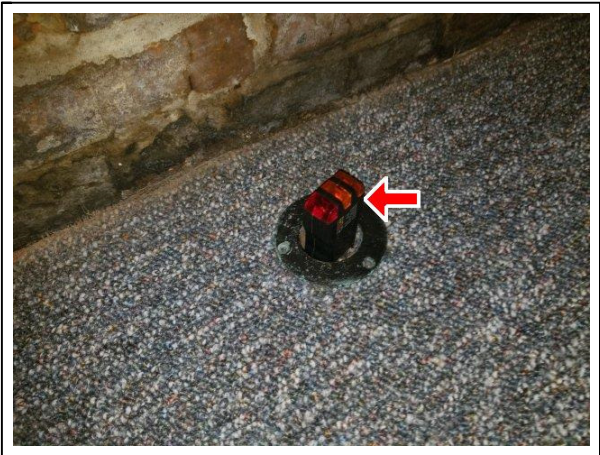
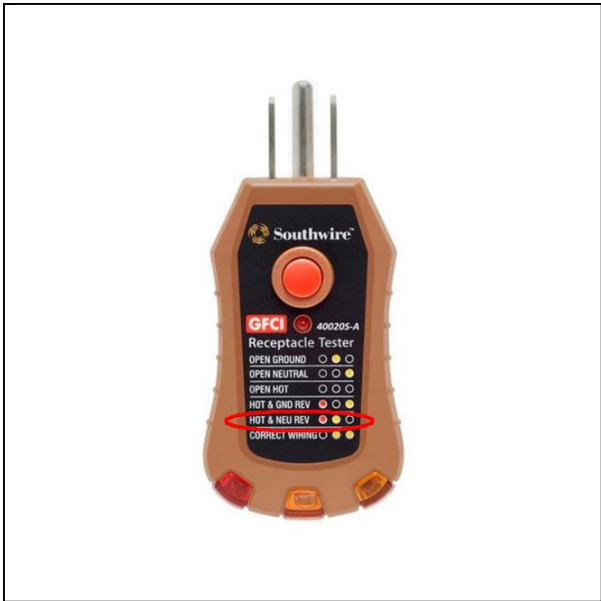
8.5 (1) Reverse polarity (hot & neutral wires crossed) was found at a receptacle outlet at the 1st FI Laundry Rm and MBR; rewired properly.

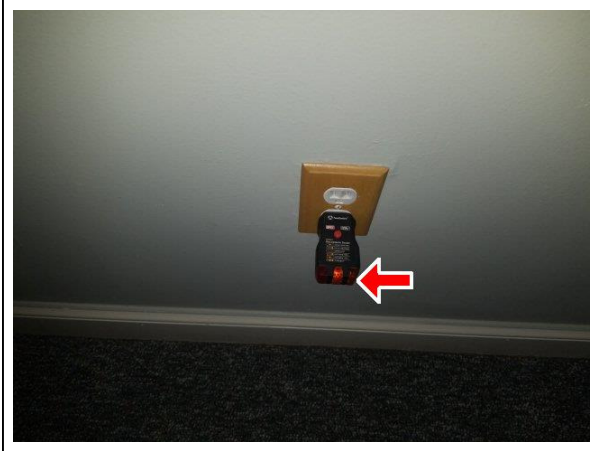
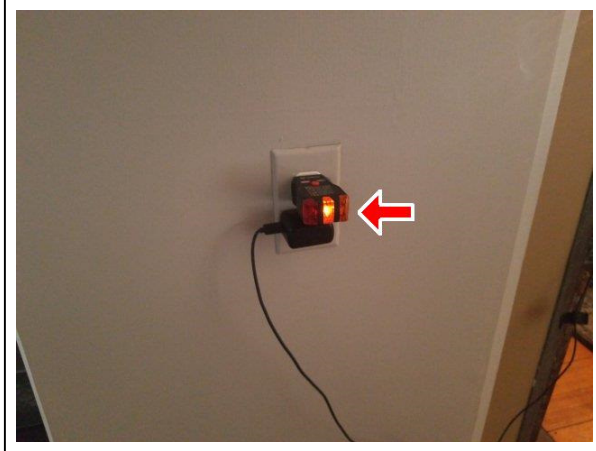
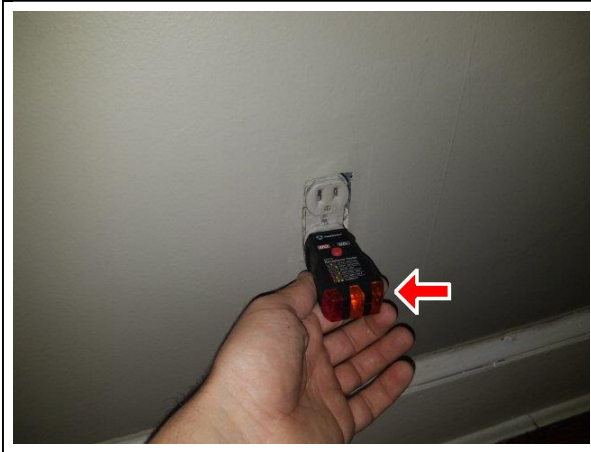
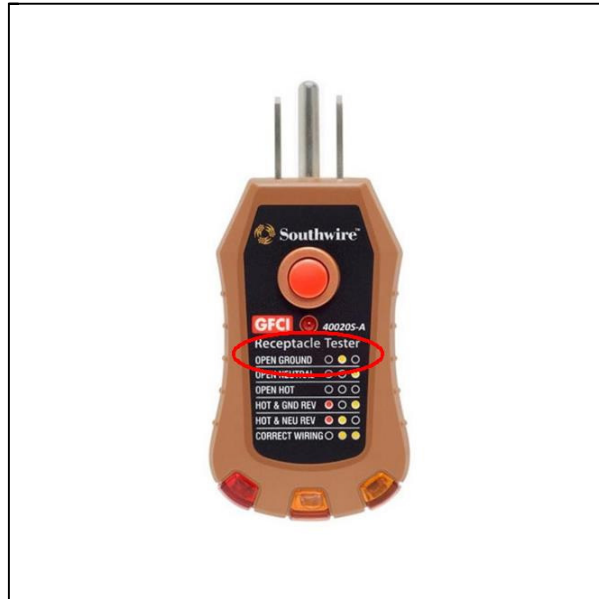
8.5 (2) Outlets with open ground connections were found in multiple locations throughout the home, suggesting that 2-prong receptacles were replaced with 3-prong units without connecting a ground wire. Much of the original circuits are wired with ungrounded cable. The third receptacle slot implies a false impression of safety when a ground is not present, and these receptacles should be replaced with 2-prong units or with GFCI units that are labeled as having "No Equipment Ground". Installing GFCI breakers on these circuits in the service panel would be acceptable as well, provided each of the receptacles is labeled as being "GFCI Protected" and having "No Equipment Ground". Have checked and correct as required by a licensed Electrical Contractor prior to closing.

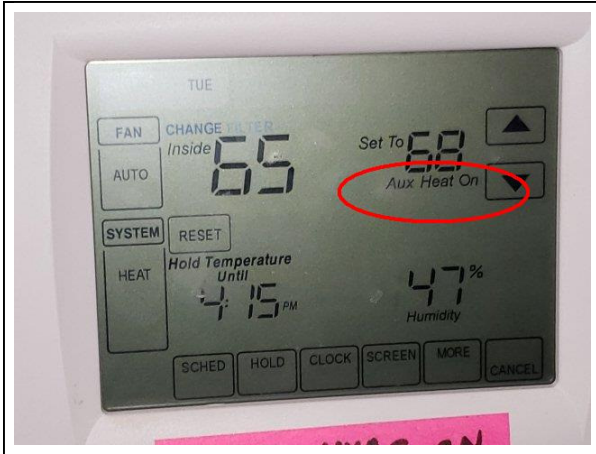
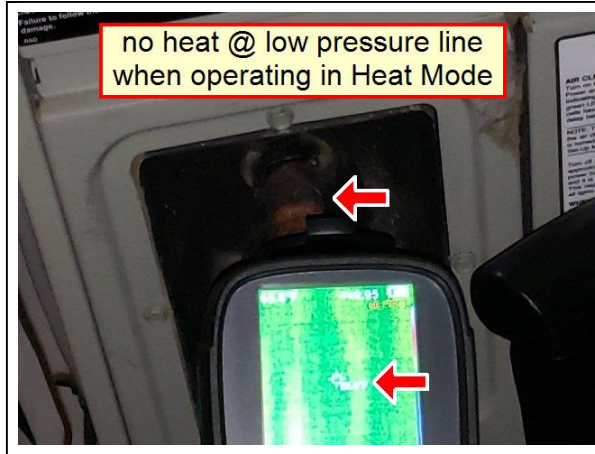
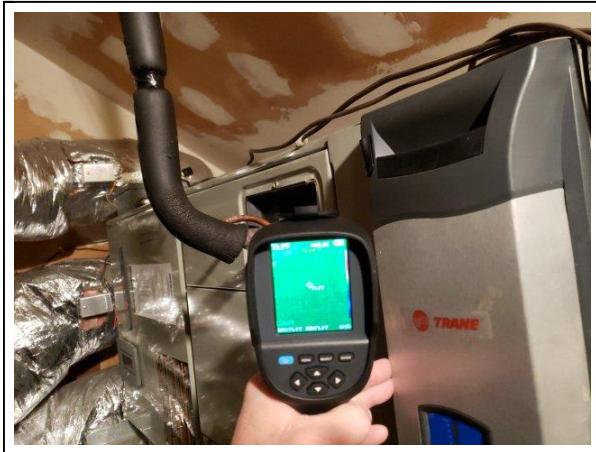
9.0 (1) Most of the systems were inoperable and/or defective at the time of inspection. Only the main system for the 2nd FI appeared to be functioning as intended. No temperature differential was detected between the high and low pressure refrigerant lines for the Base-ment and 3rd & 4th FI systems, the wall mounted Air Handler in the 1st FI BR was noisy at the time of inspection, as was the condenser for the main 1st FI system, and the cover was falling off the Air Handler in the main Kitchen. That system could not be operated as well, as the remote control for it was missing. Additionally, the cover panel to access the wiring compartment was off the outdoor unit for the 3rd & 4th FI system. All of the equipment appears to be at or near the end of it's intended service life as well. Have evaluated, serviced, and repaired as needed by a licensed HVAC Contractor, and plan for replacements.

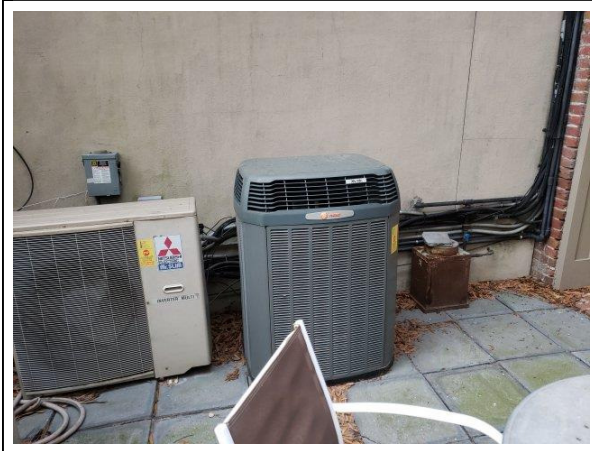
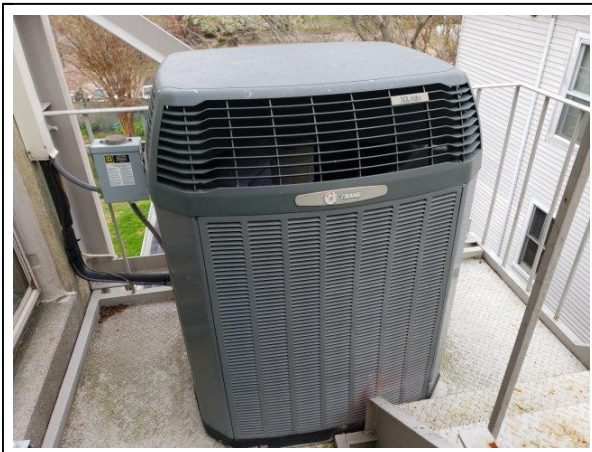
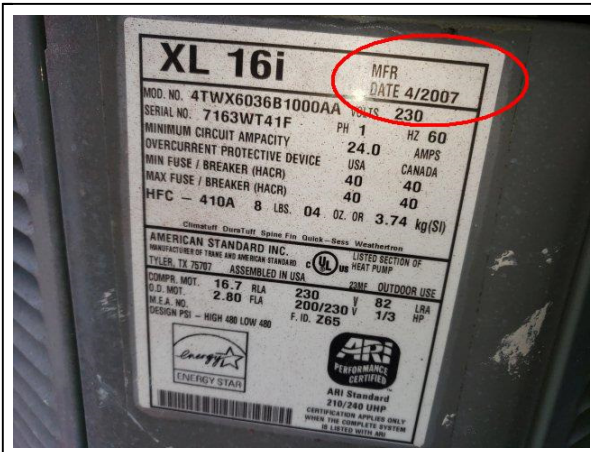
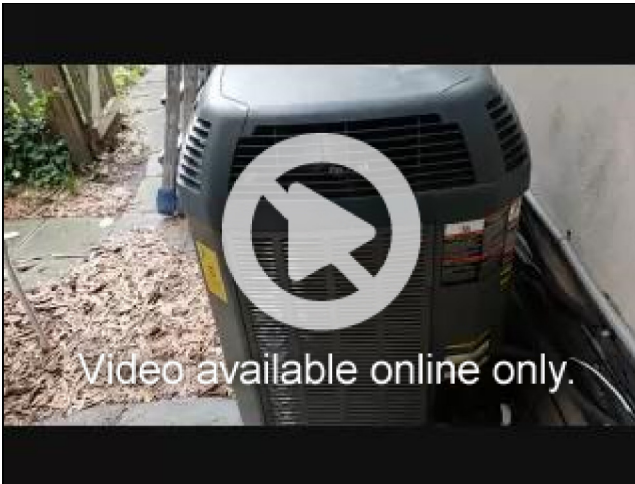
See notes above and in the Exterior Section. (condensers on fire escape should be relocated when they are replaced)

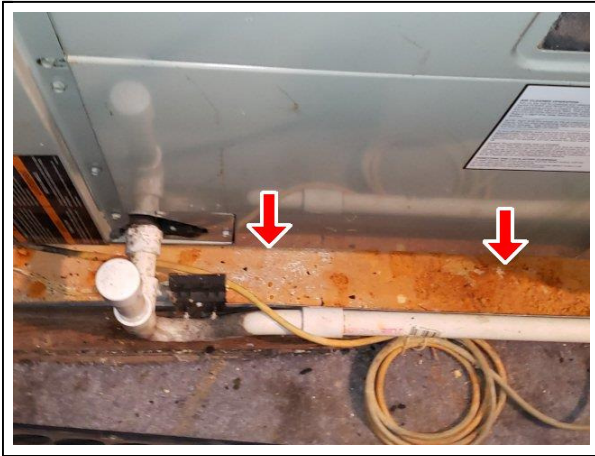
9.3 Photo 1

Evidence of prior backups in the primary drain line for the main 2nd Fl system, resulting in leaks noted at the overflow pan below the Air Handler. (rust found in the pan) Recommend having checked and corrected as needed by a licensed HVAC Contractor prior to the start of the Cooling Season.

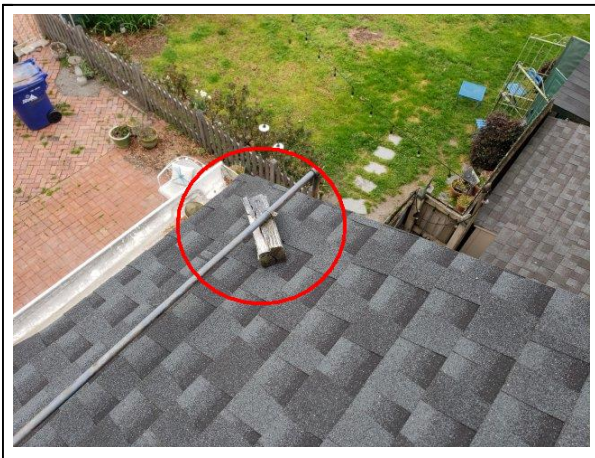
10.5 (1) The wood blocks that support the gas line on the roof of the Slave Quarters part of the building are decaying, and the straps have come loose, re-secure and maintain as needed.
