**Reserve Study**  
**Condominiums at Kirkpatrick Farms (The)**

January 31, 2013

SUBJECT: Report of Replacement Reserve Study  
Condominiums at Kirkpatrick Farms  
Aldie, Virginia  
ETC Proposal: M0-1639

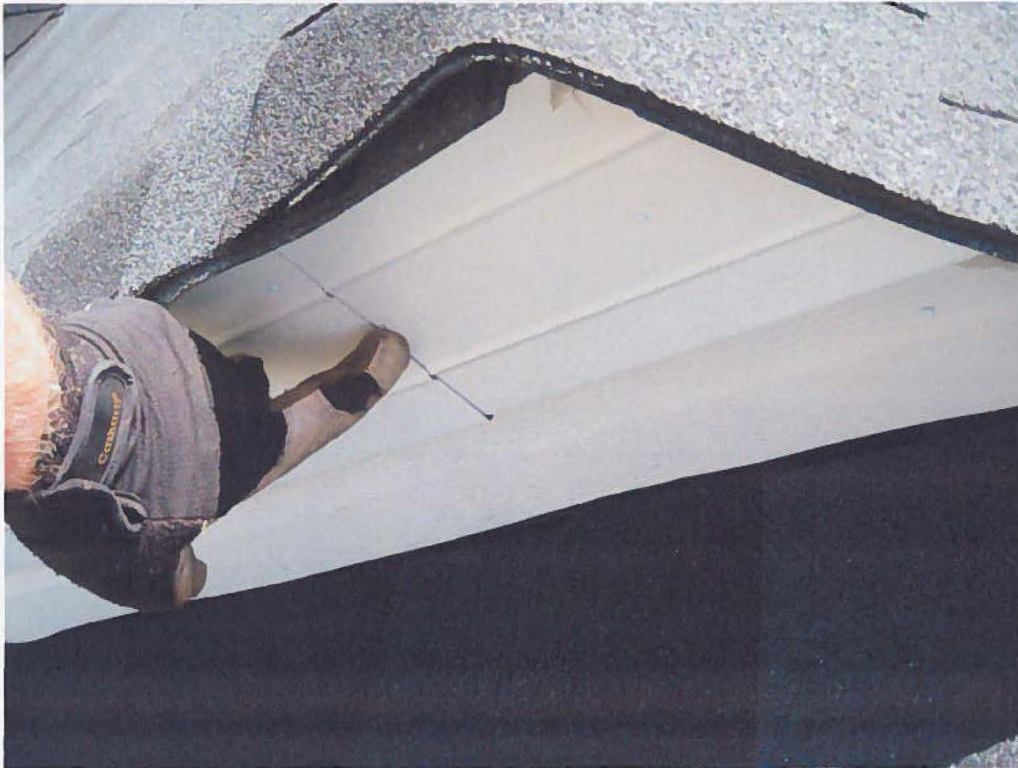
4. Some trim elements were clad with sheet metal and it was improperly installed in areas. At some building rakes lower sections of cladding were lapped over the upslope sections (see Photograph 1). That configuration will collect rather than shed water.
5. A number of sealant joints were in poor condition. Cohesive failures (tears) and adhesive failures (bond breaks) were noted in areas (see Photographs 2 and 3). Cohesive failures are usually caused by improperly sized joints (which should be approximately half as deep as they are wide) and/or three-point bonding. Adhesive failures are usually the result of improper preparation (especially cleaning) of the substrate.

**Photograph 1 – Improperly lapped trim cladding.**

Proper cap flashings should be installed at the masonry rowlock ledges. All improperly installed metal cladding on trim elements should be removed and replaced in the proper orientation.

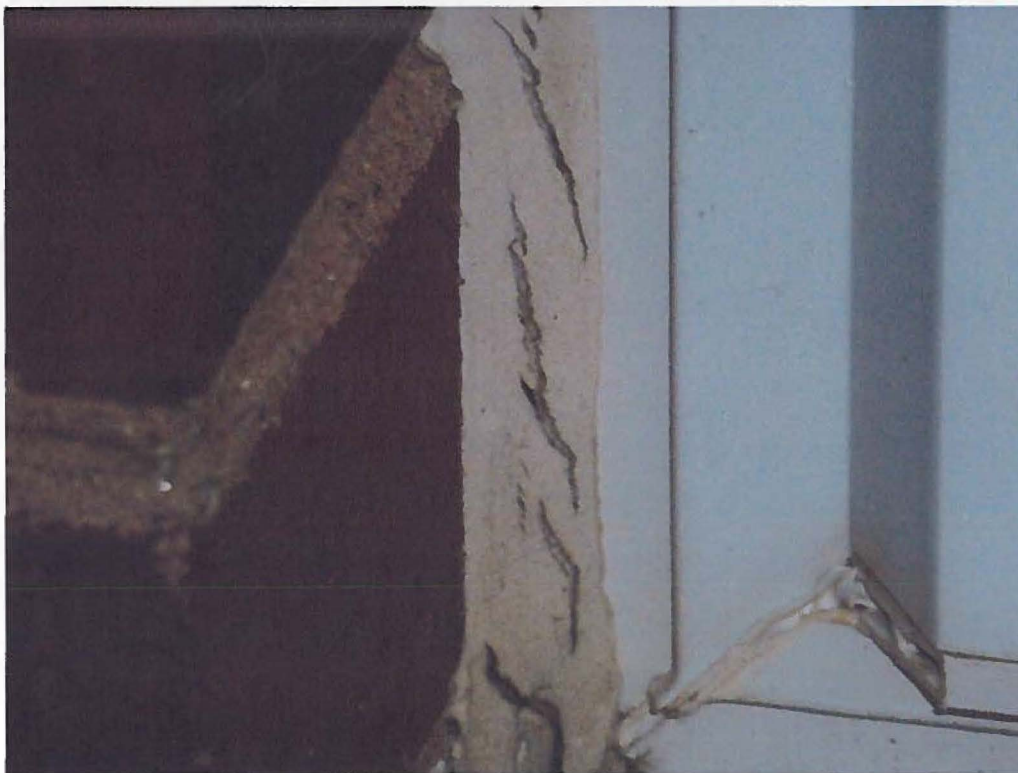
**Photograph 2 – Torn sealant.**

Defective sealants should be removed and replaced with new elastomeric sealant. The new joints should be properly sized with respect to width and depth and appropriate measures should be employed to prevent three-point bonding.

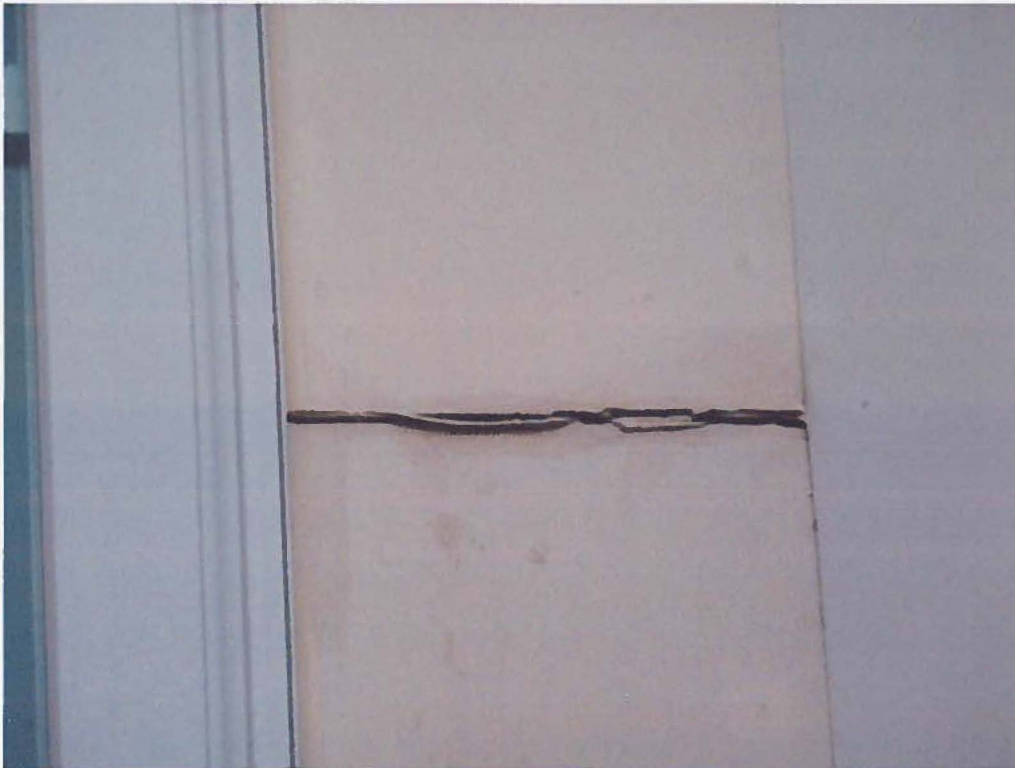
Photograph 3 - Debonded sealant.

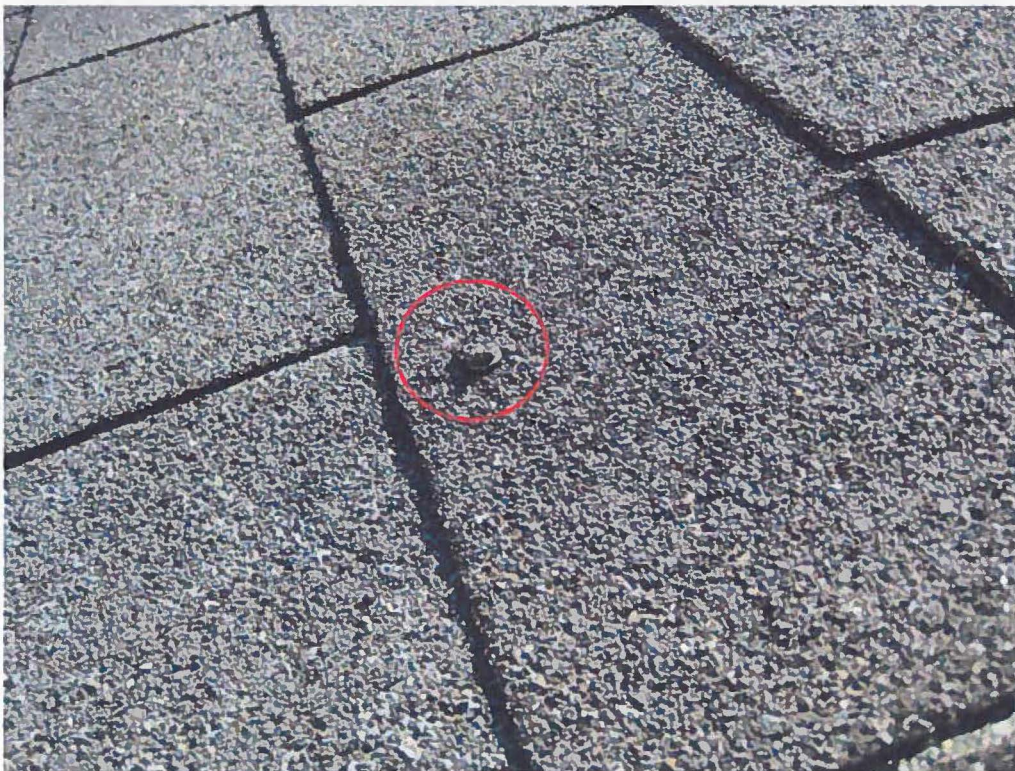
1. Shingles were improperly installed and/or damaged at numerous locations.
  - a. Numerous shingles were face-nailed, rendering them vulnerable to water intrusion (see Photograph 4).

Photograph 4 - Face-nailed shingle.

1. Removal and replacement of improperly installed, fastened, damaged and/or missing shingles;
2. Trimming of shingles with over three-eighths-inch overhang;
3. Removal and replacement of defective/deficient penetration flashings; and,
4. Installation of proper counterflashings at the utility rooms and projecting window bays.

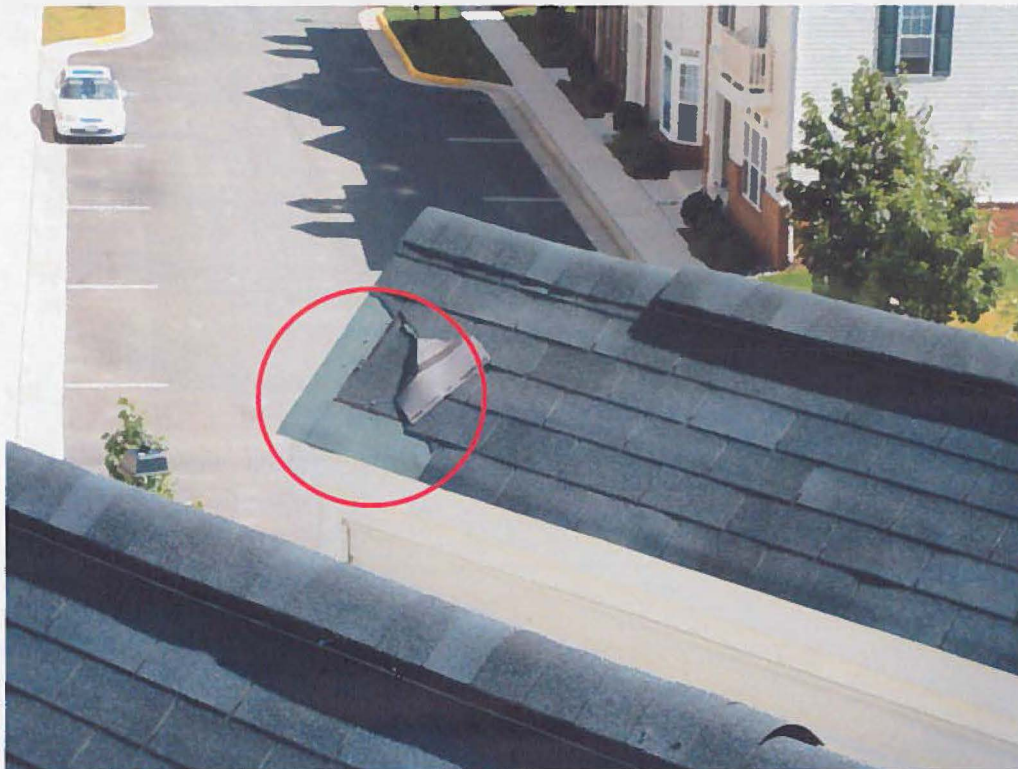
- b. A number of fasteners were improperly positioned. The involved fasteners were improperly located within or above the self-sealing strip, rendering the shingles vulnerable to wind damage. The fasteners should have been placed below the sealing strips and above the cutouts. Shingle tabs were missing in areas, probably due to improper fastening (see Photograph 5).

**Photograph 5 – Wind damaged shingles.**

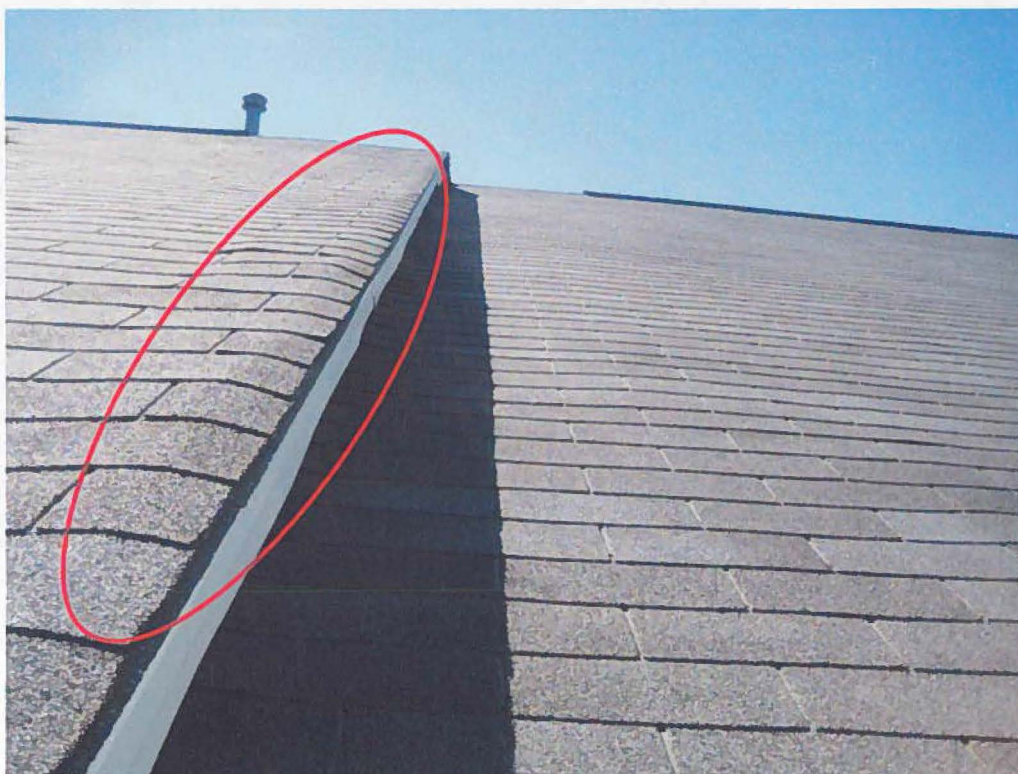
- c. The shingle overhang was excessive (as much as three to four inches) in areas (see Photograph 6). The proper overhang is between one-quarter to three-eighths of an inch, which helps protect the roof edges and renders overhanging shingles less susceptible to distortion, wind damage, etc.

**Photograph 6 – Shingles distorted due to excessive overhang.**

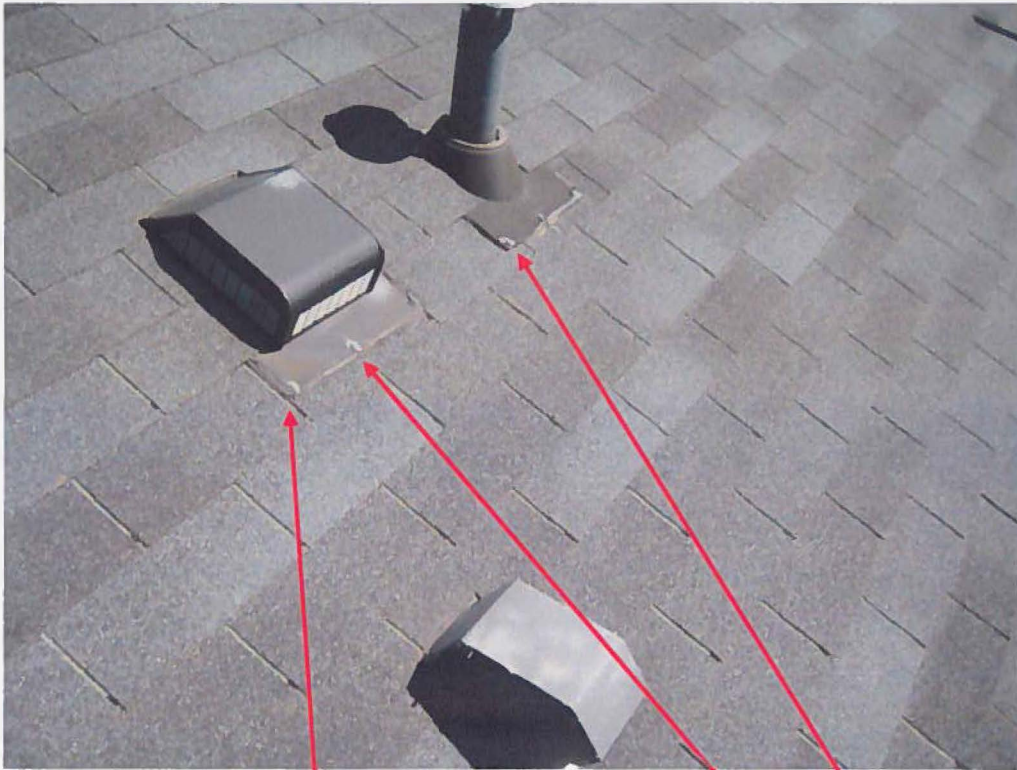
**Photograph 7 – Improperly aligned and face-nailed penetration flashings.**

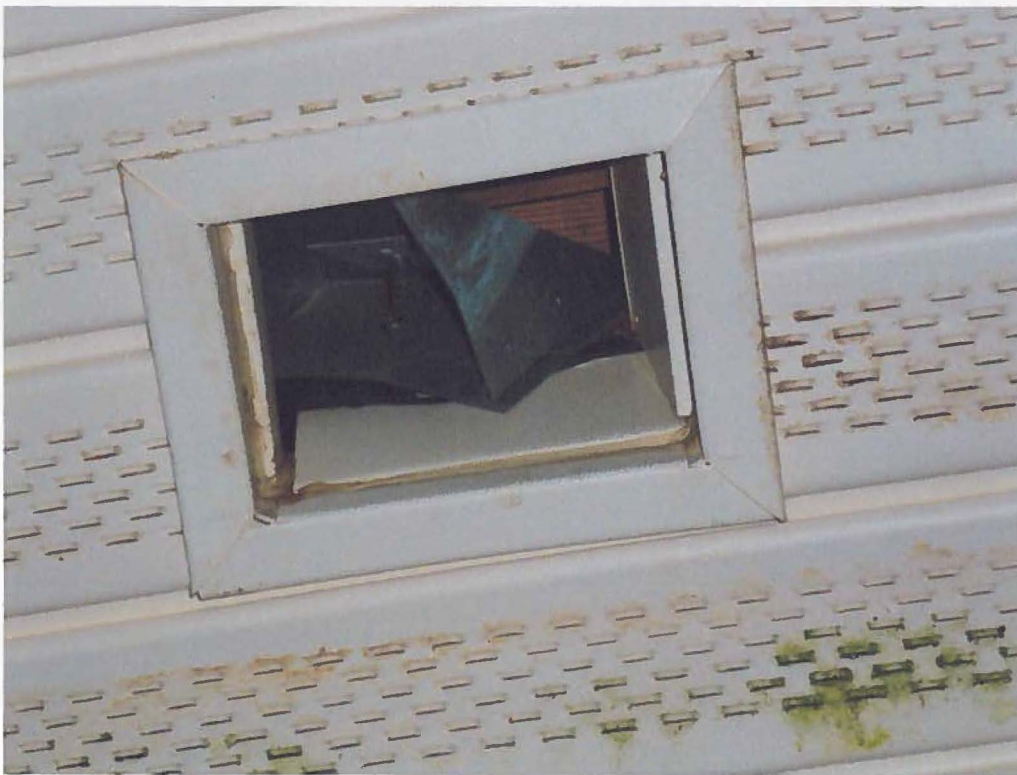
The balcony structures and decking appeared at the time of our inspection to be in good condition. Some dryer vent outlets were loose and/or do not align with the soffit openings, which probably introduces considerable water and lint into the spaces between the balcony decks and the soffits (see Photograph 8). Most of the vented soffits were stained with algae (see Photograph 9).

**Photograph 8 – Loose dryer vent at balcony soffit.**

In our opinion the balcony soffits should be permanently removed and the dryer vents should be relocated to discharge through the exterior walls. At a minimum, the misaligned and loose dryer vent outlets should be remounted.

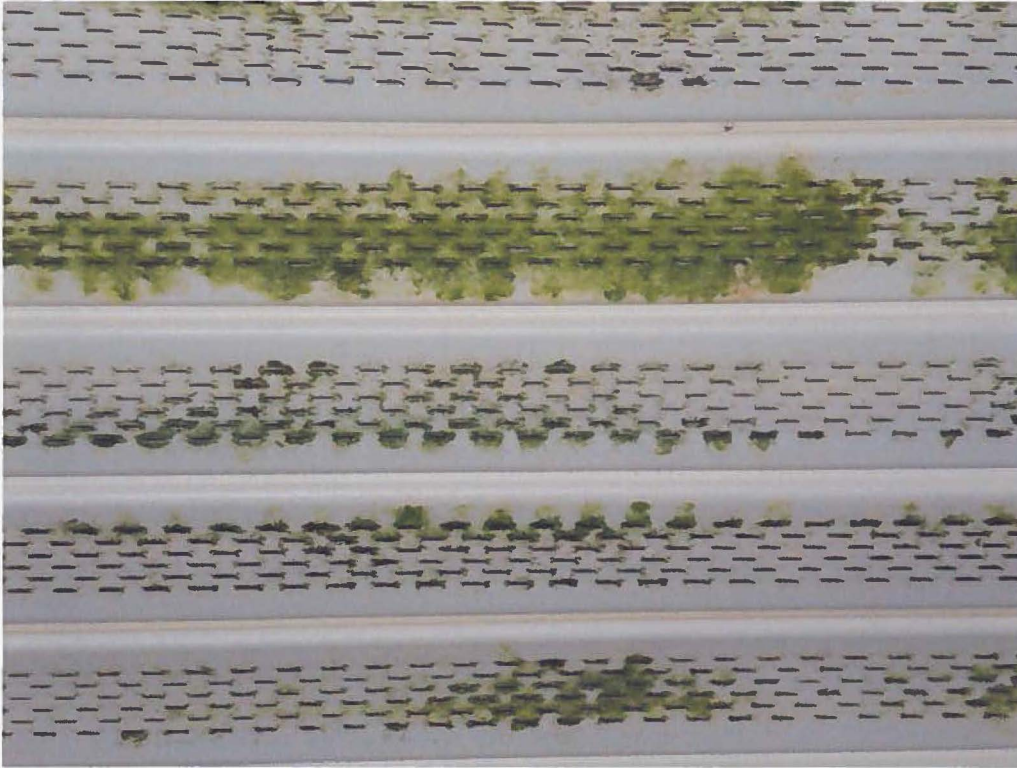
Soffits below open plank decking can accumulate substantial debris over time and are generally not recommended. The weight of accumulated debris could eventually be sufficient to dislodge panels. Furthermore, wet organic materials in the cavities could foster the growth of mold and other undesirable organisms.

**Photograph 9 – Algae staining on balcony soffit.**

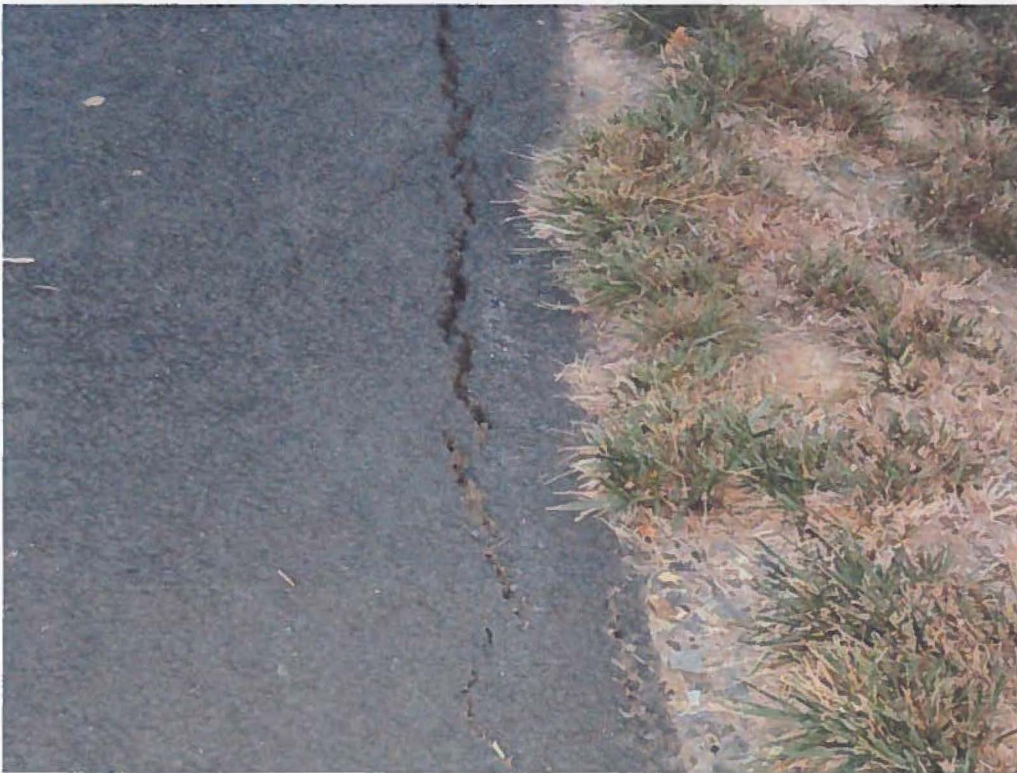
The foot path appeared overall to be in fair condition. Cracks were noted in a number of areas, particularly along path edges (see Photograph 10).

Asphalt foot paths of the type at this property typically have serviceable lives of ten (10) to fifteen (15) years. The edge cracking is likely progressive; therefore, a life cycle at the lower end of that range is projected.

**Photograph 10 – Cracked asphalt at foot path.**

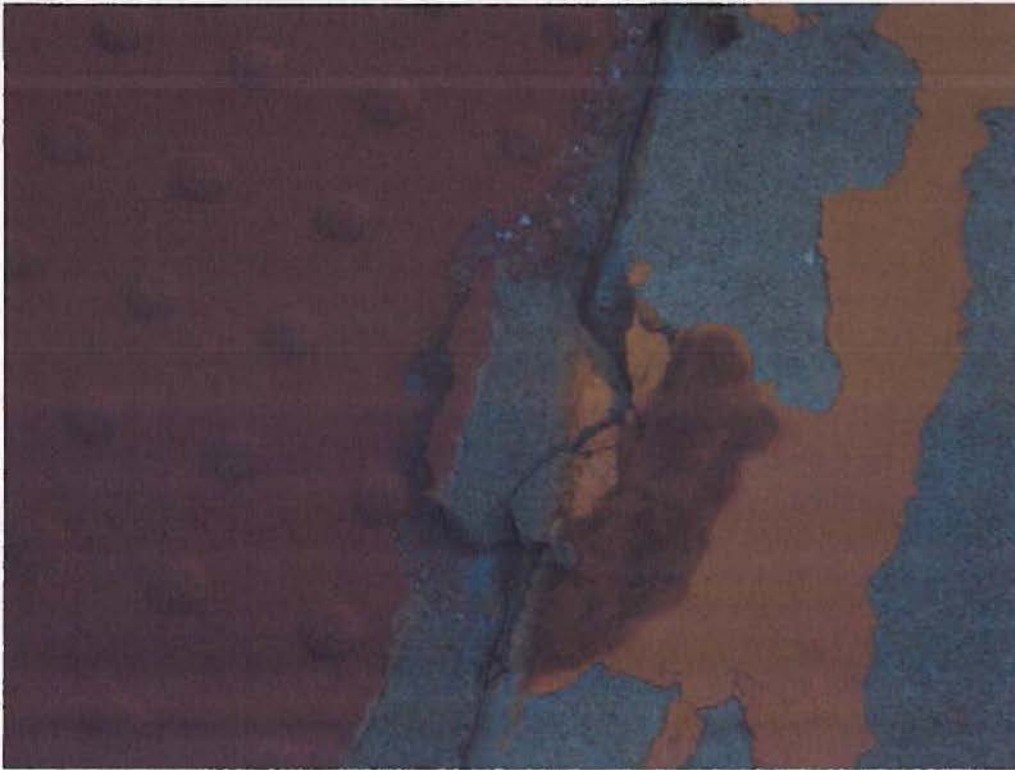
The concrete sidewalk and curb and gutter assemblies appeared overall to be in fair to good condition. Cracked/broken sections of concrete were noted in areas (see Photograph 11) and substandard repairs were executed in some instances. What appeared to be an elastomeric sealant was applied at sections of broken/chipped concrete and the material does not match the concrete with respect to color or texture (see Photograph 12).

**Photograph 11 – Broken concrete sidewalk.**

The sidewalks should be inspected at least twice a year for cracks, spalled surfaces, displacement, evidence of substrate erosion (voids), etc. Seriously distressed areas should be mapped and clearly marked (for repairs).

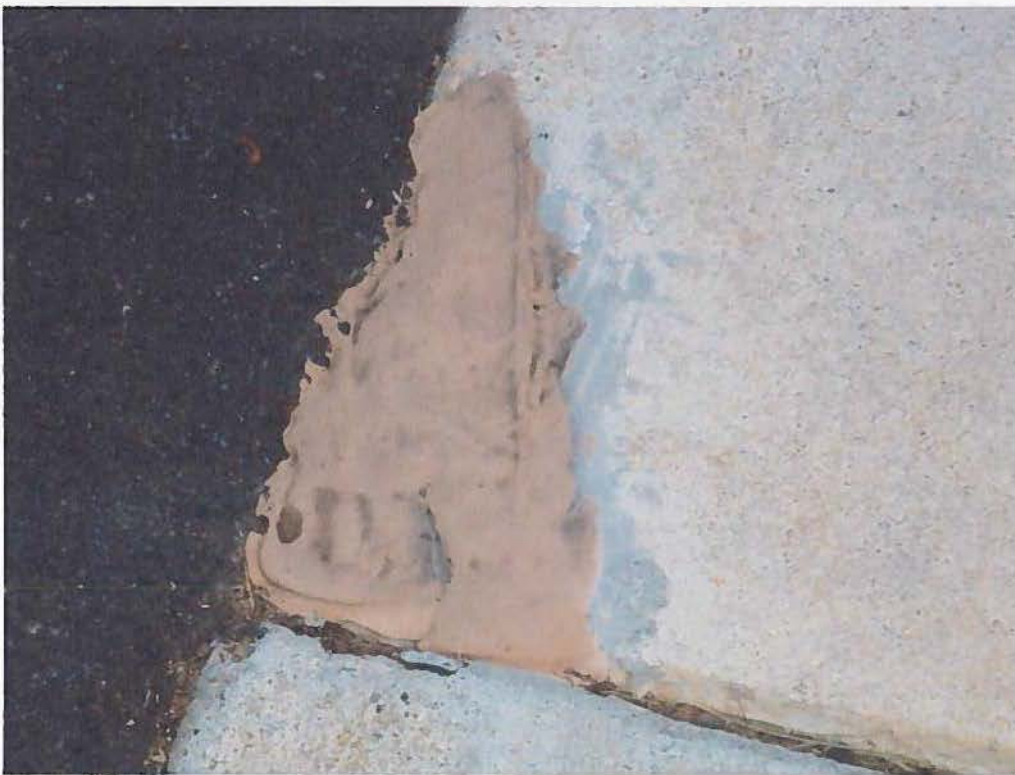
**Photograph 12 – Substandard/unsightly repair at concrete sidewalk.**
