Inspection reference: 1669

**Confidential Inspection Report**  
**2916 Smithfield Court**  
**Fredericksburg VA 22408**

**April 16, 2019**

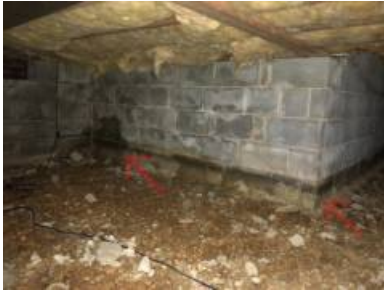
Moisture stains noted at rear wall around patio area. Monitor.

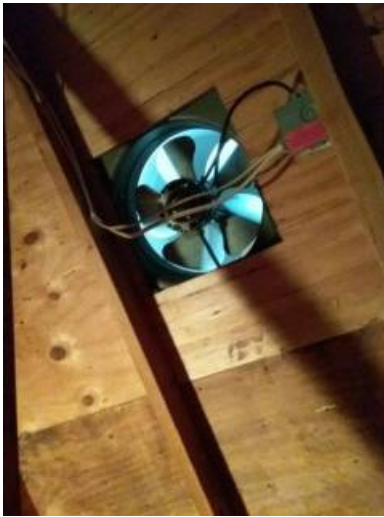
Yes - There is an attic ventilation fan installed. It is thermostatically activated, and it was not tested as a part of this inspection. The inspector does not override automatic controls as a part of the inspection.

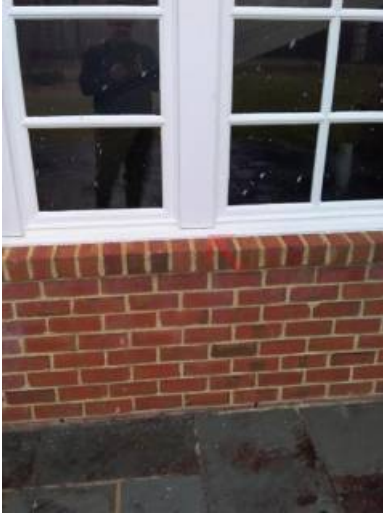
Seal gaps, holes and openings in siding and trim as needed. Repair window trim as needed.

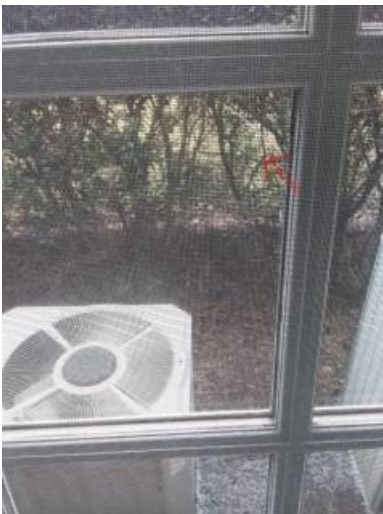
Cracked window in master bathroom, replace. Dining room window will not open and screens are loose, repair. Front left bedroom window does not open freely and screens are bent, repairs as needed. Several windows do not open besides the ones listed further evaluation of Windows needed.

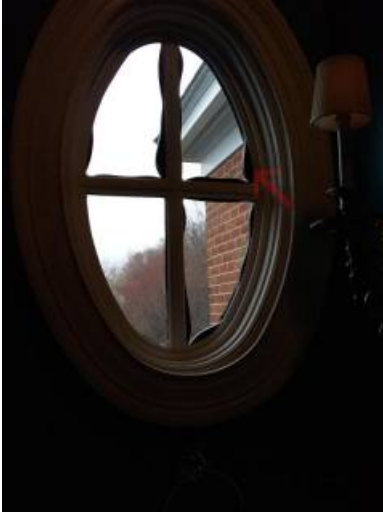
Window seal in a few window have moved, repair as needed.

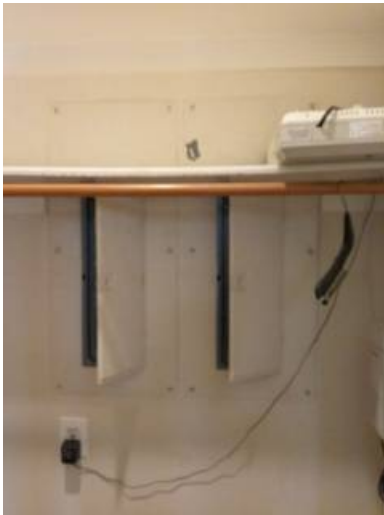
Sub panels in foyer closet unable to remove covers for full inspection.

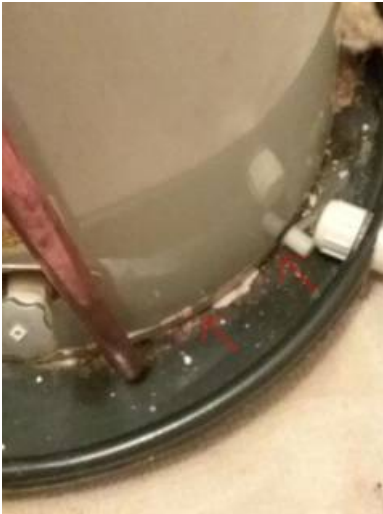
Loft closet water heater is rusty and older, monitor is not in service. Other water heaters appear newer and operational.

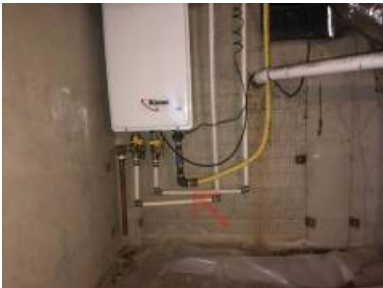
No - There is no drip leg installed on gas line to the addition water heater at its lowest point, add as needed. Installation of a drip leg is recommended to prevent debris from getting into the gas valve.

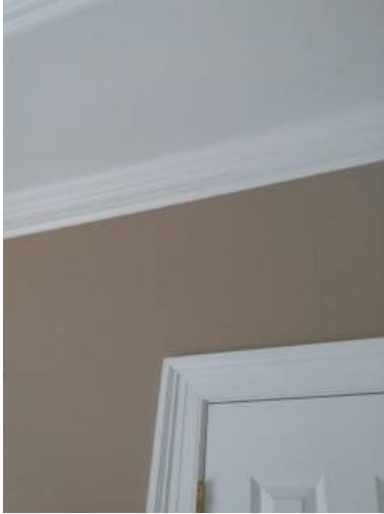
Some crack noted in a few areas, repair and monitor.

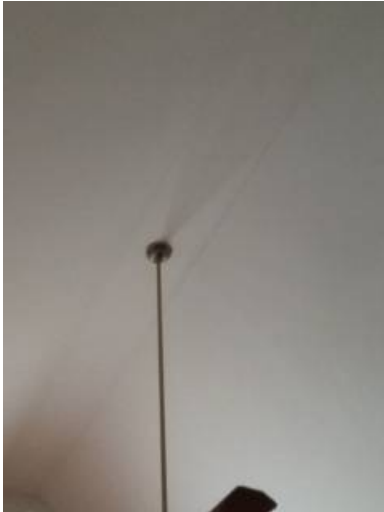
Cracks noted in office ceiling , repair.

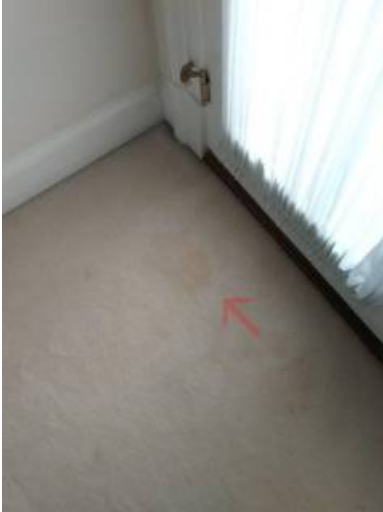
Stain and carpet at upper rear balcony door.

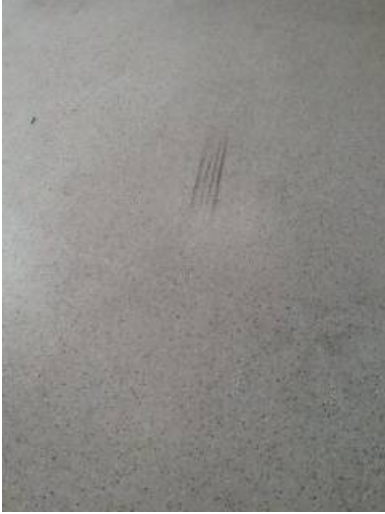
To prevent further deterioration of the slab floor, it is recommended that the cracks be sealed.
