HOME INSPECTION

04/20/18

421 W Bute Street #203 Norfolk, VA 23510

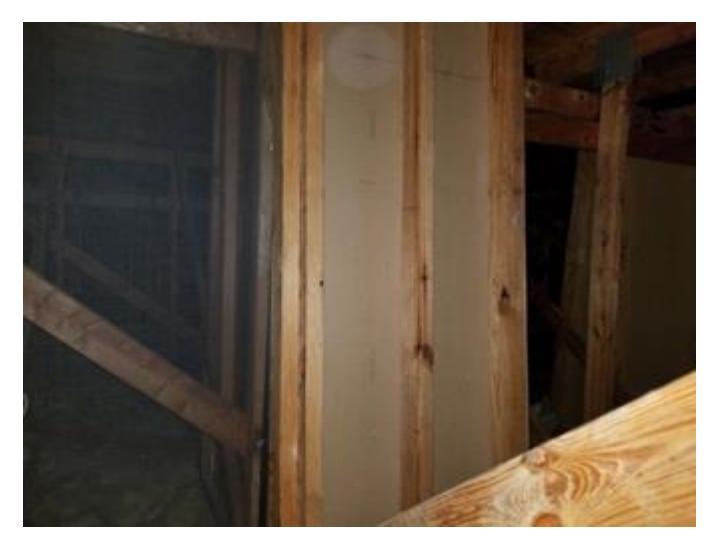
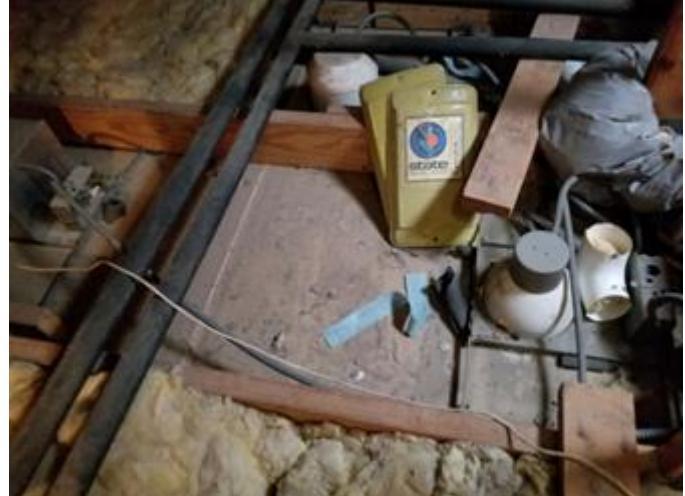
Insulation and Ventilation - Attic Insulation

Issue Insulation has been moved, leaving uninsulated areas. This affects energy efficiency.
 Location Several areas of the ceiling and missing at both sky lights
 Action Install insulation in accordance with local guidelines.

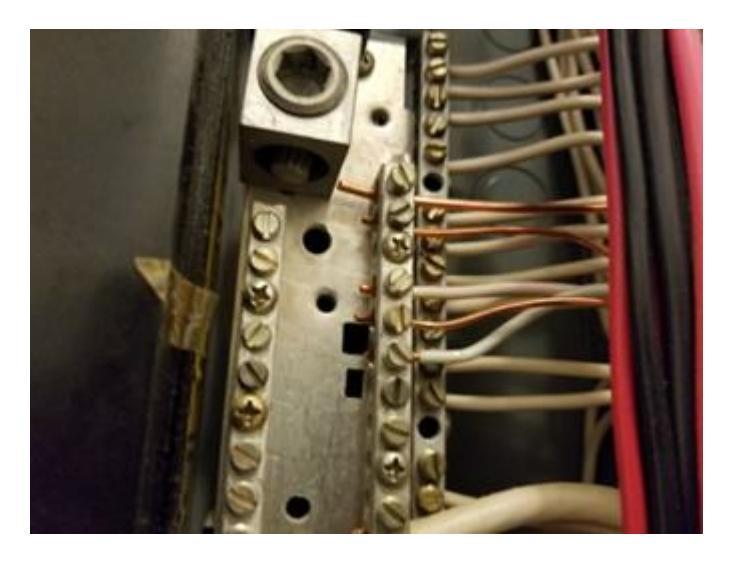
Issue The sub-panel's neutral wires are not isolated from ground. This is a safety hazard. Location Panel in closet

Action Hire an electrician to make the required repairs.

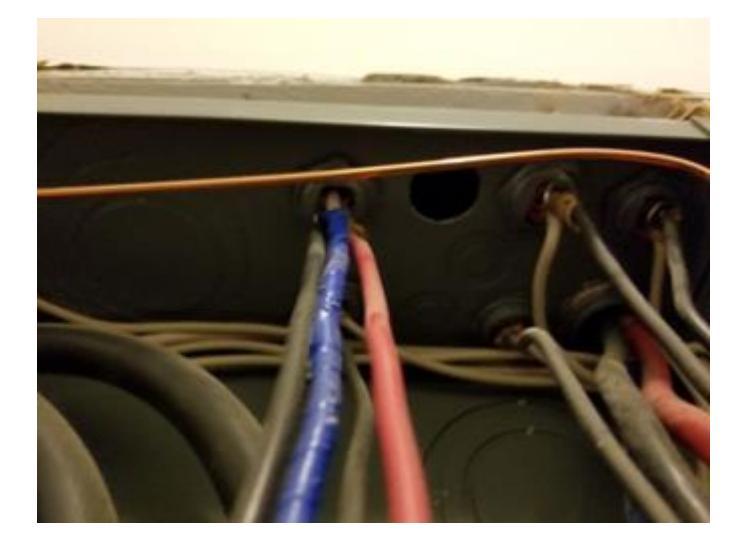
Issue There are missing knockout covers at the electrical sub-panel. This defeats the panel's fire rating, and permits accidental contact with energized components.
 Location Top of the Panel in closet

Action Hire an electrician to make the required repairs.

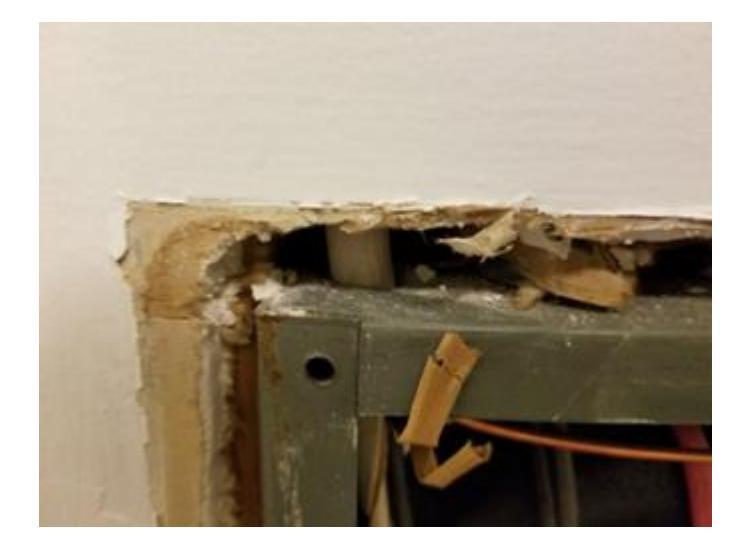
LocationOne top and one bottom of the panelActionHire an electrician to make the required repairs.

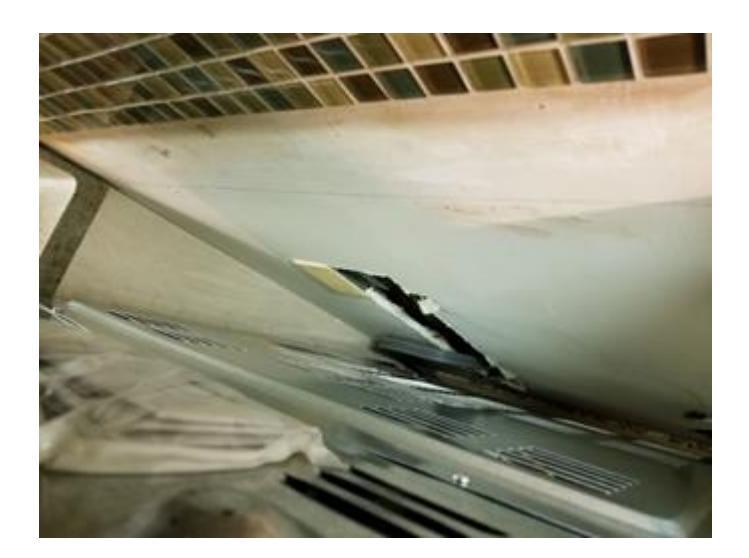
Issue The receptacle is loose and there is a hole in the wall. This is a safety hazard that can damage or loosen the wire connections.
 Location Behind the range

Action Replace the drywall and secure the receptacle.

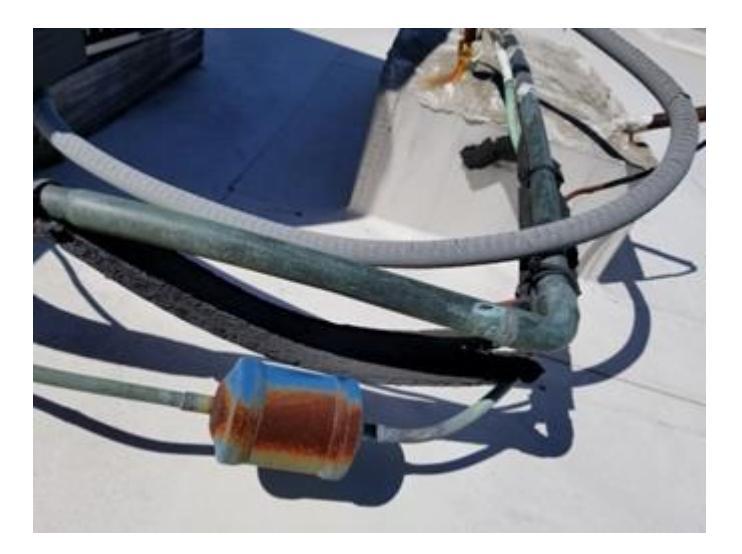
Solution is damaged or missing at the AC system's suction line. This affects the system's efficiency.

Location On the roof

Action Install an exterior-grade pipe insulation on the suction line.

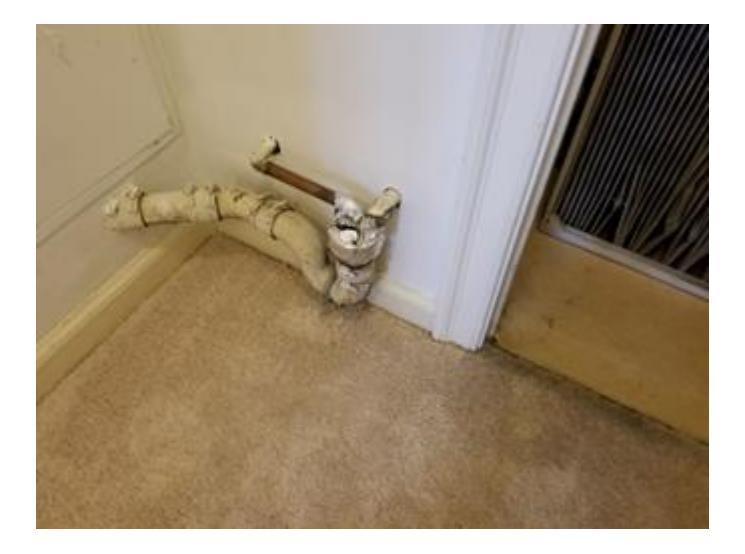
Issue The condensate line for the heat pump terminates into a drain line for the plumbing system. In the heating season the trap will dry up and may allow sewer gases to enter the dwelling.
 Location Second floor

Action Hire an HVAC contractor or plumber to make the required repairs.

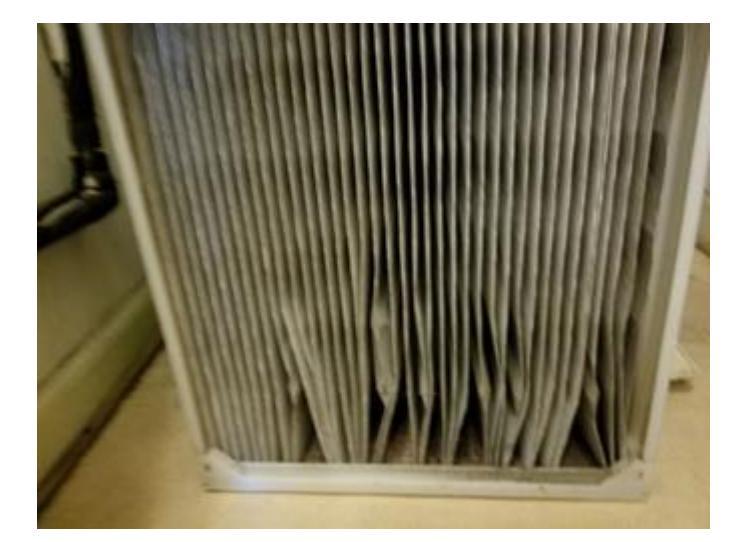
Issue The HVAC air filter is dirty and is restricting the air flow.
 Location At the air handle
 Action Replace the filter.

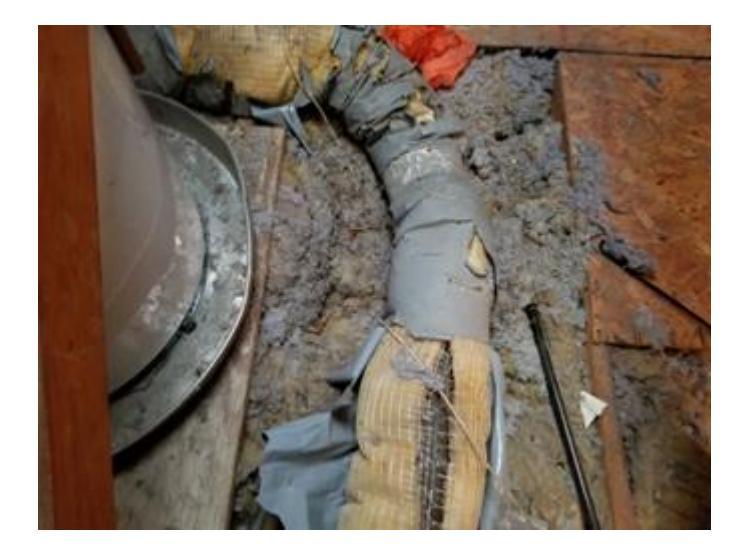
Solution Issue The ductwork insulation is missing or damaged. This reduces system efficiency and causes condensation problems.

Location Attic

Action Hire an HVAC contractor to make the required repairs.

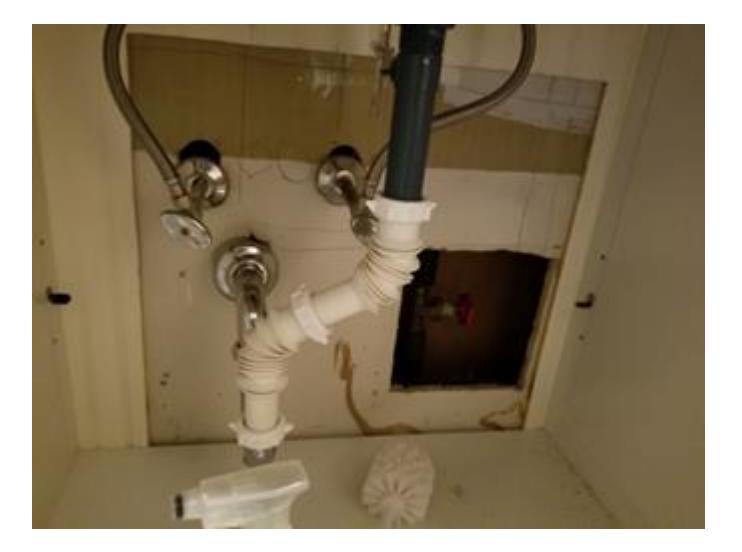
Issue The drain pipe is a corrugated or accordion style; the folds can collect debris and clog.
 Location Under the half bathroom sink, master bathroom right sink when facing the sinks
 Action Hire a plumber to replace the pipe.

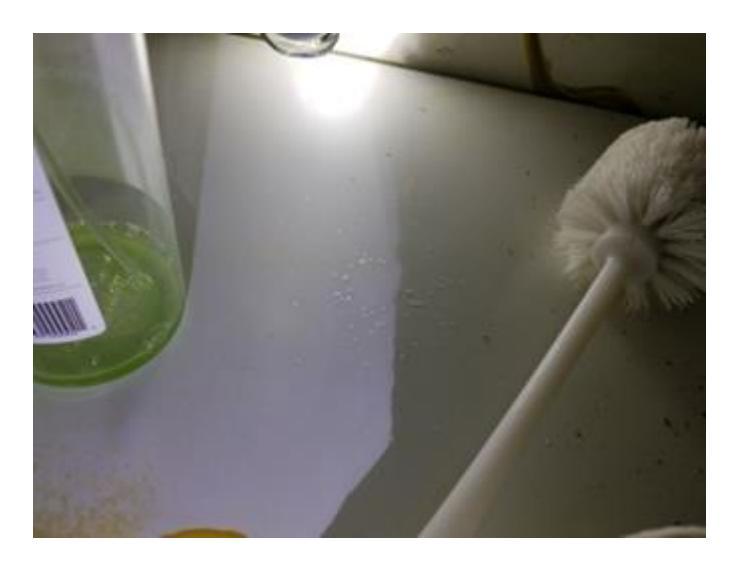
Issue The sink drain is leaking. This can allow water damage.
 Location Half bathroom
 Action Repair or replace the drain.

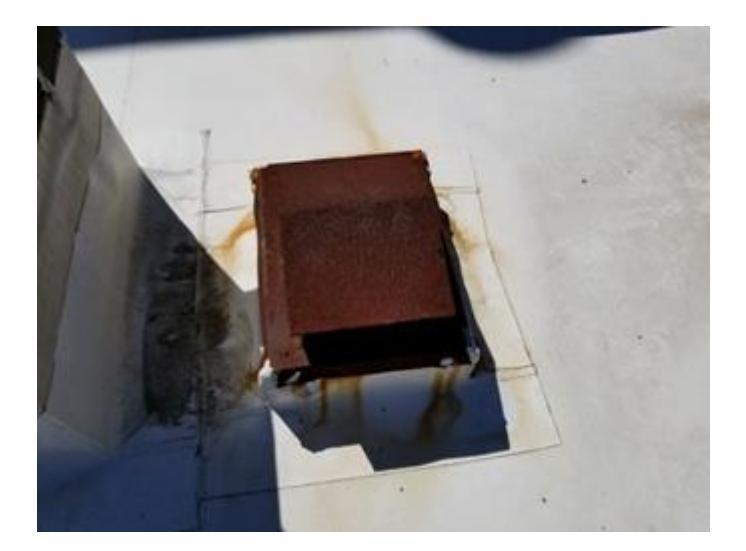
Issue The exhaust fan exterior termination hood is corroded. This can lead to leaks. Location On roof

Action Replace the hood.

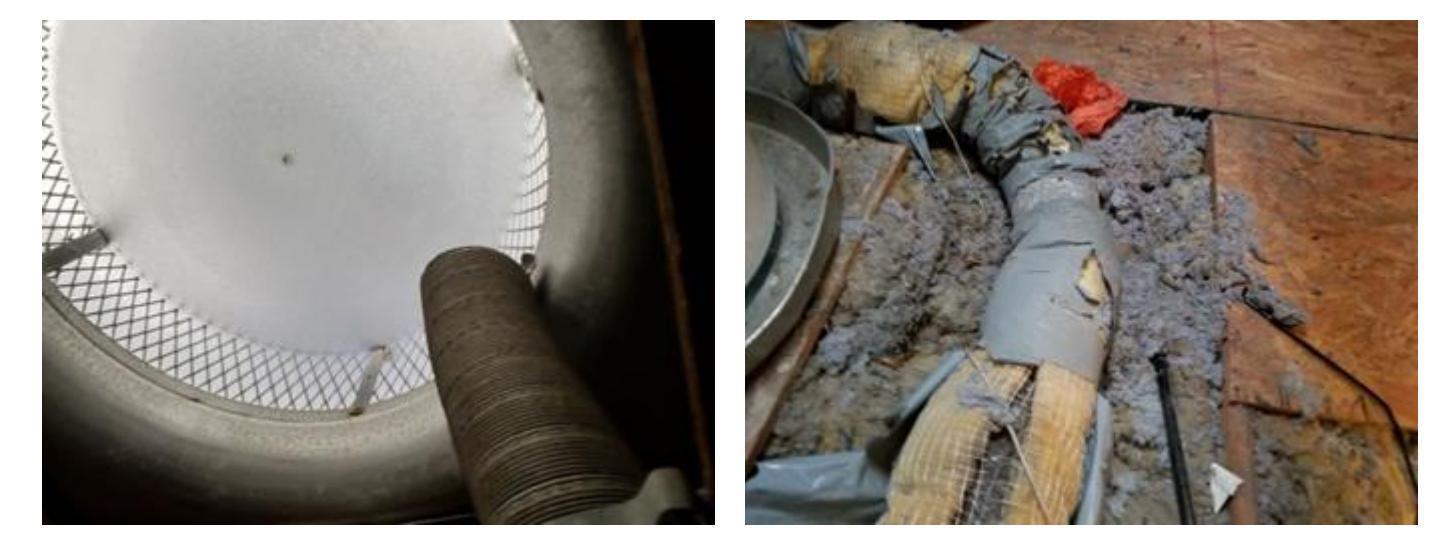
Issue The dryer's vent terminates into the attic. This creates moisture inside the attic and may cause mold or mildew problems. It is a fire hazard.

Location Vents into the roof vent

Action Reroute the vent to the exterior.
