# Inspection Report

148 Sterling Dr  
Perkasie Pa 18944

**A1 House Prep LLC and Inspections**

<b>Date:</b> 09/11/20	<b>Time:</b> 01:30 PM	<b>Report ID:</b> 6909 Kenneth & Melody Byler
<b>Property:</b> 148 Sterling Dr Perkasie Pa 18944	<b>Customer:</b> Kenneth Byler	<b>Real Estate Professional:</b> Michelle Hunsberger Alderfer Real Estate

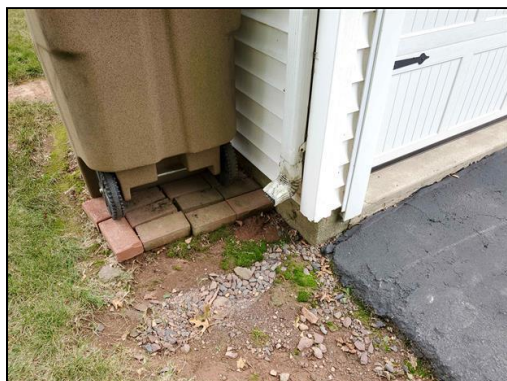
1.3 Item 1(Picture)

Downspouts are not moving water effectively away from the foundation. Suggest to extend downspouts as discussed for better drainage away from the foundation. Saturating foundation walls for extended periods of time can cause potential unseen structural damage from water and insects. Could not determine how long water was flowing towards the foundation.

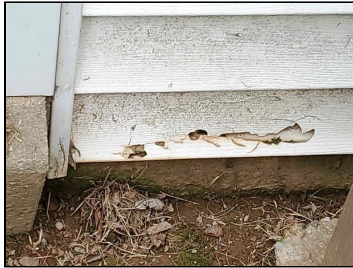
2.0 Item 1(Picture)

📌 (1) Damaged vinyl siding. Recommend to replace damaged siding as needed by a qualified person or professional.

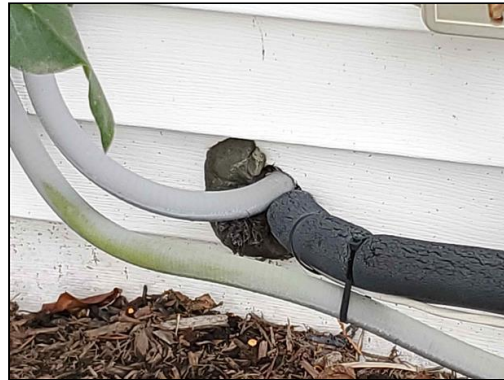
2.0 Item 7(Picture)

(2) The hole in siding needs closing off with sealant or liquid foam at the exterior where compressor lines enter the home.

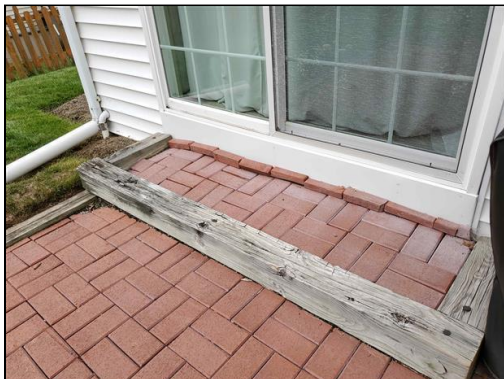
2.3 Item 1(Picture)

(1) Rotated pavers and deteriorated rail road tie edging. Recommend to reset pavers and replace all deteriorated edging as needed by a qualified person or professional. Potential tripping hazard and insect infestation exists.

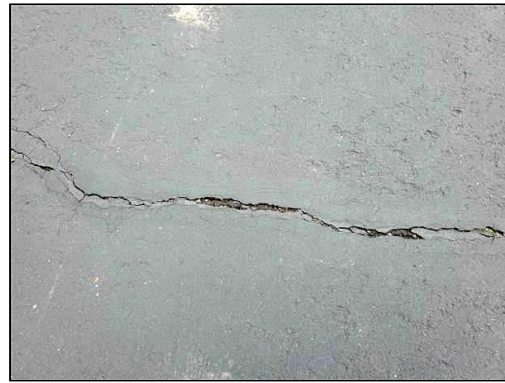
2.3 Item 5(Picture)

📌 (2) Typical driveway settlement cracks. Recommend to repair or fill all cracks as needed by a qualified person. Also suggest to recoat driveway every 4 to 5 years. This would be considered normal maintenance.

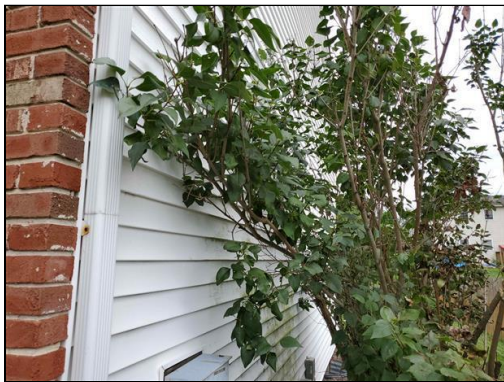
2.3 Item 6(Picture)

📌 (3) Shrubbery is growing too close to the siding for proper ventilation. Recommend to trim shrubbery a minimum of 12 to 16 inches away from the siding to restore proper ventilation. This would be considered normal maintenance.

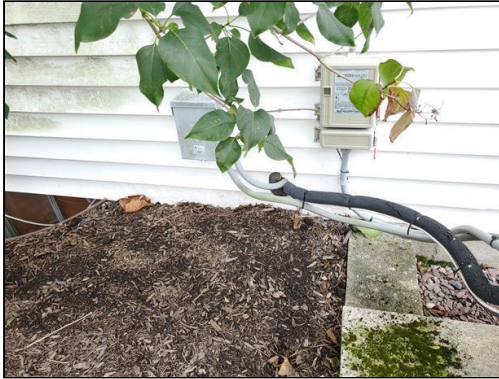
2.3 Item 8(Picture)

(4) Mulch is covering the siding. Recommend to remove mulch as needed to prevent insect penetration.

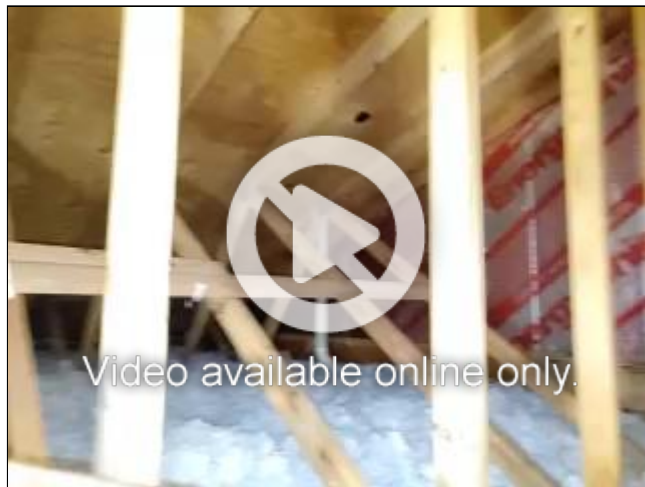
3.0 Item 1(Video) \*\*\* GARAGE ATTIC VIDEO \*\*\*

**GARAGE ATTIC VIDEO**

**Suggest to view garage attic video for more information.**

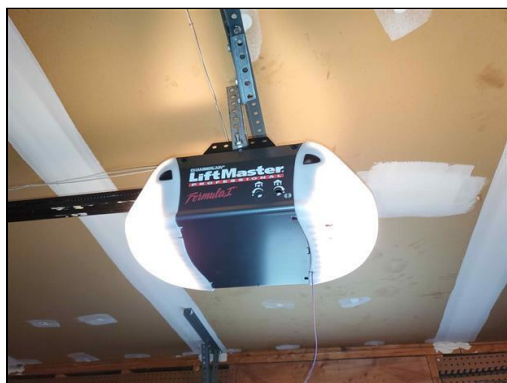
3.5 Item 1(Picture)

Both garage doors needed excessive pressure for the auto reverse function to work properly. Recommend to adjust doors as needed by a qualified person for auto reverse to work correctly. Potential safety hazard exists.

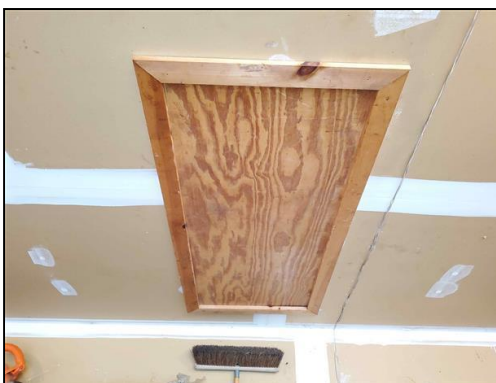
3.9 Item 1(Picture)

Scuttle hole in garage is not considered fire rated. Recommend to fire rate scuttle hole as needed by a qualified person or professional. Potential fire hazard exists.

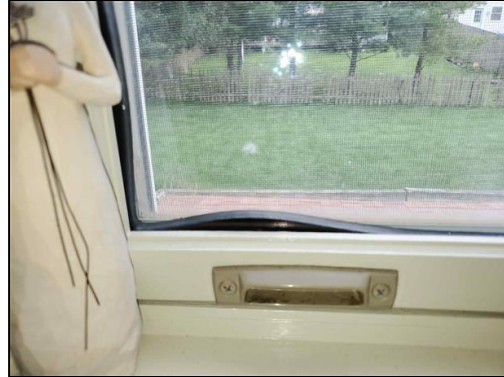
4.5 Item 1(Picture)

(1) Loose rubber seal at thermal insulated window in the kitchen. Recommend to replace as needed by a qualified professional.

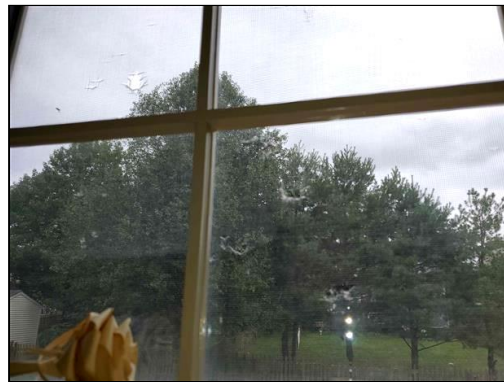
4.5 Item 2(Picture)

(2) Damaged screen in the kitchen window. **FYI**

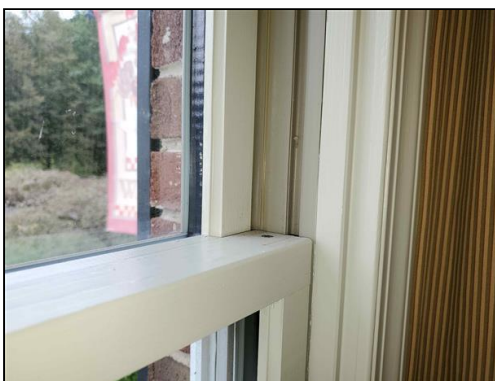
5.0.C Item 1(Picture)

Spring balancers are broken in one window located in the living room. Recommend to replace spring balancers as needed by a qualified window installer.

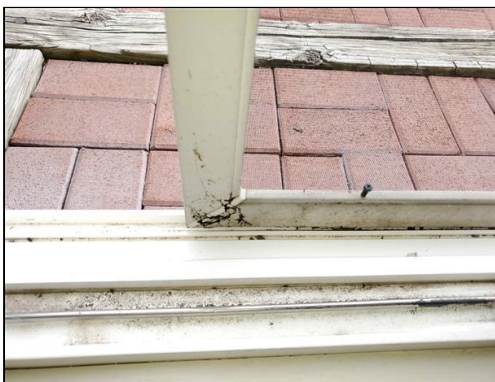
5.2.D Item 1(Picture)

Sliding screen door is not functioning properly. Recommend to lubricate door as needed. **FYI**

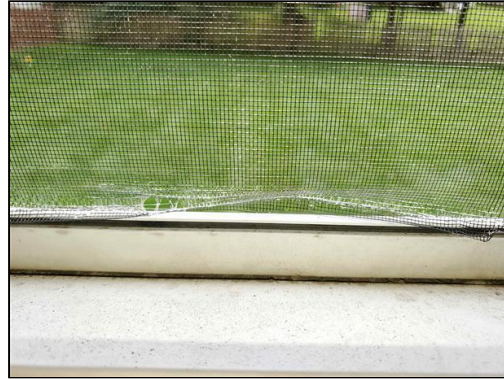
5.0.E Item 1(Picture)

Damaged screen in family room window. Recommend to repair as needed by a qualified person. **FYI**

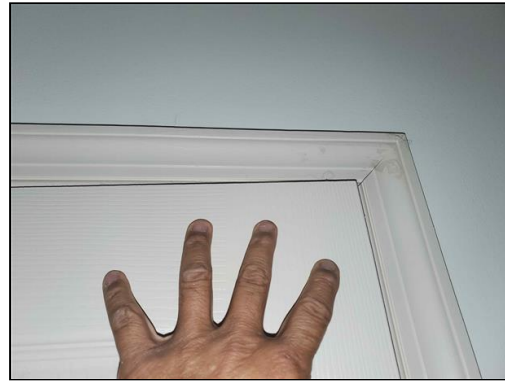
5.2.H Item 1(Picture)

Bedroom #3 entrance door is binding in the door frame. Recommend to adjust door as needed to restore proper door function by a qualified person.

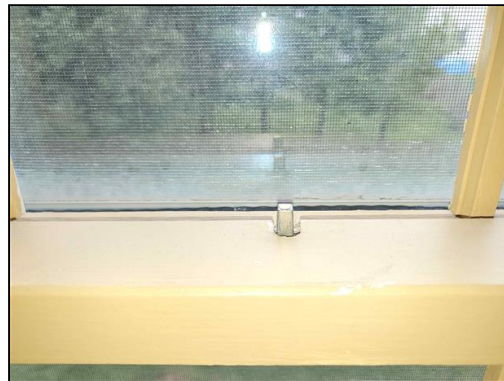
6.0.C Item 1(Picture)

Damaged window hardware in the owners suite bath. Recommend to repair as needed by a qualified person.

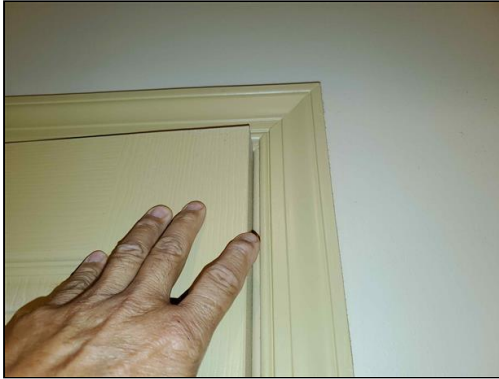
6.1.C Item 1(Picture)

Owners' suite bath door is binding in the door frame. Recommend to adjust door as needed to restore proper door function by a qualified person.

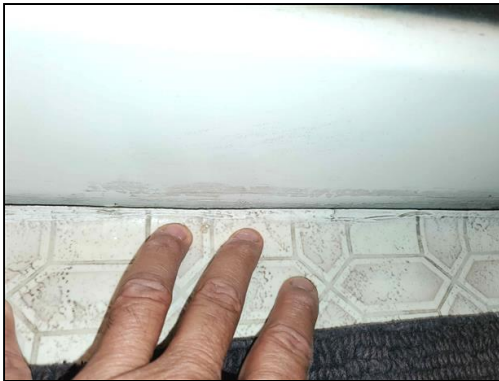
6.3.C Item 1(Picture)

Suggest to silicone between vinyl floor and shower stall. **FYI**

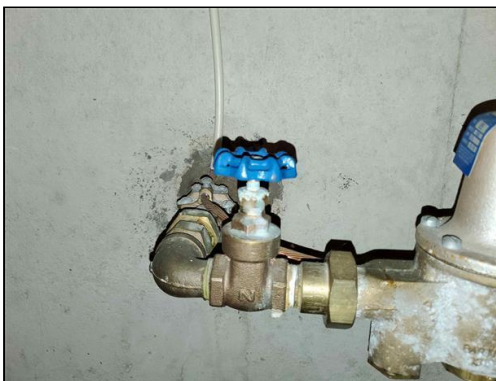
9.3 Item 1(Picture)

The main shut off is the blue knob located in the basement. This is for your information.

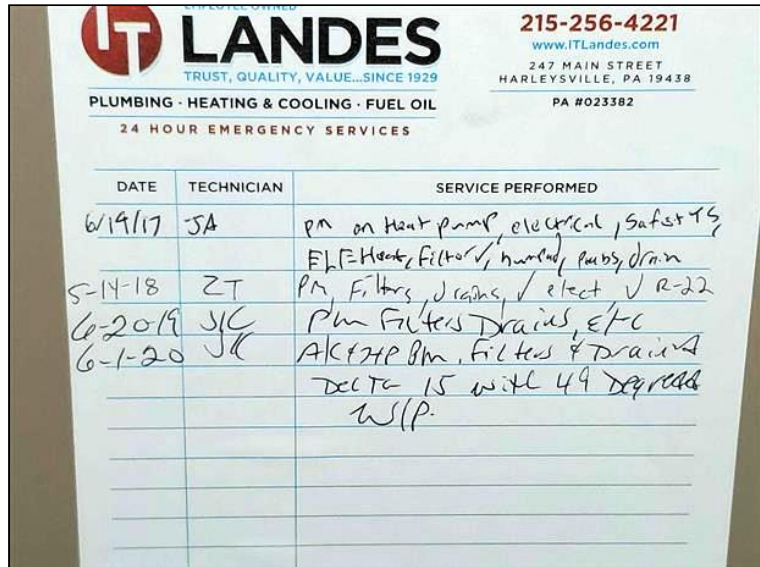
10.0 Item 1(Picture)

**See service sticker.** Recommend to have heat pump serviced on an annual basis.

DATE	TECHNICIAN	SERVICE PERFORMED
6/19/17	JA	PM on heat pump, electrical, safety, etc. FHE=Heat Filter ✓, handle, pump, drain
5-14-18	ZT	PM Filters, drains, ✓ elect ✓ R-22
6-20-19	JIC	PM Filters, drains, etc
6-1-20	JIC	AKC 2HP Blm, Filters & drains Ducts 15 with 49 degrees W/P

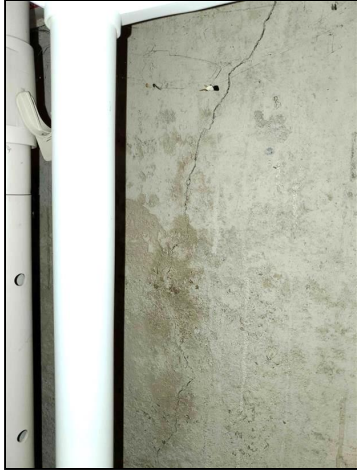
11.3 Item 1(Picture)

Typical settlement crack located in the foundation wall. Recommend to seal crack as discussed using a hydraulic cement. This will enable you to monitor same area for potential further movement.

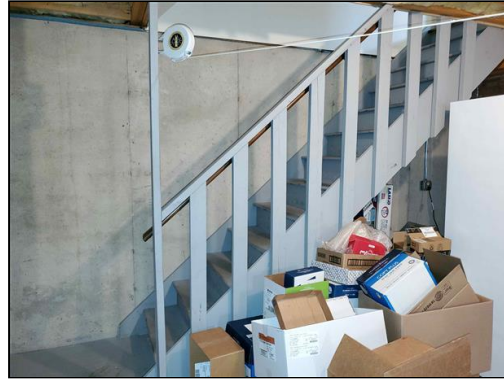
11.6 Item 1(Picture)

Space between guardrailing is greater than 4 inches. Recommend to add additional guardrailing as needed by a qualified person.

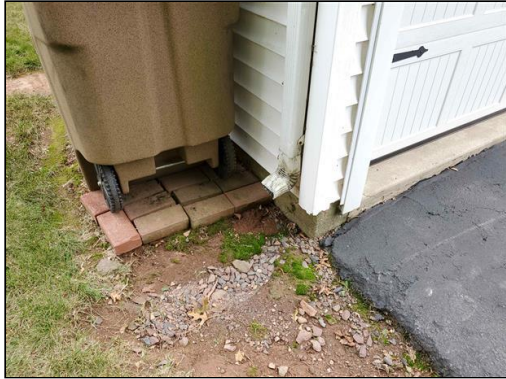
1.3 Item 1(Picture)

Downspouts are not moving water effectively away from the foundation. Suggest to extend downspouts as discussed for better drainage away from the foundation. Saturating foundation walls for extended periods of time can cause potential unseen structural damage from water and insects. Could not determine how long water was flowing towards the foundation.

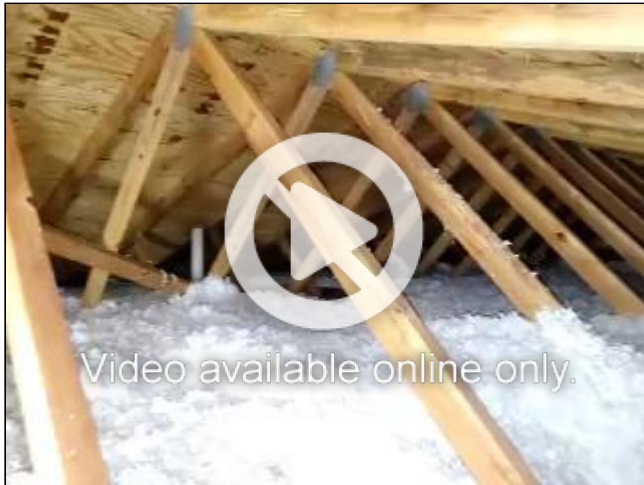
1.4 Item 1(Video) \*\*\* ATTIC VIDEO \*\*\*

**View ATTIC VIDEO for more information.**

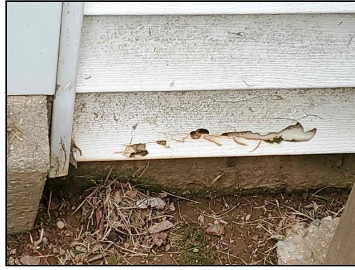
2.0 Item 1(Picture)

(1) Damaged vinyl siding. Recommend to replace damaged siding as needed by a qualified person or professional.

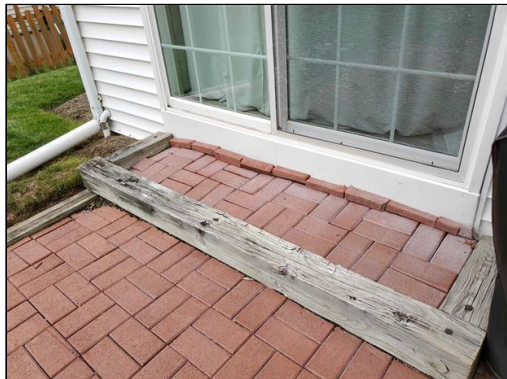
2.3 Item 1(Picture)

(1) Rotated pavers and deteriorated rail road tie edging. Recommend to reset pavers and replace all deteriorated edging as needed by a qualified person or professional. Potential tripping hazard and insect infestation exists.

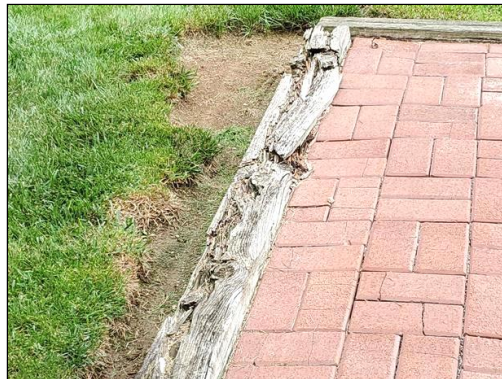
2.3 Item 2(Picture)

**2.3 VEGETATION, GRADING, DRAINAGE, DRIVEWAYS, PATIO FLOOR, WALKWAYS AND RETAINING WALLS (With respect to their effect on the condition of the building)**

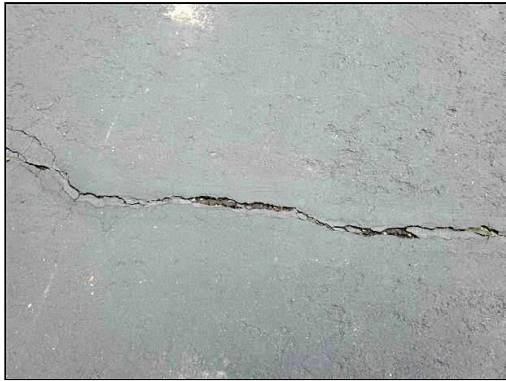
2.3 Item 5(Picture)

(2) Typical driveway settlement cracks. Recommend to repair or fill all cracks as needed by a qualified person. Also suggest to recoat driveway every 4 to 5 years. This would be considered normal maintenance.

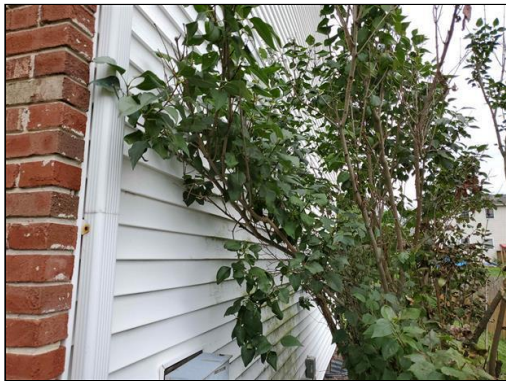
2.3 Item 6(Picture)

(3) Shrubbery is growing too close to the siding for proper ventilation. Recommend to trim shrubbery a minimum of 12 to 16 inches away from the siding to restore proper ventilation. This would be considered normal maintenance.

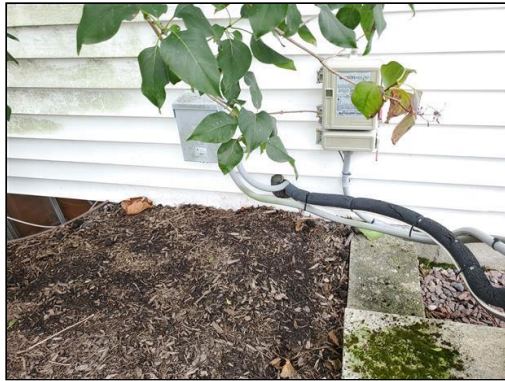
2.3 Item 8(Picture)

(4) Mulch is covering the siding. Recommend to remove mulch as needed to prevent insect penetration.

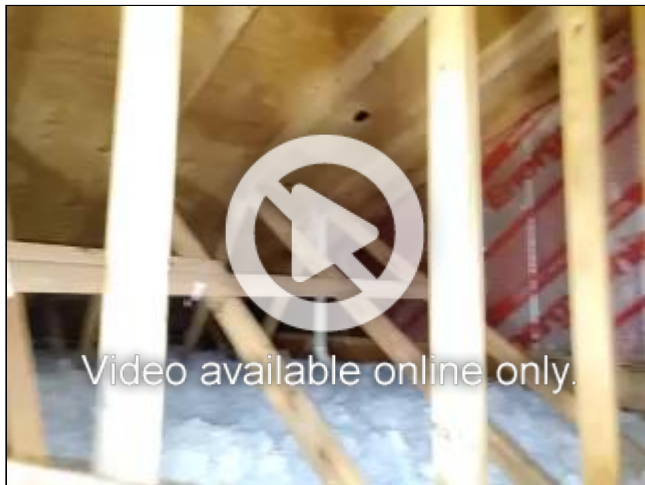
3.0 Item 1(Video) \*\*\* GARAGE ATTIC VIDEO \*\*\*

**GARAGE ATTIC VIDEO**

**Suggest to view garage attic video for more information.**

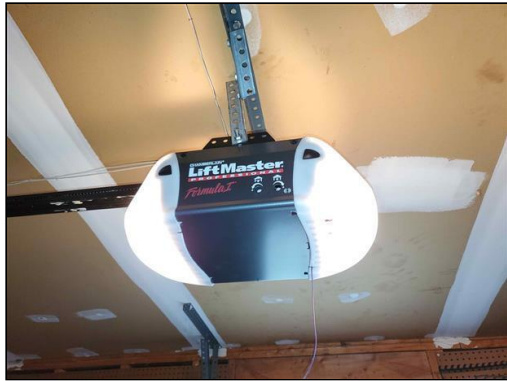
3.5 Item 1(Picture)

Both garage doors needed excessive pressure for the auto reverse function to work properly. Recommend to adjust doors as needed by a qualified person for auto reverse to work correctly. Potential safety hazard exists.

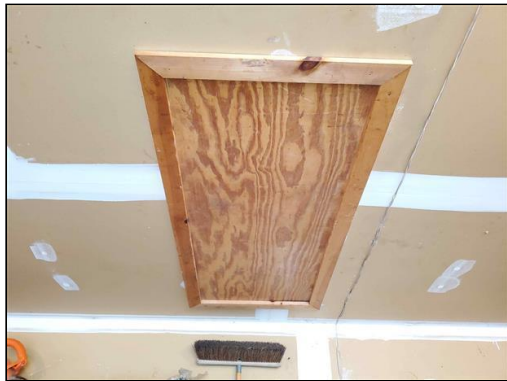
3.9 Item 1(Picture)

**See garage attic video for more information.**

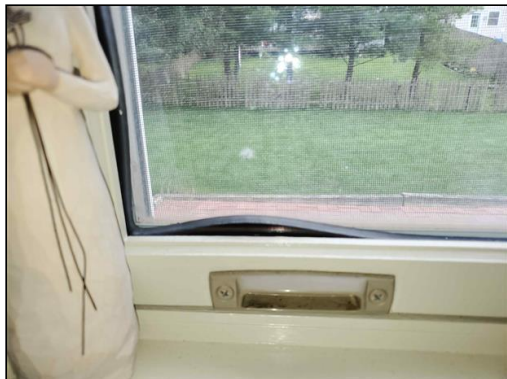
4.5 Item 1(Picture)

(1) Loose rubber seal at thermal insulated window in the kitchen. Recommend to replace as needed by a qualified professional.

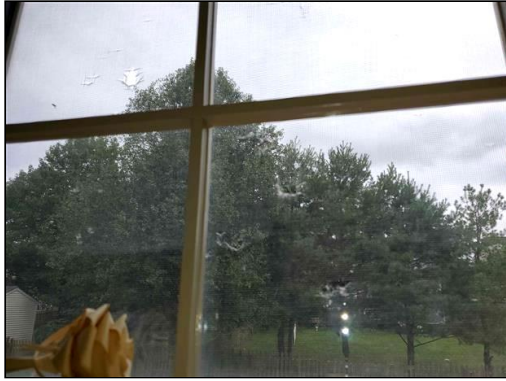
4.5 Item 2(Picture)

(2) Damaged screen in the kitchen window. **FYI**

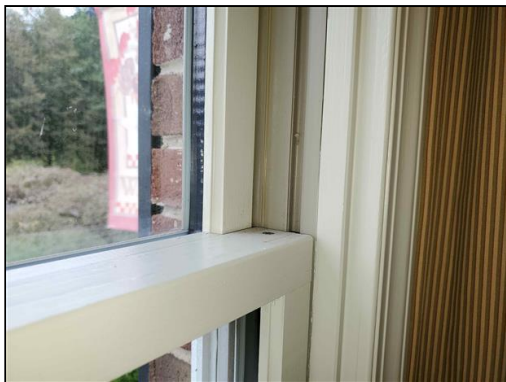
5.0.C Item 1(Picture)

Spring balancers are broken in one window located in the living room. Recommend to replace spring balancers as needed by a qualified window installer.

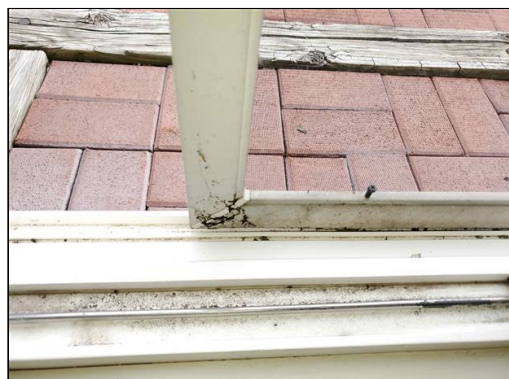
5.2.D Item 1(Picture)

Sliding screen door is not functioning properly. Recommend to lubricate door as needed. **FYI**

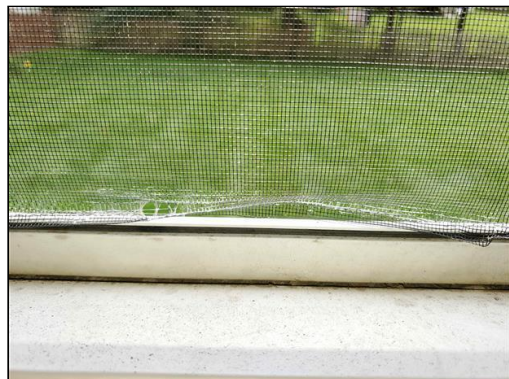
5.0.E Item 1(Picture)

Damaged screen in family room window. Recommend to repair as needed by a qualified person. **FYI**

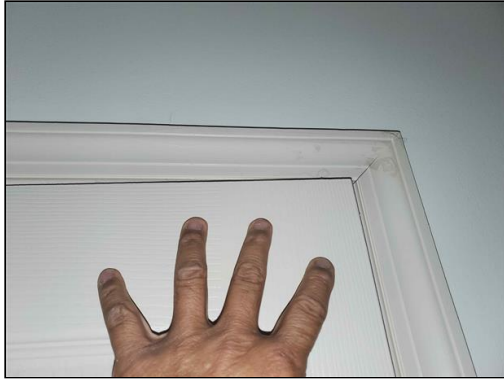
5.2.H Item 1(Picture)

Bedroom #3 entrance door is binding in the door frame. Recommend to adjust door as needed to restore proper door function by a qualified person.

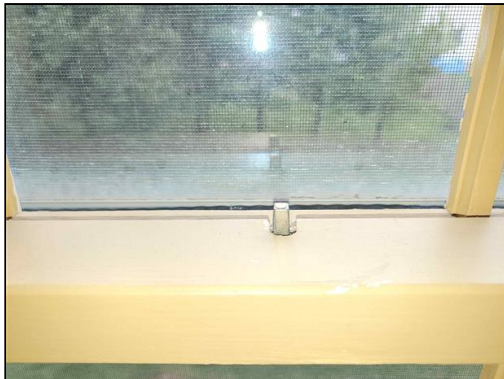
6.0.C Item 1(Picture)

Damaged window hardware in the owners suite bath. Recommend to repair as needed by a qualified person.

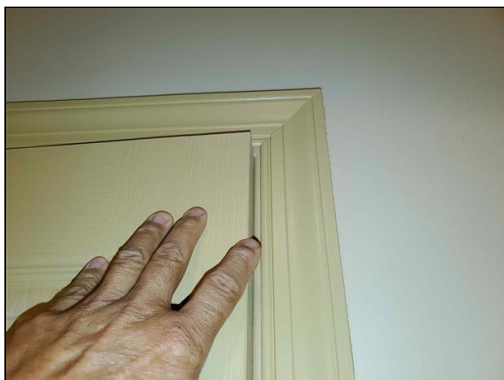
6.1.C Item 1(Picture)

Owners' suite bath door is binding in the door frame. Recommend to adjust door as needed to restore proper door function by a qualified person.

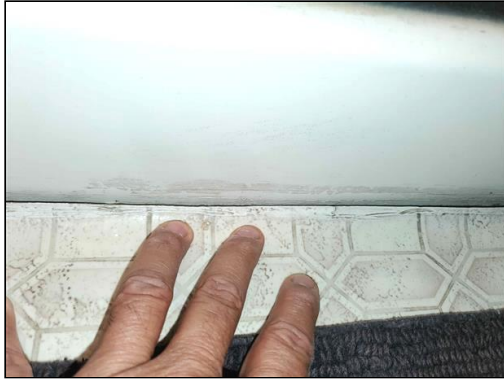
6.3.C Item 1(Picture)

Suggest to silicone between vinyl floor and shower stall. **FYI**

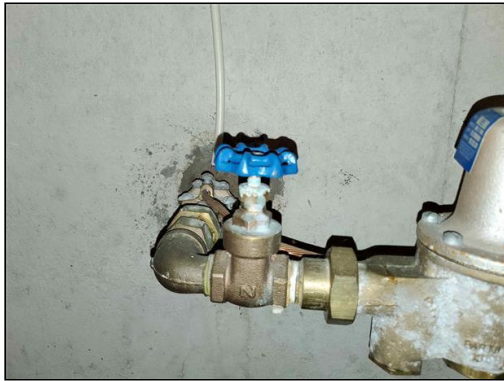
9.3 Item 1(Picture)

The main shut off is the blue knob located in the basement. This is for your information.

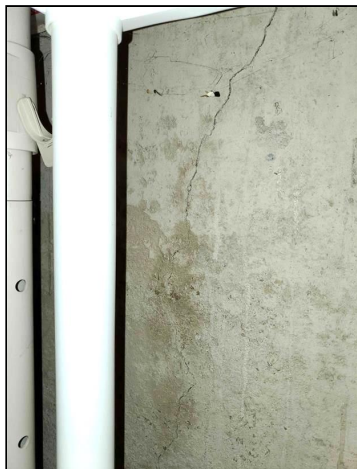
11.3 Item 1(Picture)

Typical settlement crack located in the foundation wall. Recommend to seal crack as discussed using a hydraulic cement. This will enable you to monitor same area for potential further movement.

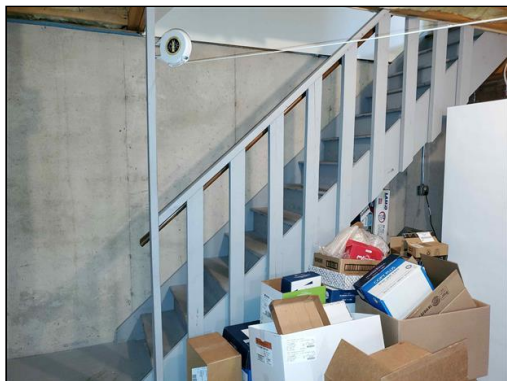
11.6 Item 1(Picture)

Space between guardrailing is greater than 4 inches. Recommend to add additional guardrailing as needed by a qualified person.

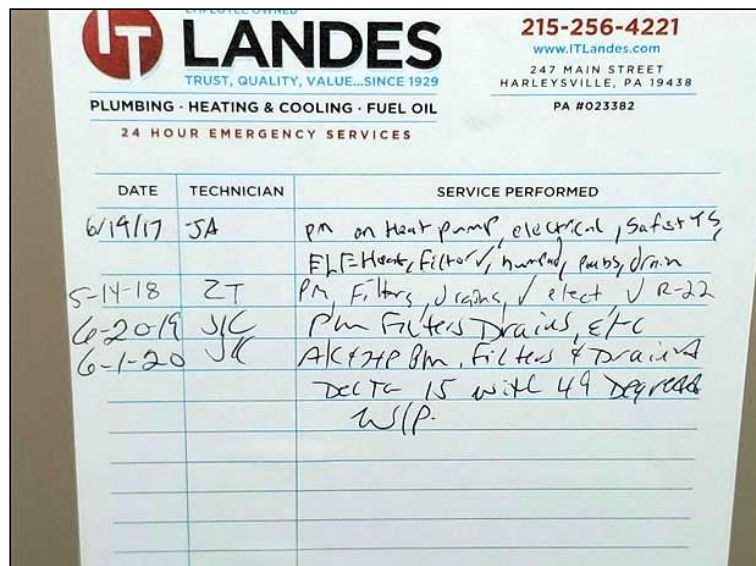
10.0 Item 1(Picture)

**See service sticker.** Recommend to have heat pump serviced on an annual basis.
