Inspection Report

Property Address:
124 Fairway Dr
Harleysville Pa 19438

A1 House Prep LLC and Inspections

Date: 09/29/20	Time: 10:00 AM	Report ID: 6921 Susan Douglas
Property: 124 Fairway Dr Harleysville Pa 19438	Customer: Susan Douglas	Real Estate Professional: Michelle Hunsberger Alderfer Real Estate

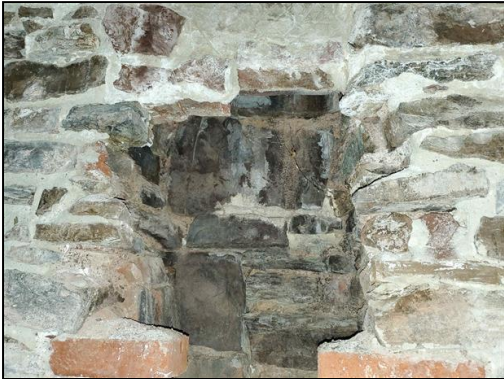
1.2 Item 1(Picture)

1.2 SKYLIGHTS, CHIMNEYS AND ROOF PENETRATIONS

Capped off chimney in attic. **FYI**

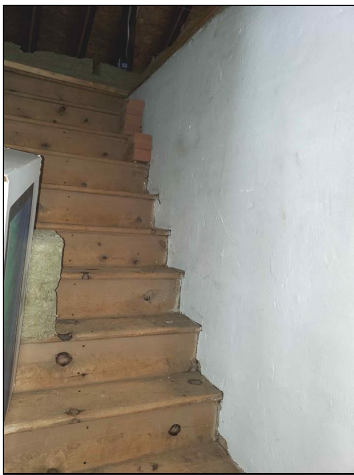
1.10 Item 1(Picture)

1.10 STEPS, STAIRWAYS AND RAILINGS

Suggest to install a handrailing at the attic steps. Potential tripping hazard exists. **FYI**

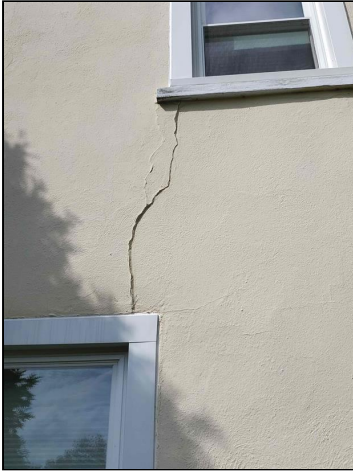
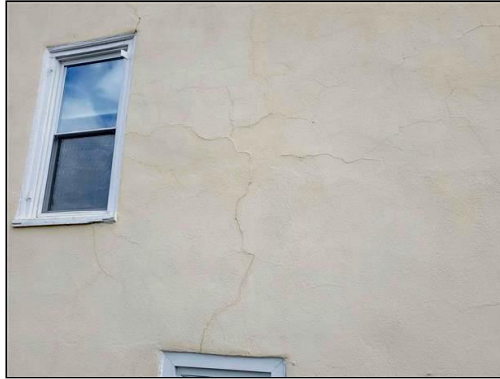
2.0 Item 1(Picture)

2.0 WALL CLADDING FLASHING AND TRIM

Typical fractures and cracks in stucco exterior. Recommend to fill or repair cracks as needed by a qualified professional. This will help prevent further deterioration.

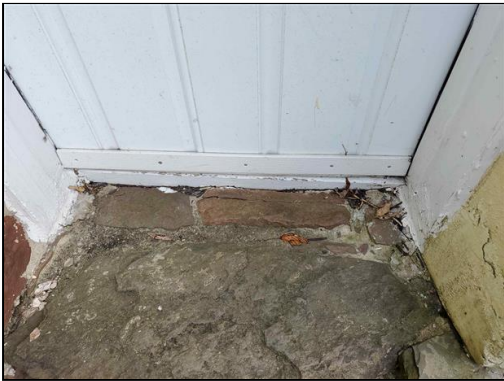
2.2 Item 1(Picture)

2.2 DOORS (Exterior)

Negative grade at the basement entrance door. Recommend to correct as needed to prevent water penetration.

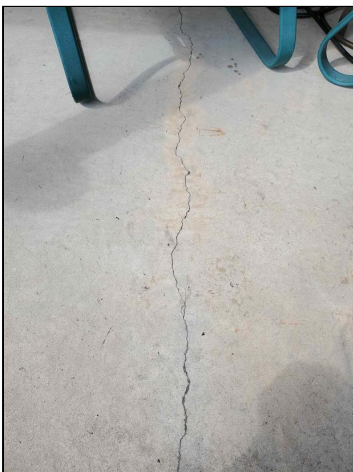
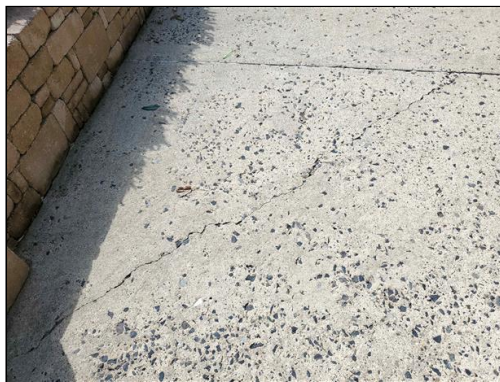
2.3 Item 1(Picture)

(1) Typical settlement cracks in front concrete patio. Recommend to patch or repair cracks as needed by a qualified person or professional. This would be considered normal maintenance.

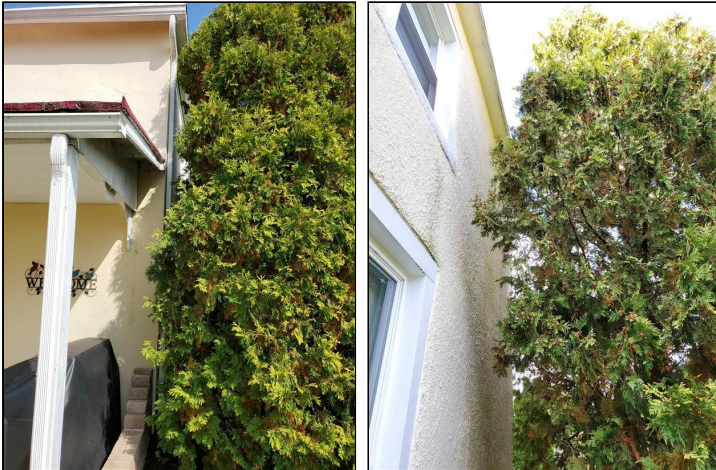
2.3 Item 3(Picture)

(2) Shrubberty and tree are growing too close to the siding for proper ventilation. Recommend to trim shrubberty and tree a minimum of of 12 to 16 inches away from the siding to restore proper ventilation. This would be considered normal maintenance.

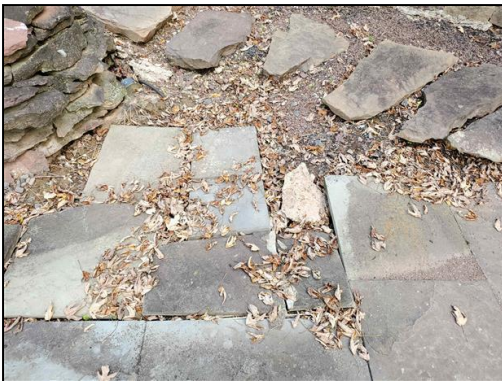
2.3 Item 5(Picture)

(3) Loose and rotated pavers at the rear of the house. Recommend to reset pavers as needed by a qualified person. This is considered normal maintenance.

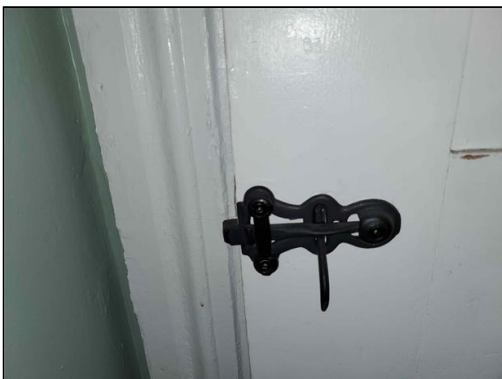
3.3.A Item 1(Picture)

3.3.A DOORS

Missing hardware on one door in the kitchen. Recommend to replace hardware as needed by a qualified person.

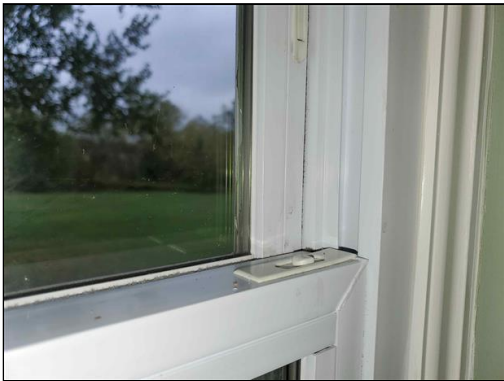
3.5.A Item 1(Picture)

3.5.A WINDOWS (REPRESENTATIVE NUMBER)

Broken spring balancer on one kitchen window. Recommend to repair hardware as needed by a qualified person.

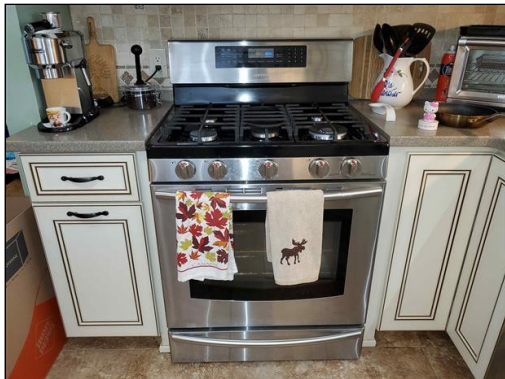
3.13.A Item 1(Picture)

3.13.A RANGES/OVENS/COOKTOPS

Oven was fully functional. Suggest to install an anti tip device. This is considered an added safety precaution against a potential scalding accident to a small child.

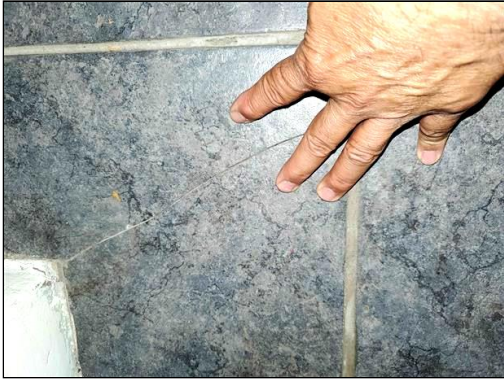
3.0.B Item 1(Picture)

3.0.B FLOORS

One cracked floor tile in the in law suite kitchen. Recommend to replace tile as needed by a qualified person.

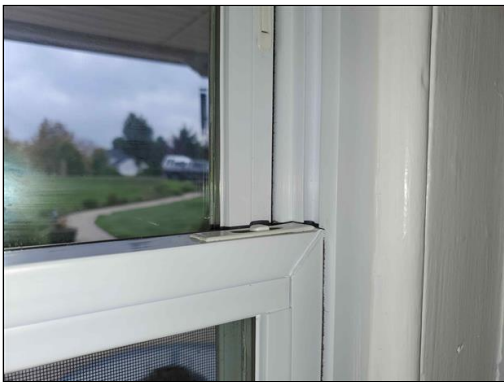
4.0.D Item 1(Picture)

4.0.D WINDOWS (REPRESENTATIVE NUMBER)

One window in the dining room has a broken spring balancer. Recommend to repair spring balancers as needed by a qualified window installer.

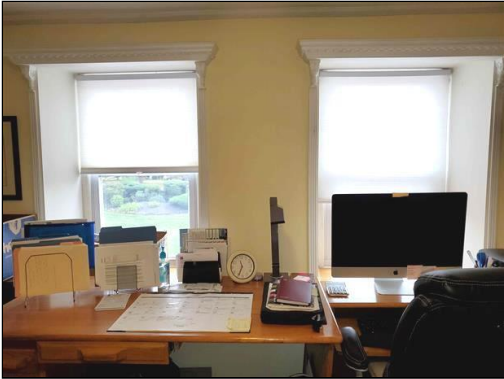
4.0.F Item 1(Picture)

4.0.F WINDOWS (REPRESENTATIVE NUMBER)

Unable to access windows. Recommend to have windows inspected for function.

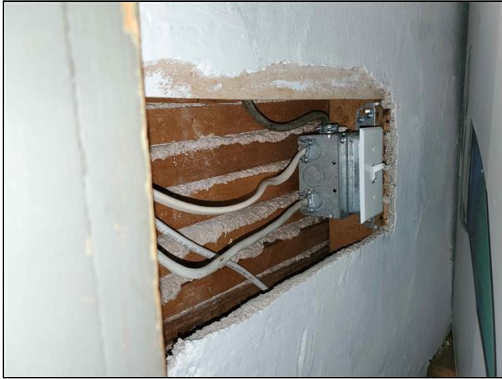
4.1.H Item 1(Picture)

4.1.H WALLS

Recommend to finish drywall in bedroom #2 closet leading to attic.

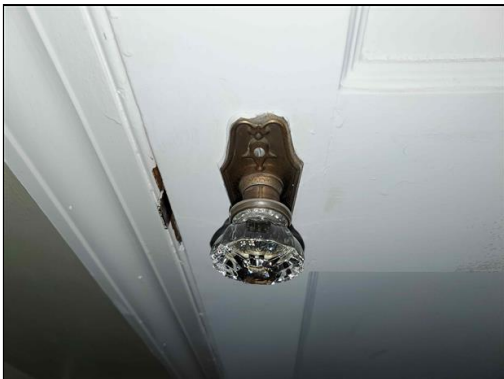
4.2.I Item 1(Picture)

4.2.I DOORS (REPRESENTATIVE NUMBER)

Loose hardware on one door in bedroom #3. Suggest to adjust hardware as needed by a qualified person. **FYI**

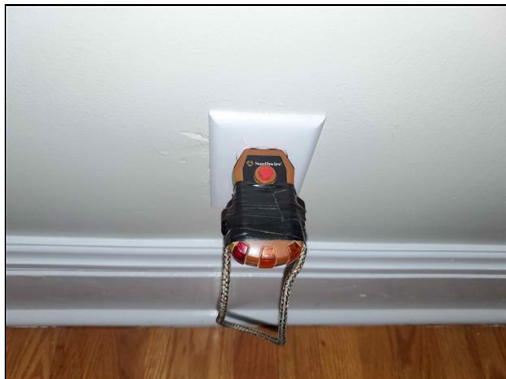
4.7.K Item 1(Picture)

4.7.K OUTLETS SWITCHES AND FIXTURES

1 reverse polarity receptacle located in the inlaw living room. Recommend to repair reverse polarity receptacle as needed by a qualified professional.

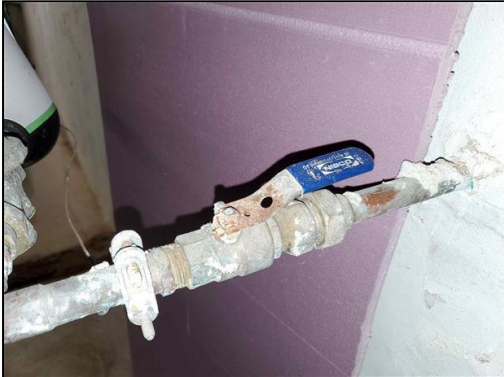
8.3 Item 1(Picture)

8.3 MAIN WATER SHUT-OFF DEVICE (Describe location)

The main shut off is the blue lever located in the basement. This is for your information.

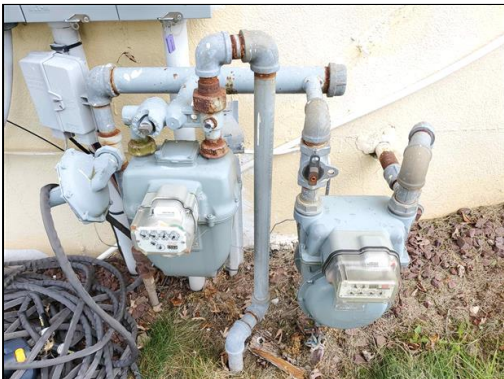
8.5 Item 1(Picture)

8.5 MAIN FUEL SHUT OFF (Describe Location)

The main fuel shut off is at gas meter outside. FYI

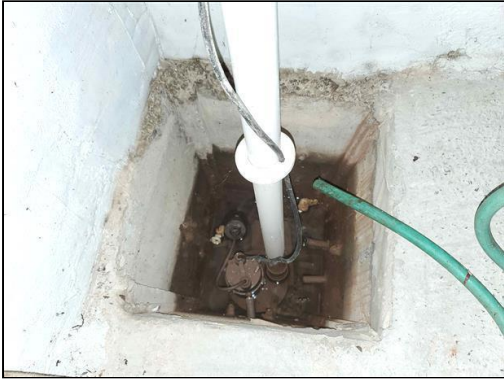
8.7 Item 1(Picture)

8.7 SUMP PUMP

Sump pump is missing a cover plate. Recommend to install a cover plate by a qualified person.
