**REPORT OF PHASE I
ENVIRONMENTAL SITE ASSESSMENT AND MINE DOCUMENT REVIEW**

**Approximately 133 Acre Site
Off Edwards Lake Road and Turncliff Parkway
Birmingham, Jefferson County, Alabama 35235**

**May 2005
QORE Project 11243**

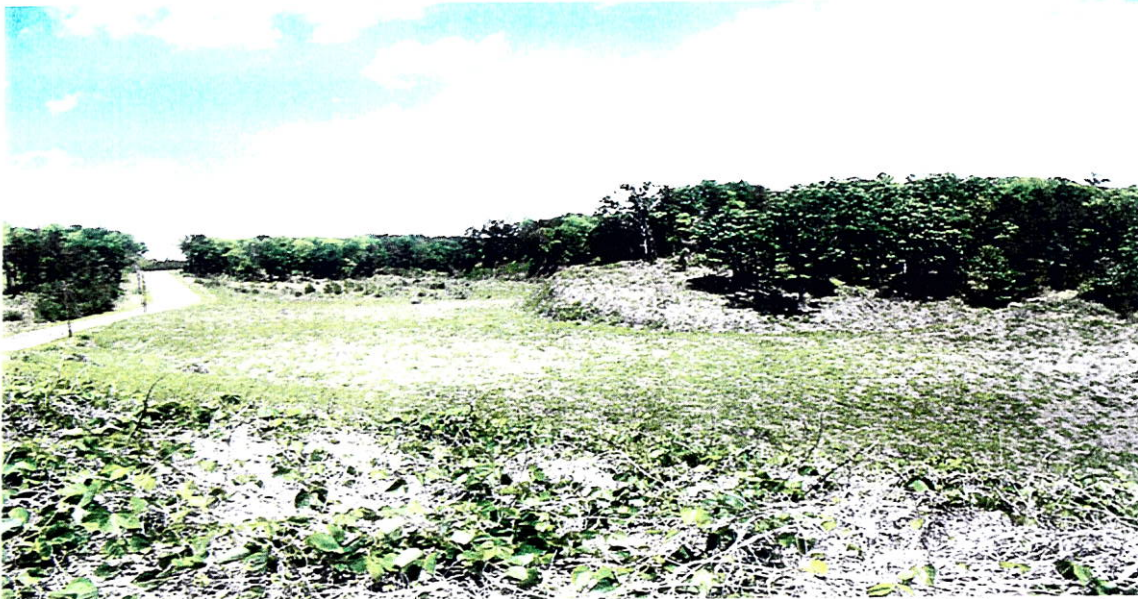
Photograph 1: North view of the subject property – showing the Turncliff Parkway and the kudzu covered strip mine/landfill areas.

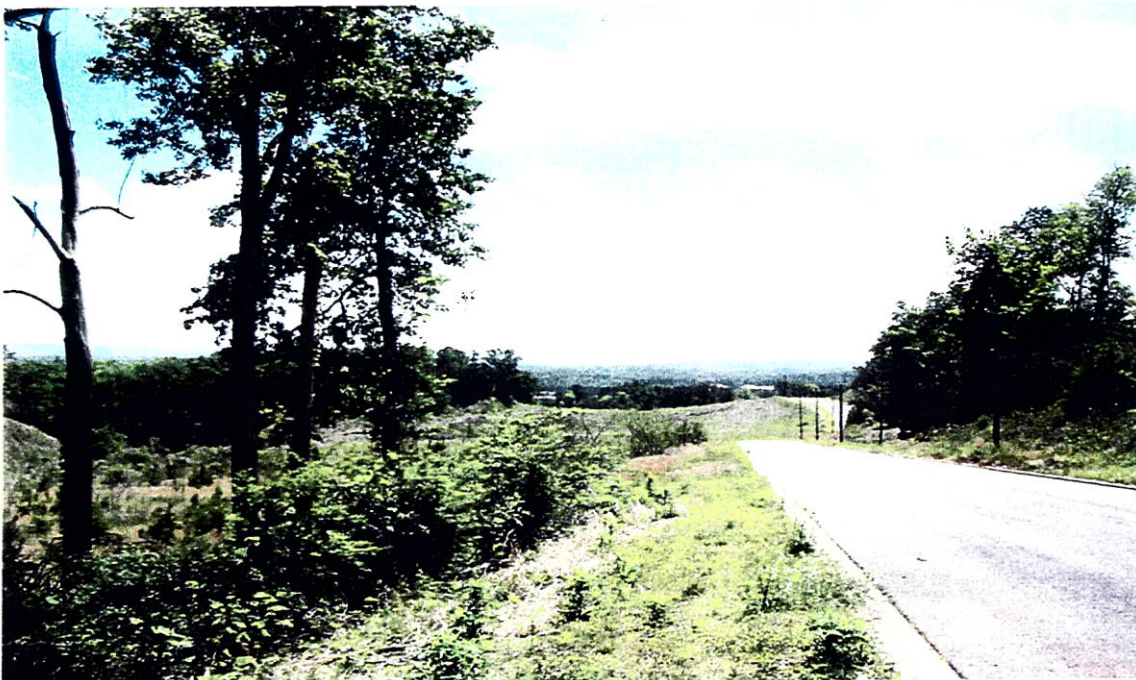
Photograph 2: South view of the subject site – showing the Turncliff Parkway.

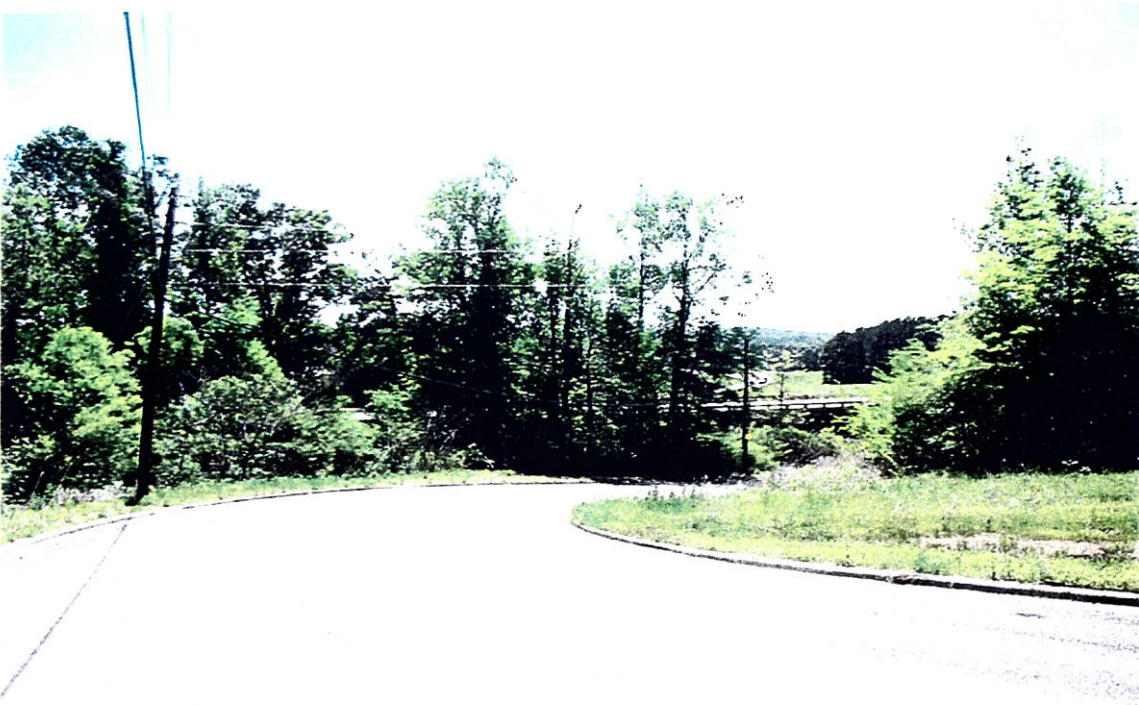
Photograph 4: South view of the southeastern portion of the subject property – showing Turncliff Parkway and Interstate 59 in the distance.

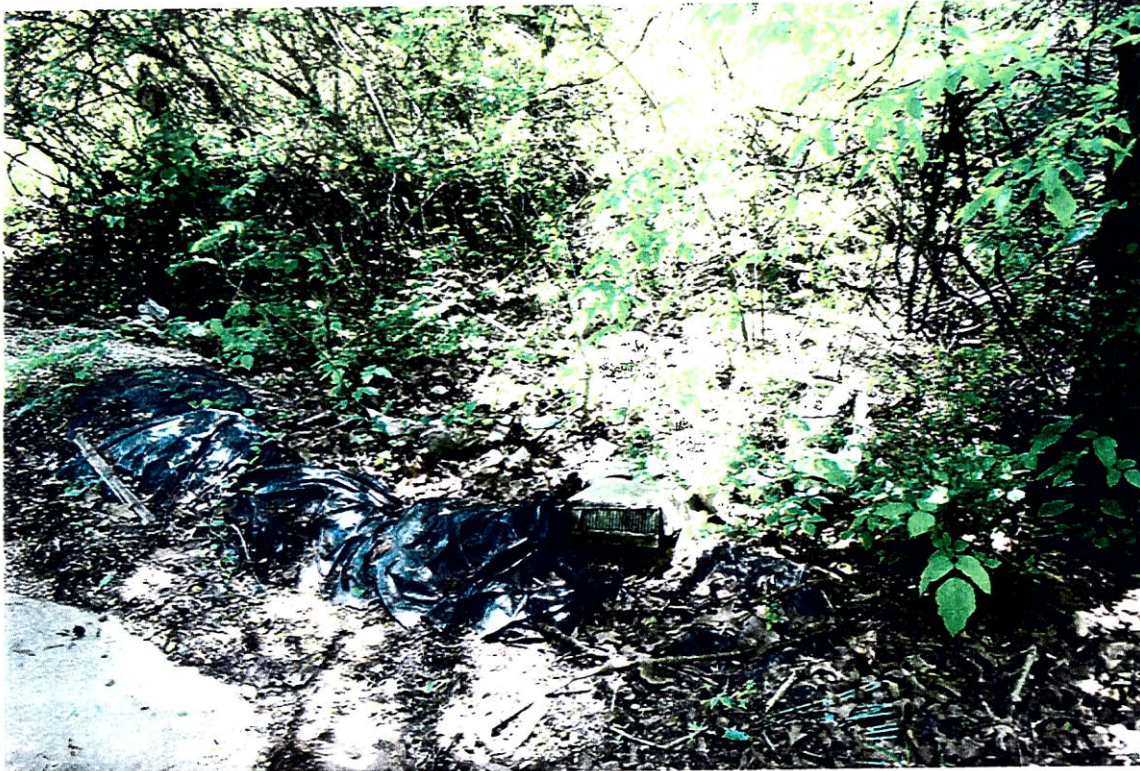
Several small areas of debris such as several tires, furniture, and household waste were observed at this site. None of these items appeared to be hazardous in nature but should be properly disposed.

Photograph 5: View of a small area of household waste dumping located in the southeastern portion of the subject property.

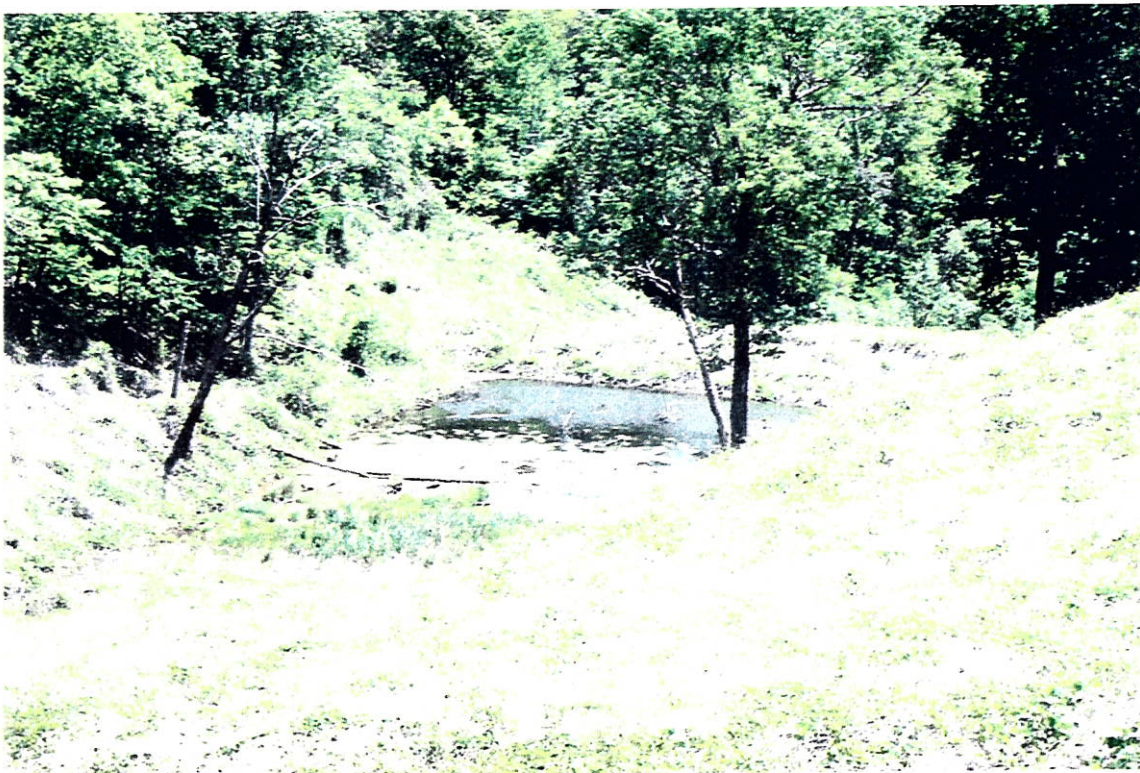
Photograph 6: View of a surface water detention pond located in the central portion of the subject property.
