December 2, 2019

Mold Inspection Report for
TVA Greenway Warehouse
4202 Greenway Drive
Knoxville, TN 37918

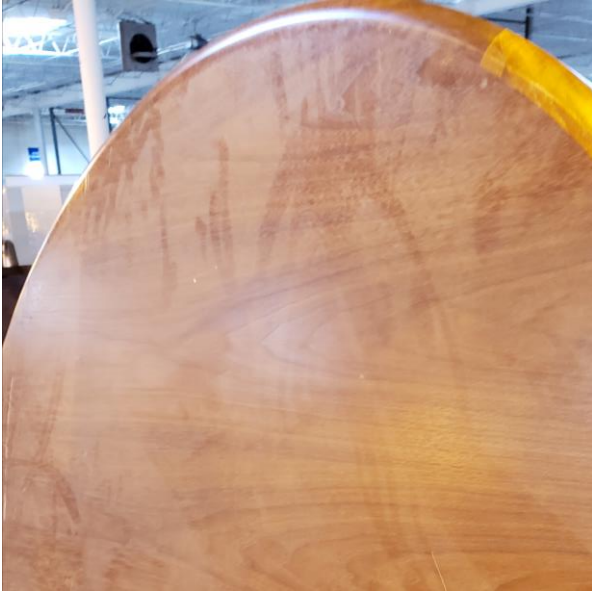
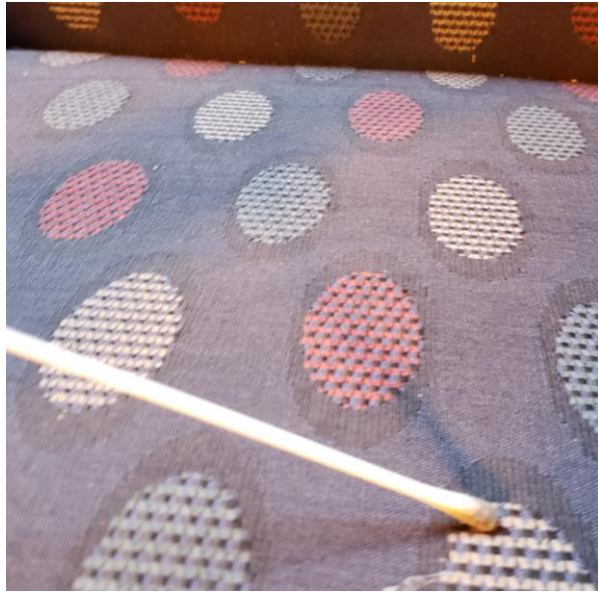
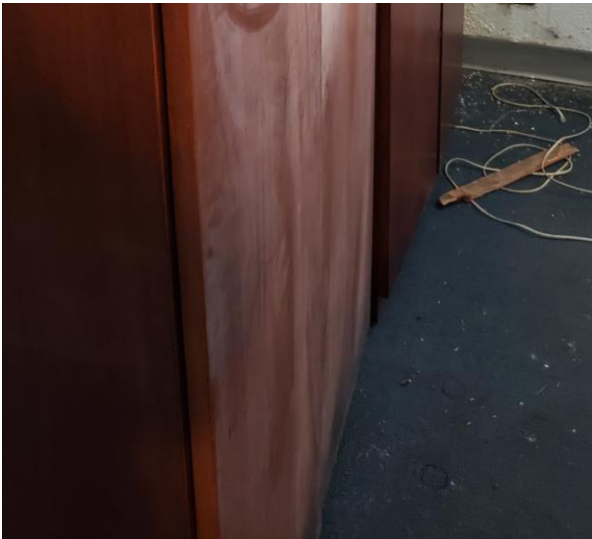
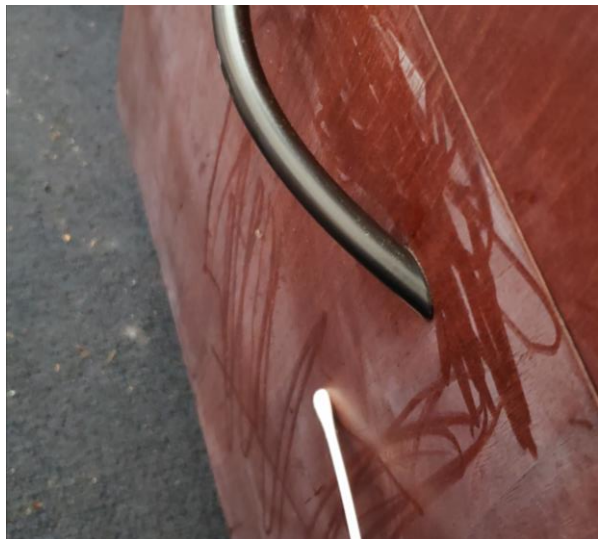
There was what appeared to be a ghosting of light mold on several items in this storage facility, and there was clearly a musty odor present at the time of this inspection. Although it was a clear dry day with low ambient humidity outside, at 40% rh, inside levels were on average between 57% to 61% rh. So, on a humid day outside, these numbers would be easily over 60% rh.

Pictures of the affected furniture from inside the warehouse storage areas.

In the ambient dust collected on the furniture there were also mold spores found to be present.

****While the numbers were generally not remarkable, it is highly recommended that these items be HEPA vacuumed and wiped down with a biocide/disinfectant before being moved into a clean space. If they are to remain at this location after cleaning, it is highly recommended that the space be properly conditioned to prevent future microbial growth.***

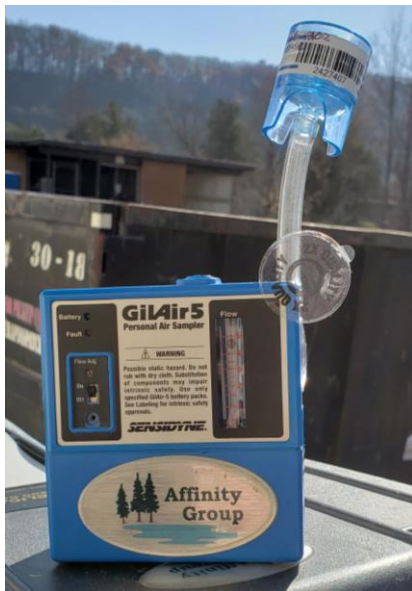
TVA-01 Sampling Site

TVA-01 Outside Air Sample – The total spore count here was 5160 spores. The spores present here in descending order were: 3360 basidiospores; 1280 cladosporium; 280 penicillium/aspergillus; 120 ascospores; 80 hyphal elements; and 40 nigrospora.

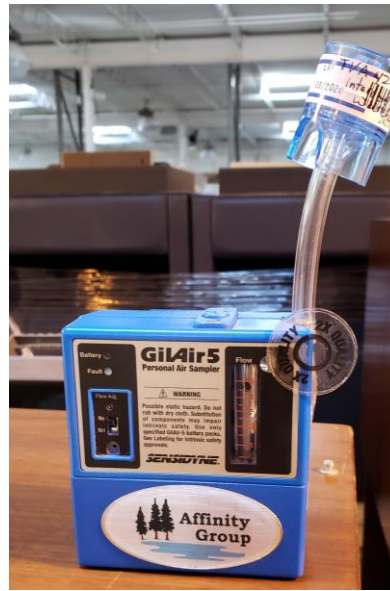
TVA-02 Sampling Site

TVA-02 Warehouse Left Front Air Sample – The total spore count here was 520 spores. The spores present here in descending order were: 360 basidiospores; 80 ascospores; 40 pithomyces; and 40 smuts, periconia, myxomycetes. Minus the outside influence of the 360 basidiospores and the 80 ascospores, the adjusted total spore count here was 80 spores.

This is well below the 2000 total spore count we look for inside with no spores of concern over a 500 total spore count. This would be considered a ***Condition 1 Area*** – having a normal fungal ecology and represents excellent indoor air quality as it related to indoor mold spore counts.

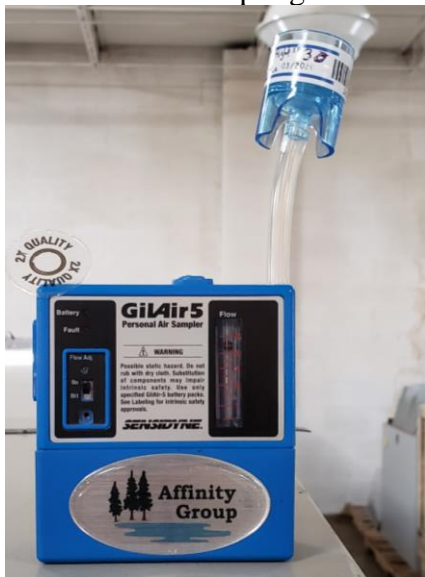
TVA-03 Sampling Site

TVA-03 Warehouse Back Right Air Sample – The total spore count here was 400 spores. The spores present here in descending order were: 200 basidiospores; 120 penicillium/aspergillus; 40 ascospores; and 40 cladosporium. Minus the outside influence of the 200 basidiospores and the 40 ascospores, the adjusted total spore count here was 160 spores.

This is well below the 2000 total spore count we look for inside with no spores of concern over a 500 total spore count. This would be considered a ***Condition 1 Area*** – having a normal fungal ecology and represents excellent indoor air quality as it related to indoor mold spore counts.

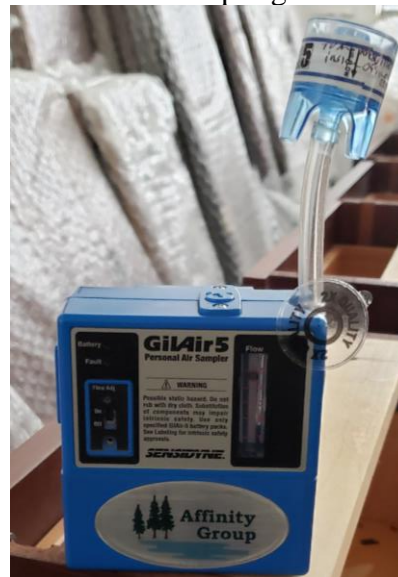
TVA-04 Sampling Site

TVA-04 Warehouse Office Air Sample – The total spore count here was 2360 spores. The spores present here in descending order were: 1080 penicillium/aspergillus; 720 cladosporium; 360 basidiospores; 80 ascospores; 80 smuts, periconia, myxomycetes; and 40 pithomyces.

Minus the outside influence of the 360 basidiospores and the 80 ascospores, the adjusted total spore count here was 1920 spores.

While this is below the 2000 total spore count we look for indoors, there were two spores of concern, the 1080 penicillium/aspergillus, which was 3.86 times higher than our outside count of 280 spores; and the 720 cladosporium spores, while lower than the outside count of 1280 spores, was still over the 500 total we look for indoors.

This would be considered a **Condition 3 Area** – (actual growth): an indoor environment contaminated with a slightly higher presence of actual mold growth and associated spores than those which were outside.

****These spore counts do not represent a serious problem, however, if the contents present here are to be moved to another location, it is highly recommended that they be HEPA vacuumed and then wiped down with a biocide/disinfectant to prevent any possibility of cross contamination in the area into which they are moved.***

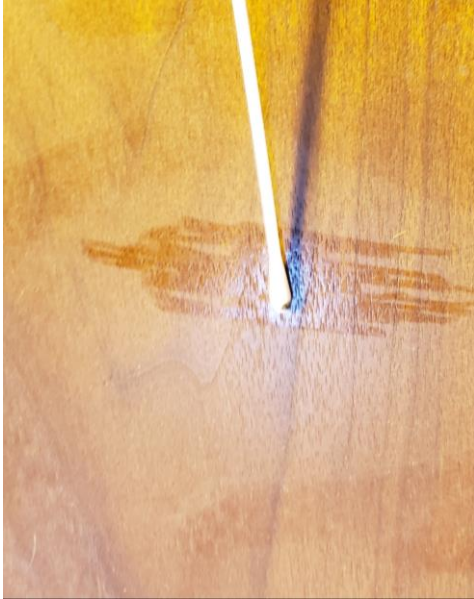
TVA-S1 Sampling Site

TVA-S1 Swab Sample – There were two mold spores identified on this swab sample: occasional ascospores and basidiospores.

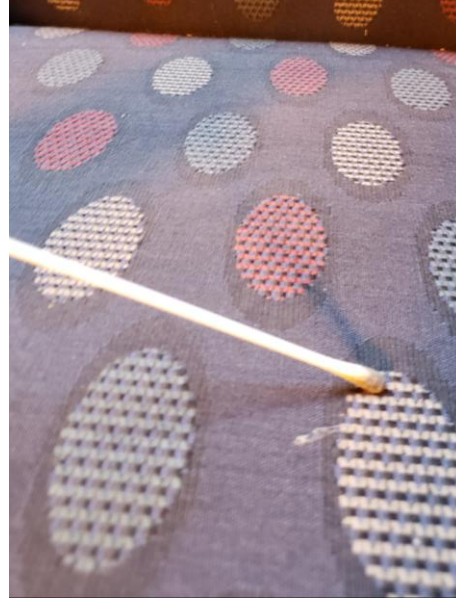
TVA-S2 Sampling Site

TVA-S2 Swab Sample – There were two mold spores identified on this swab sample: occasional ascospores and exosporium-like spores; along with occasional hyphal elements.

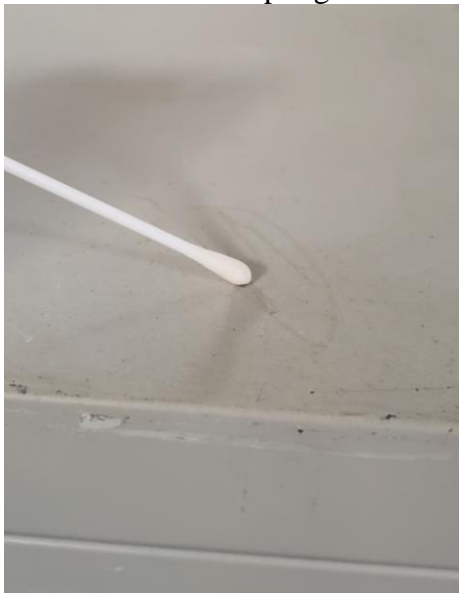
TVA-S3 Sampling Site

TVA-S3 Swab Sample – There were two mold spores identified on this swab sample: occasional basidiospores, cladosporium spores, penicillium/aspergillus spores, and pithomyces spores.

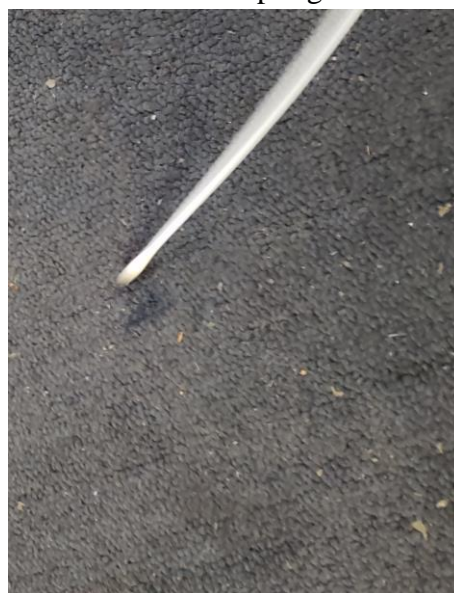
TVA-S4 Sampling Site

TVA-S4 Swab Sample – There were two mold spores identified on this swab sample: occasional ascospores and basidiospores.

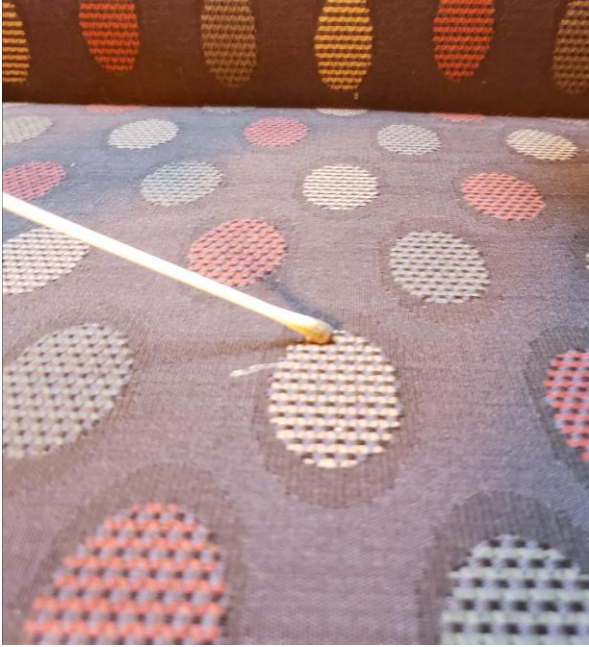
TVA-S5 Sampling Site

TVA-S5 Swab Sample – There were two mold spores identified on this swab sample: occasional basidiospores and pithomyces spores.

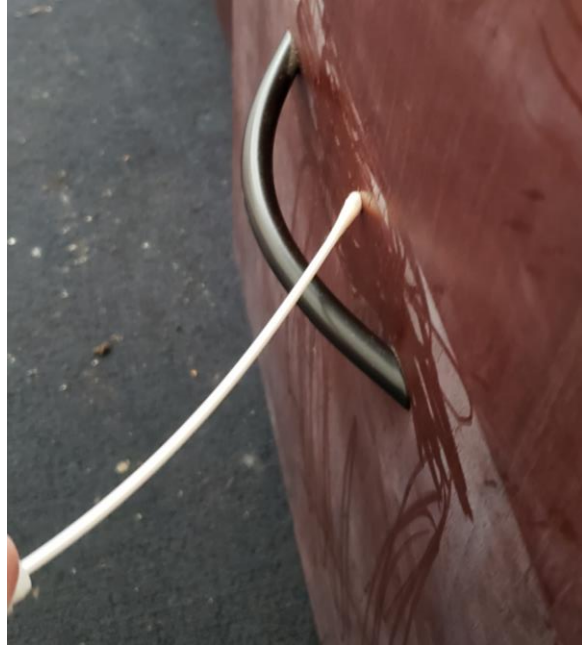
TVA-S6 Sampling Site

TVA-S6 Swab Sample – There were no fungal spores identified on this swab sample.

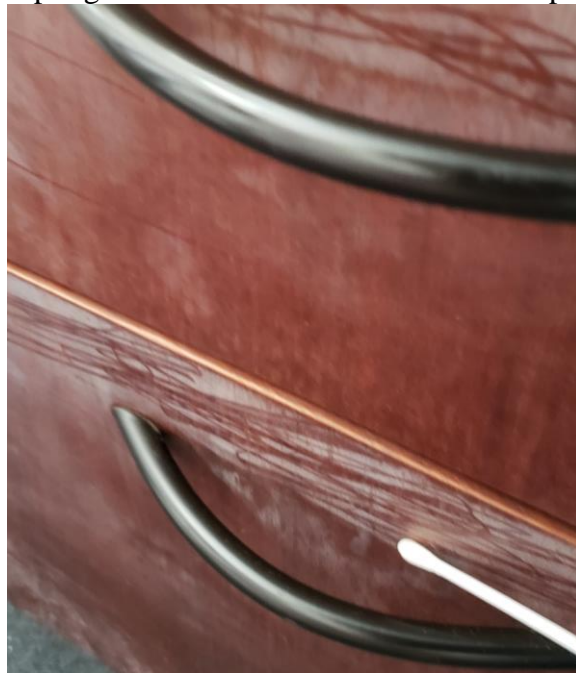
TVA-S7 Sampling Site

TVA-S7 Swab Sample – There were no fungal spores identified on this swab sample.
