Sam Agnew Home Inspections

Property Inspection Report

Client(s): **Ashton Burton (authorized agent)**
Property address: **115 Louden Dr.
 Mooresville, NC 28115**
Inspection date: **Wednesday, June 5, 2019**

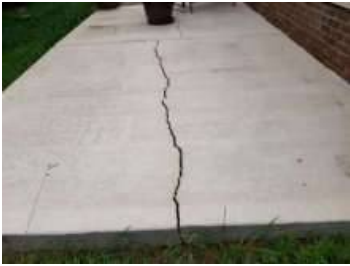
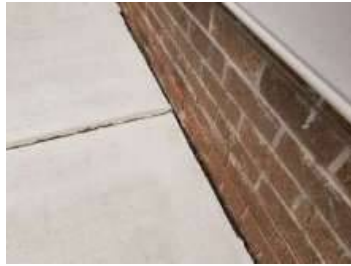
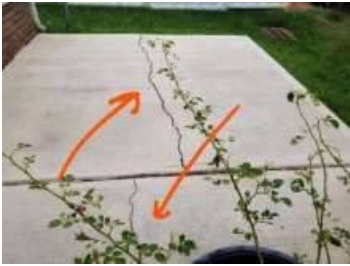
Cracks, holes, settlement, heaving and/or deterioration were found in sidewalks and/or patios. Recommend that qualified contractor repair as necessary.

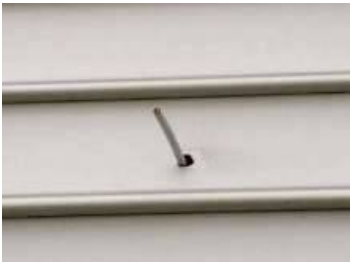
Photo 4-1

One or more holes or gaps were found in siding or trim. Vermin, insects or water may enter the structure. Recommend that a qualified person repair as necessary.

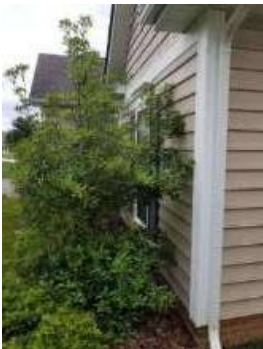
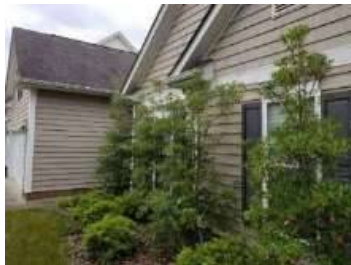
Vegetation such as trees, shrubs and/or vines was in contact with or close to the building exterior. Vegetation can serve as a pathway for wood-destroying insects and can retain moisture against the exterior after it rains. This is a conducive condition for wood-destroying organisms. Recommend pruning, moving or removing vegetation as necessary to maintain at least 6 inches of space between it and the building exterior. A 1-foot clearance is better.

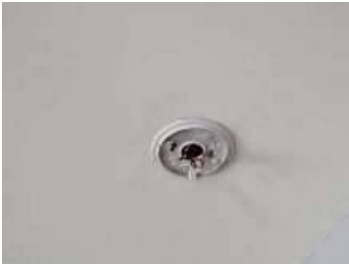
Photo 6-1

One or more smoke alarms were missing, damaged, or missing components. Smoke alarms should be replaced as necessary. For more information, visit:

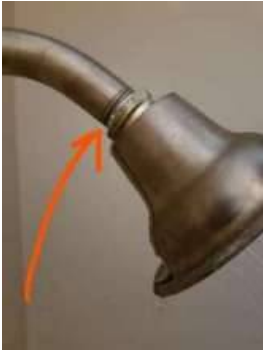
Photo 8-1

The master bathroom shower head drips when the water is on. A minor adjustment or tightening may be required.

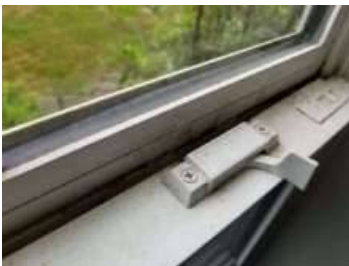
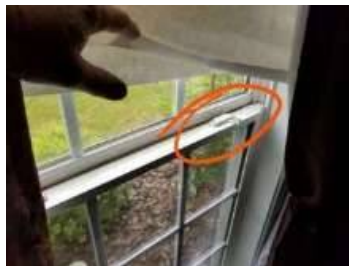
Lock mechanisms on one or more windows were inoperable. This can pose a security risk. Recommend that a qualified person repair as necessary.

Front right bedroom window.

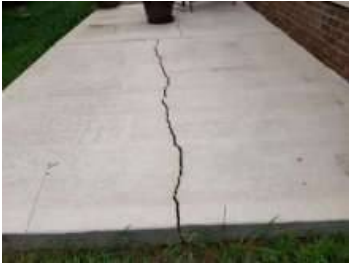
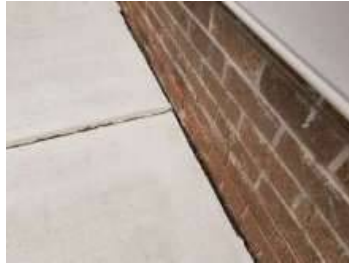
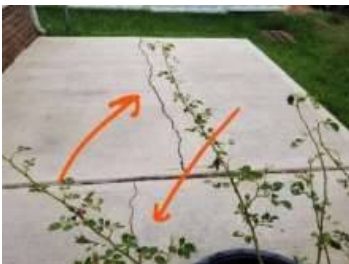
2) **w** Cracks, holes, settlement, heaving and/or deterioration were found in sidewalks and/or patios. Recommend that qualified contractor repair as necessary.

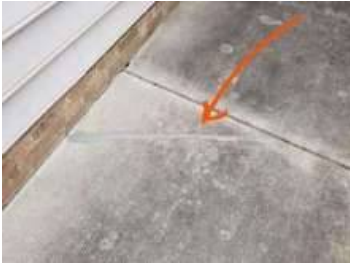
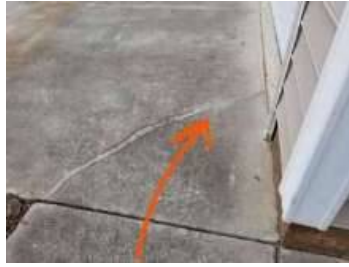
3) **i** Minor deterioration (e.g. cracks, holes, settlement, heaving) was found in the driveway, but no trip hazards were found. The client may wish to have repairs made for cosmetic reasons.

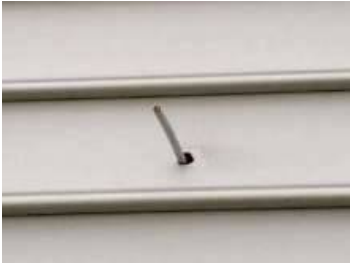
Photo 4-1

One or more holes or gaps were found in siding or trim. Vermin, insects or water may enter the structure. Recommend that a qualified person repair as necessary.

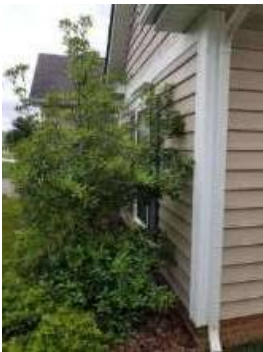
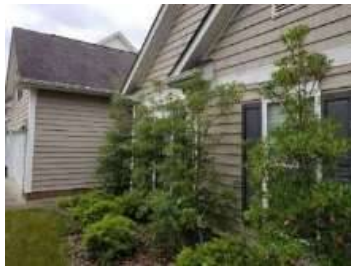
Vegetation such as trees, shrubs and/or vines was in contact with or close to the building exterior. Vegetation can serve as a pathway for wood-destroying insects and can retain moisture against the exterior after it rains. This is a conducive condition for wood-destroying organisms. Recommend pruning, moving or removing vegetation as necessary to maintain at least 6 inches of space between it and the building exterior. A 1-foot clearance is better.

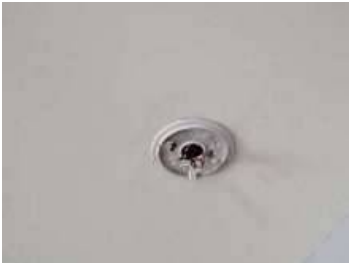
Photo 6-1

One or more smoke alarms were missing, damaged, or missing components. Smoke alarms should be replaced as necessary. For more information, visit:

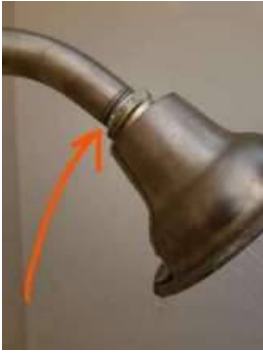
Photo 8-1

The master bathroom shower head drips when the water is on. A minor adjustment or tightening may be required.

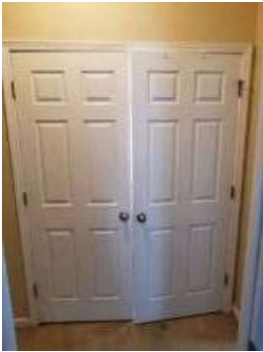
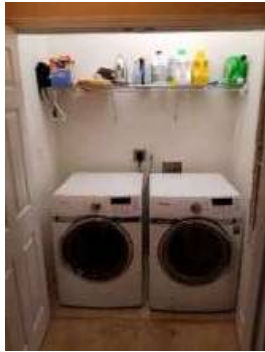
9) There is no ventilation in the laundry room. A passive vent between the laundry room and hall walls should be considered.

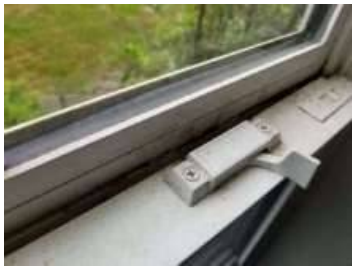
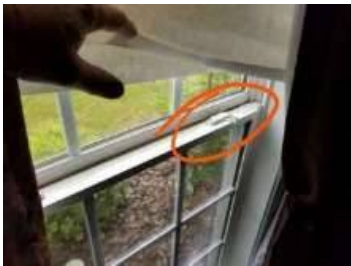
10) Lock mechanisms on one or more windows were inoperable. This can pose a security risk. Recommend that a qualified person repair as necessary.

Front right bedroom window.
