Inspection Report

Property Address:
552 Colonial Ave
Souderton Pa 18964

A1 House Prep LLC and Inspections

Date: 04/14/20	Time: 11:00 AM	Report ID: 6824 Matthew Missimer
Property: 552 Colonial Ave Souderton Pa 18964	Customer: Matthew Missimer	Real Estate Professional: Lon Clemmer Sanford Alderfer Real Estate

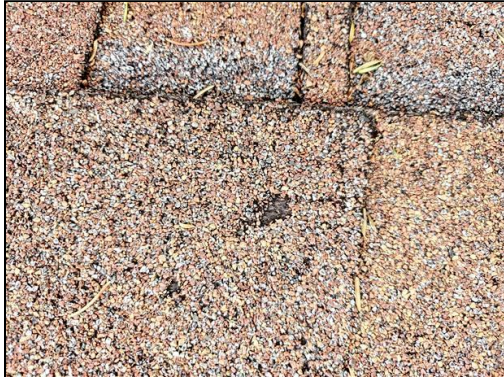
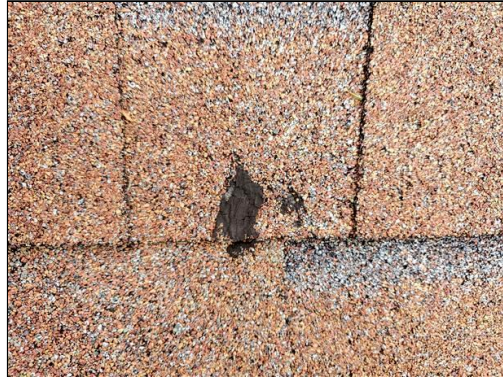
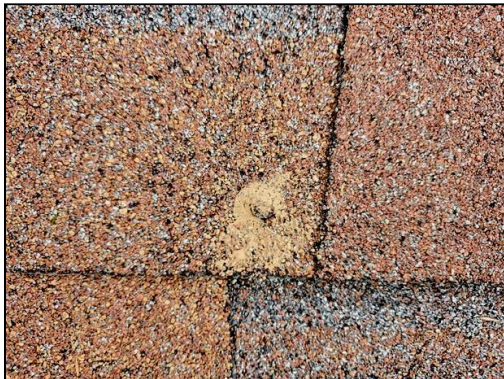
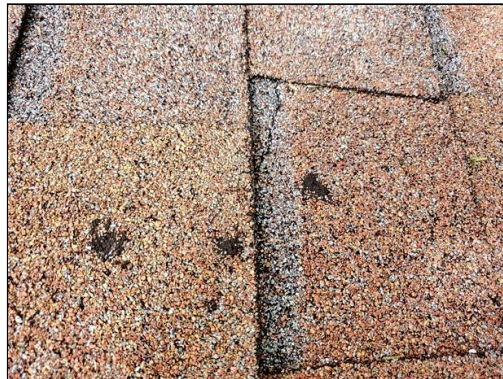
- Lower roof has signs of wear and tear and patched nail holes. Projected life span on lower roof; 5-7 years remaining with proper maintenance.
- Upper back roof appears newer and is in very good condition.

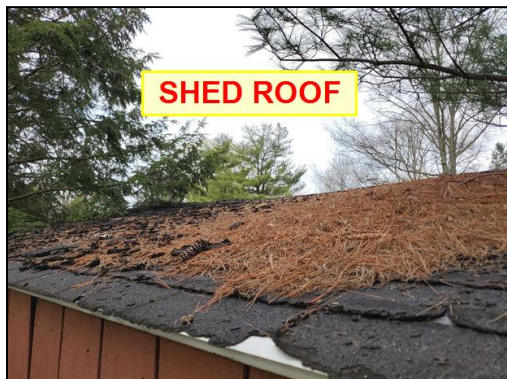
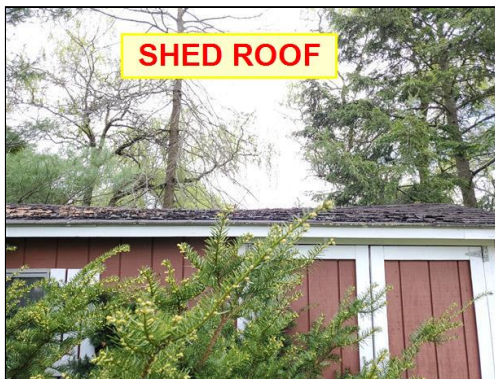
📍 (3) Shed roof is at the end of its' projected lifespan. Recommend to replace shed roof as needed by a qualified professional.

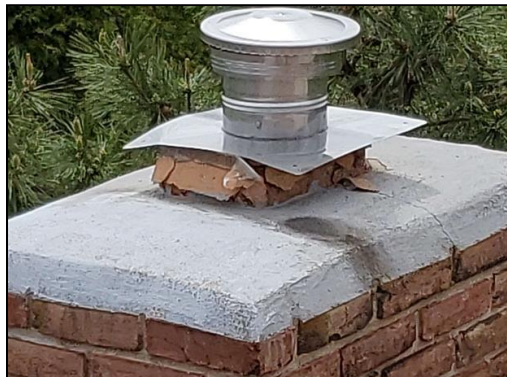
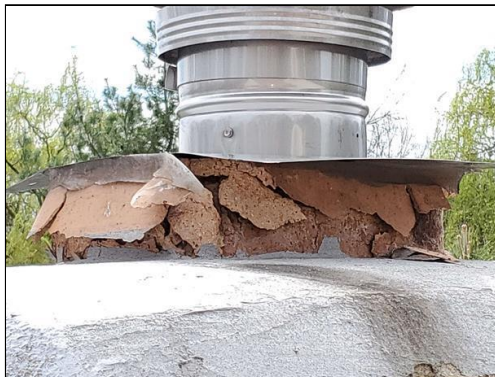
📍 Cracked flue pipe. Recommend to repair or replace as needed by a qualified professional.

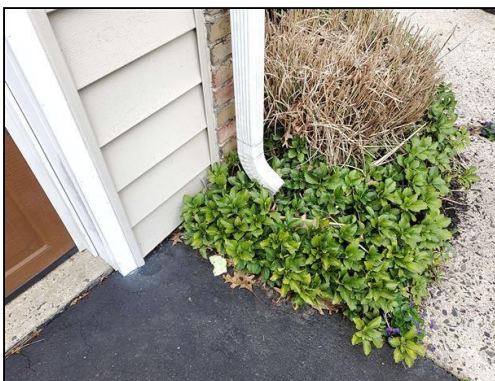
1.4 Item 1(Picture)

📍 (1) Downspouts are not moving water effectively away from the foundation. Suggest to extend downspouts as discussed for better drainage away from the foundation. Saturating foundation walls for extended periods of time can cause potential unseen structural damage from water and insects. Could not determine how long water was flowing towards the foundation.

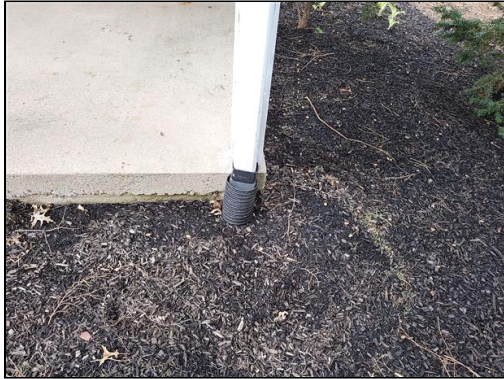
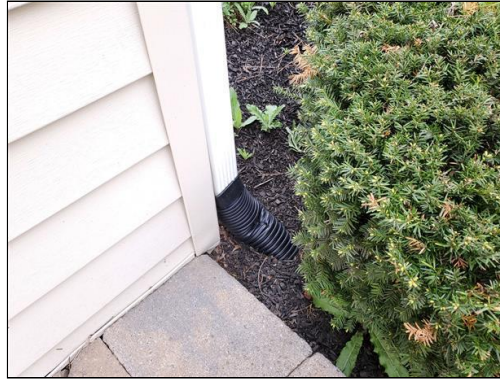
(2) Gutters appear to be working properly. Could not verify condition of the downspouts and drains. Suggest to verify condition of all downspout drains as needed. Many basement leaks occur from clogged downspout drains.

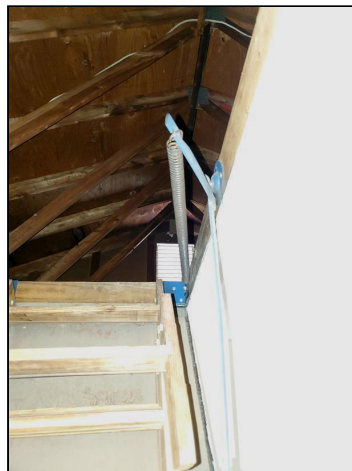
1.11 Item 1(Picture)

Bent bracket at the pull down stairs. Recommend to repair as needed by a qualified person.

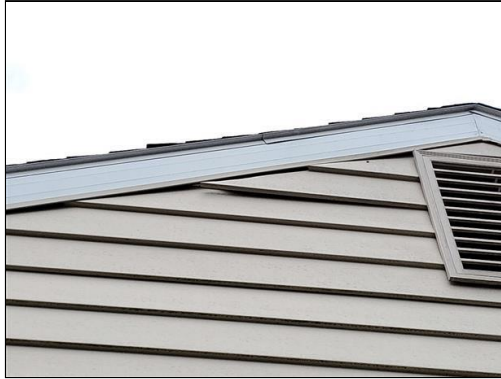
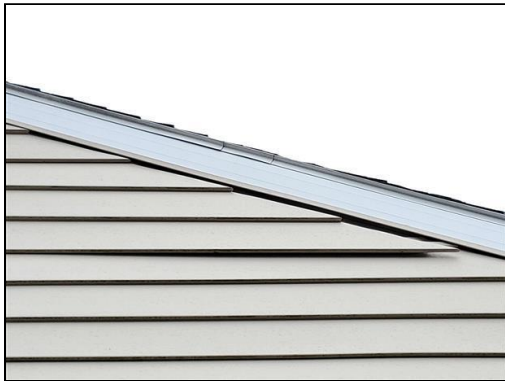
🏠 (1) Loose siding at the right and left side of the house. Recommend to secure siding as needed by a qualified professional.

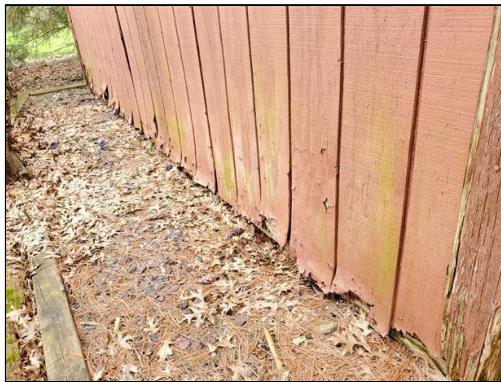
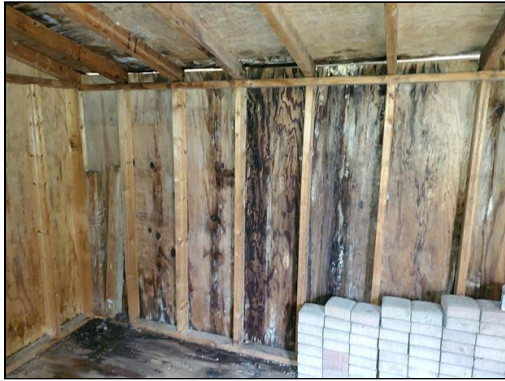
🏠 (2) Deteriorated wood siding at the bottom of shed and interior walls. Recommend to repair or replace deteriorated wood as needed by a qualified person or professional.

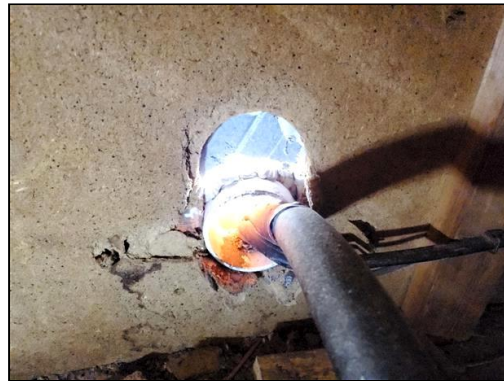
2.0 Item 7(Picture)

📌 (3) The hole in siding needs closing off with sealant or liquid foam at the exterior where compressor lines enter the home in the attic. Potential for insect penetration.

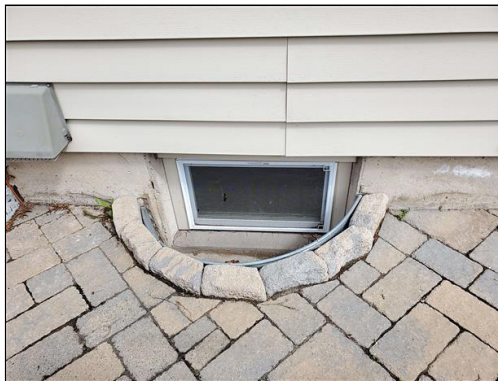
2.1 Item 2(Picture)

📌 Missing a window well covers. Suggest to install clear plastic well covers over window wells to prevent potential well saturation which could overflow window sill and spill into the basement. **This is considered optional.**

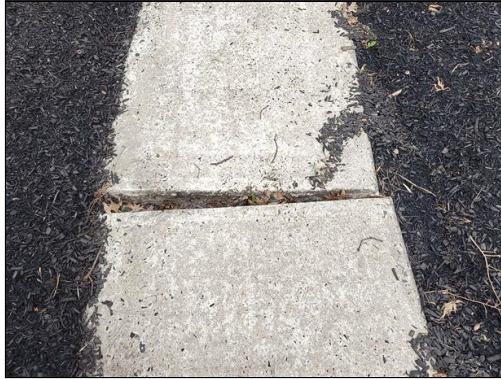
2.3 Item 2(Picture)

📍 (1) Rotated and uneven concrete walkway. Recommend to repair as needed by a qualified person or professional. Potential tripping hazard exists.

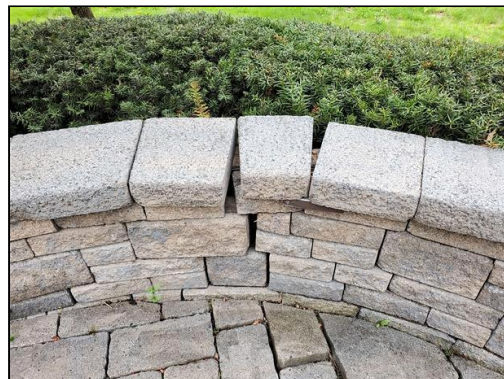
2.3 Item 6(Picture)

📍 (2) Settled and separated patio wall at the rear of the house. Recommend to reset settled block as needed by a qualified person or professional.

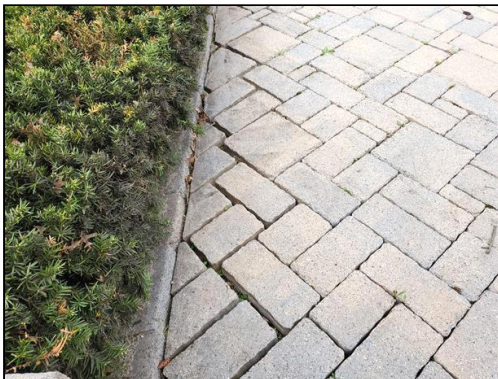
2.3 Item 7(Picture)

📍 (3) Separated and rotated pavers at the rear of the house. Recommend to reset pavers as needed by a qualified person or professional.

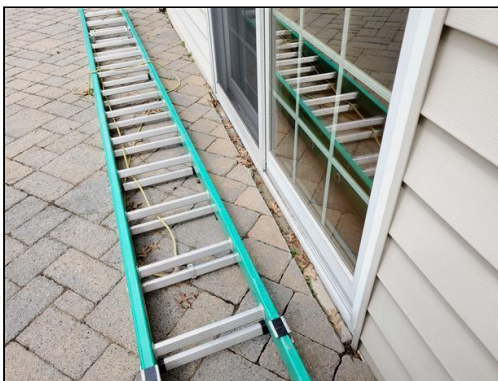
2.3 Item 8(Picture)

📍 (4) Gap between pavers and foundation at the rear of the house. Recommend to fill gap as needed to prevent potential water penetration.

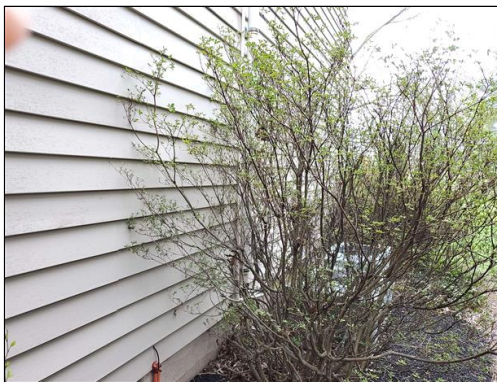
2.3 Item 10(Picture)

📍 (5) Shrubbbery and vegetation is growing too close to the siding for proper ventilation. Recommend to trim shrubbbery a minimum of of 12 to 16 inches away from the siding to restore proper ventilation. This would be considered normal maintenance.

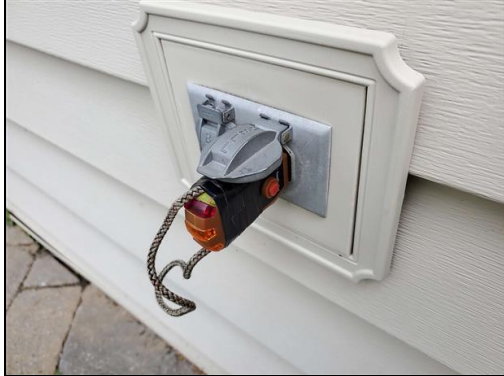
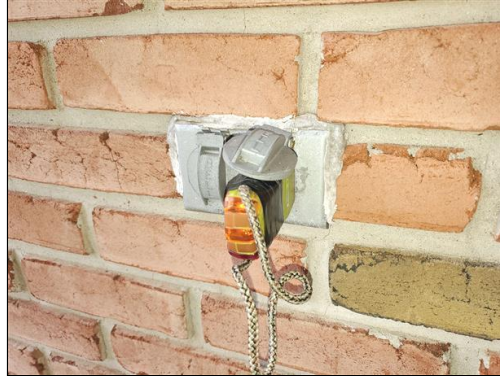
2 outside receptacles are non GFI receptacles. Suggest to convert to GFIs for added protection against a potentially lethal electrical shock. Replace as needed by a qualified person or electrician.

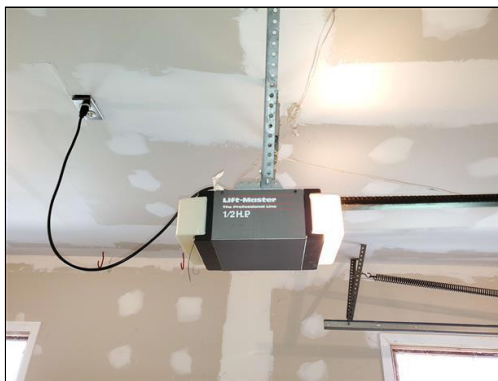
3.4 Item 2(Picture)

🏠 Both garage doors needed excessive pressure for the auto reverse function to work properly. Recommend to adjust doors as needed by a qualified person for auto reverse to work correctly. Potential safety hazard exists.

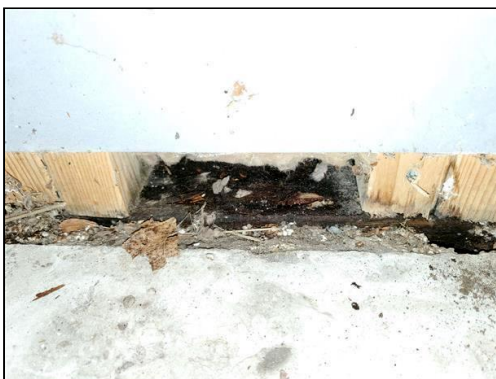
3.5 Item 1(Picture)

🏠 Rotted and deteriorated sill plate from excessive water penetration on the exterior. Recommend to properly grade the exterior and repair as needed to prevent water and insect damage.

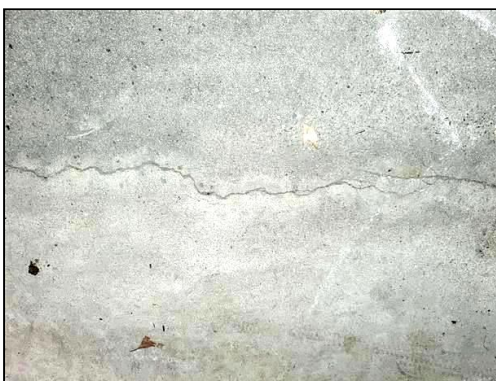
3.6 Item 1(Picture)

🏠 Typical hairline cracks located in the garage floor. Recommend to seal all cracks as discussed using a hydraulic cement as a way of monitoring floor for potential further movement. Repair as needed by a qualified person. This would be considered normal maintenance.

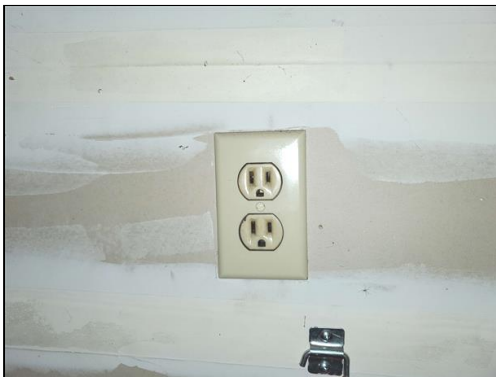
3.9 Item 1(Picture)

Recommend to replace 3 conventional receptacles in the garage with GFI receptacles. This would be considered an added safety precaution against a potential severe electrical shock. Replace as needed by a qualified person.

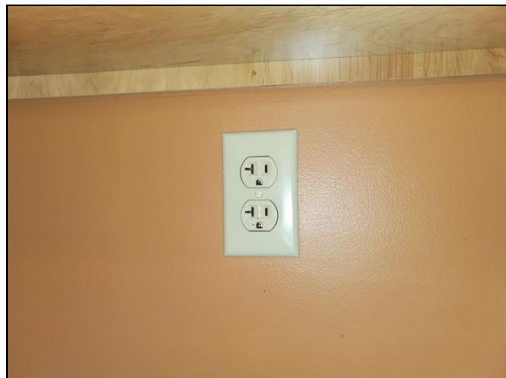
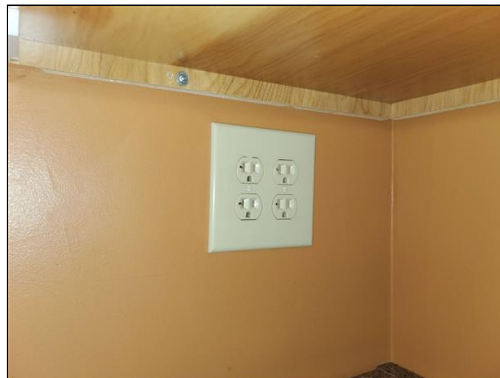
(1) Recommend to replace conventional outlets within 6 feet of kitchen sink with GFI receptacles. This would be considered an added safety precaution against a potential severe electrical shock.

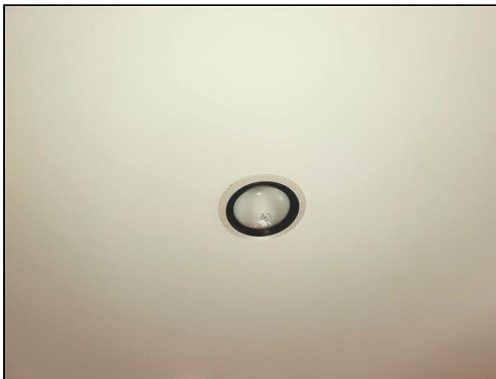
4.7 Item 3(Picture)

🏠 (2) One nonfunctional recessed light fixture in the kitchen. Recommend to replace the bulb and test for function.

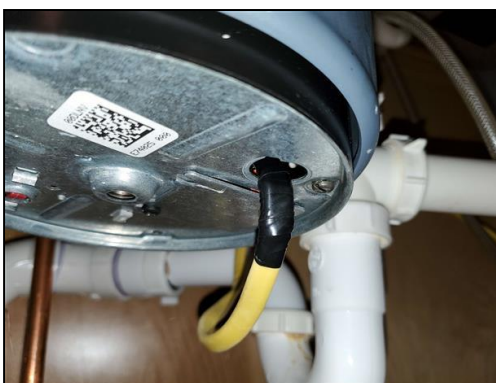
4.9 Item 1(Picture)

🔧 The food disposer wiring is missing a romex connector (anti-strain device). I recommend repair as needed.

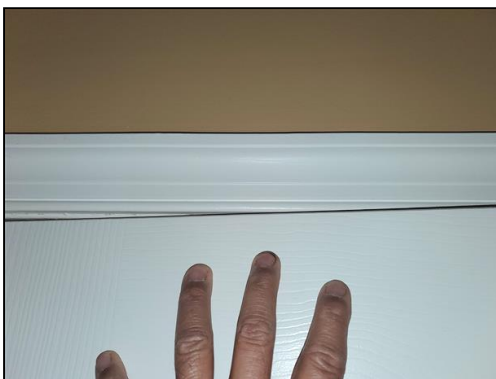
5.2.B Item 1(Picture)

Hollowcore door in the mudroom is binding in the door frame. Recommend to adjust door as needed to restore proper door function by a qualified person.

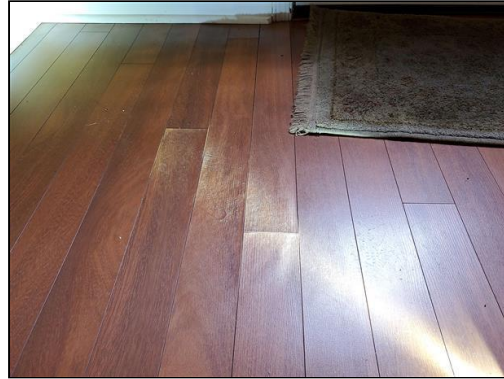
5.3.B Item 1(Picture)

Typical warped pergo floor from minor water penetration. FYI This is located in the mudroom.

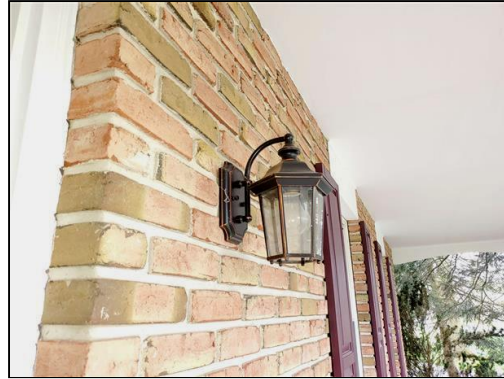
5.7.C Item 1(Picture)

Exterior light fixture was nonfunctional. Recommend to replace the bulb and test for function.

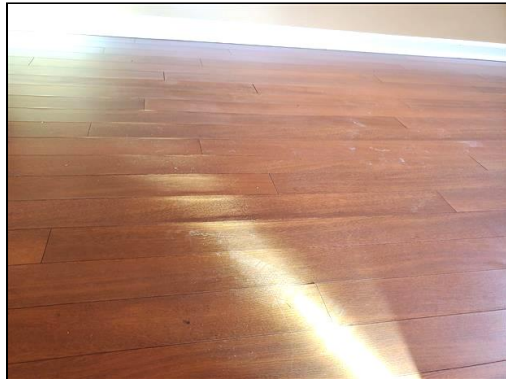
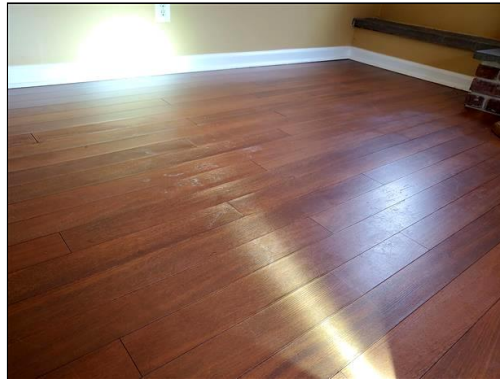
Typical warped pergo floor from minor water penetration. FYI This is located in the family room.

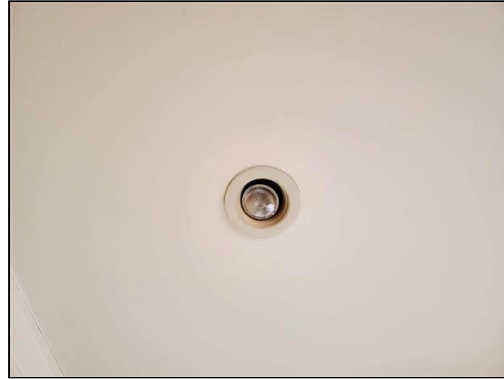
5.7.E Item 1(Picture)

Nonfunctional recessed light fixture in the family room. Recommend to replace the bulb and test for function.

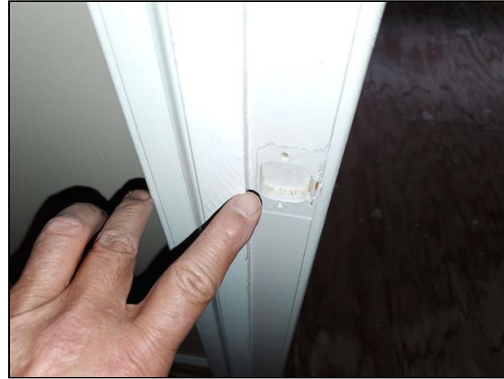
5.2.G Item 1(Picture)

Bedroom #2 entrance door is missing a striker plate. Recommend to install a striker plate as needed by a qualified person.

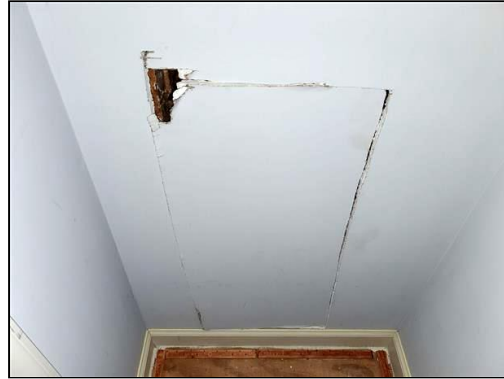
5.1.I Item 1(Picture)

Unfinished drywall in bedroom #4 closet. Recommend to repair or install a door as needed by a qualified person or professional.

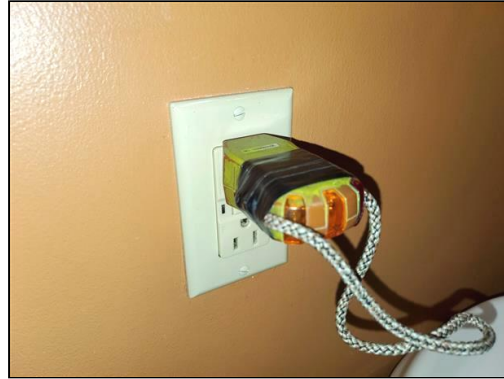
6.5.A Item 1(Picture)

Nonfunctional GFI receptacle in the 1/2 bath. Recommend to replace nonfunctional GFI receptacle as needed by a qualified electrician. Potential safety hazard exist.

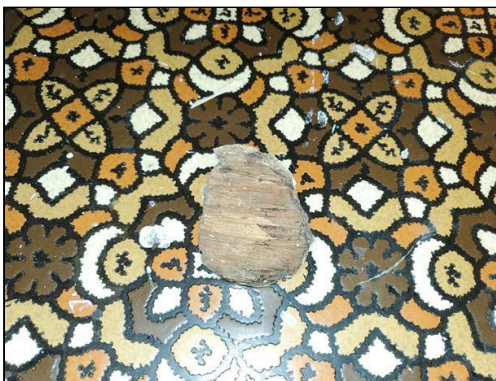
6.3.B Item 1(Picture)

Damaged vinyl floor in the hall bath. Recommend to repair or replace flooring as needed by a qualified person or professional.

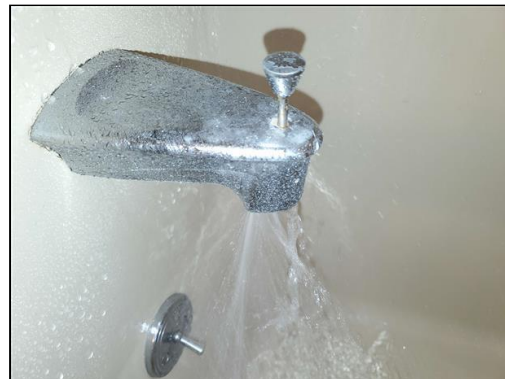
6.8.B Item 1(Picture)

🚿 Shower diverter valve in the hall bath is not functioning properly. Recommend to replace diverter valve as needed by a qualified plumber.

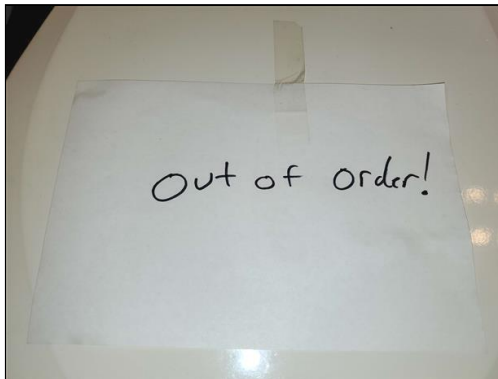
6.9.B Item 2(Picture)

Toilet in the hall bath very loose and nonfunctional. Recommend to repair as needed by a qualified plumber.

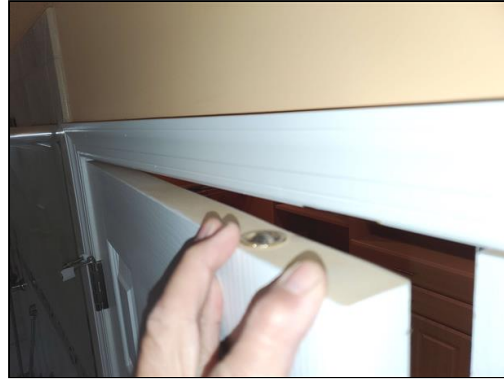
6.1.C Item 1(Picture)

Door hardware in the owners' suite bath is not latching properly. Recommend to adjust or repair hardware as needed by a qualified person.

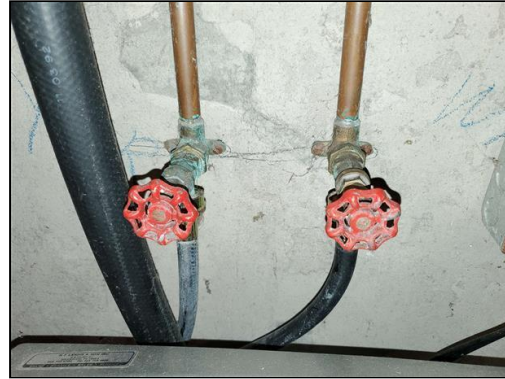
7.6 Item 1(Picture)

Suggest to replace rubber washing machine hose with stainless steel braided burst proof hose. This would be considered optional.

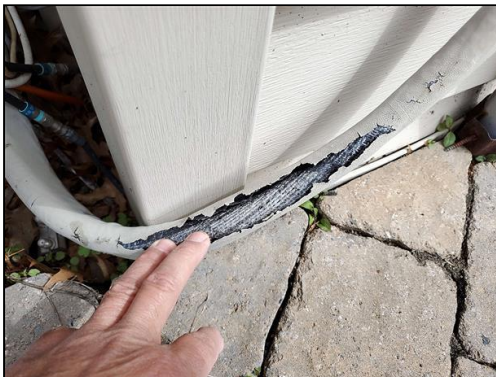
8.0 Item 1(Picture)

Main electrical line is frayed and deteriorated and in need of replacement. Recommend to replace main power line as needed by a qualified electrician. Potential safety hazard exist.

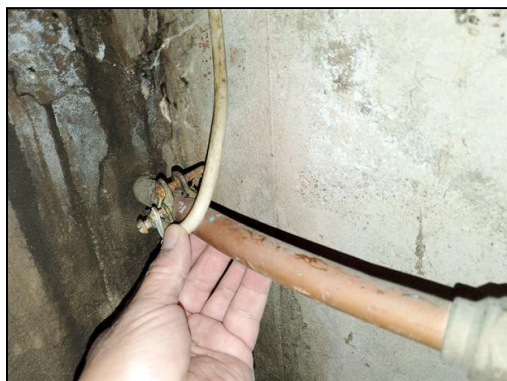
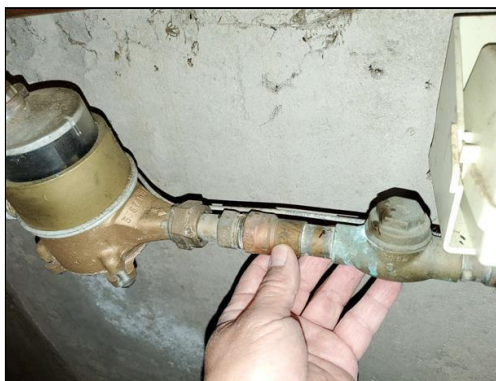
Ground wire must be attached to both sides of the water meter. Attach as needed by a qualified professional.

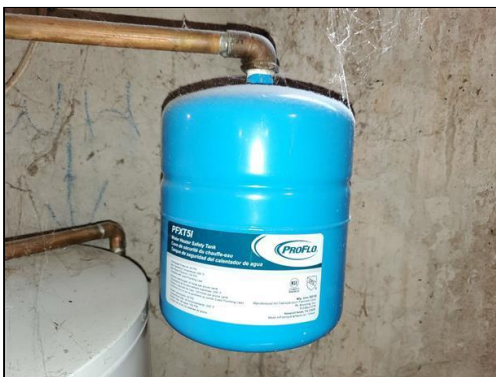
9.2 Item 1(Picture)

Hot water expansion tank is water logged. Recommend to repair or replace expansion tank as needed by a qualified person or plumber.

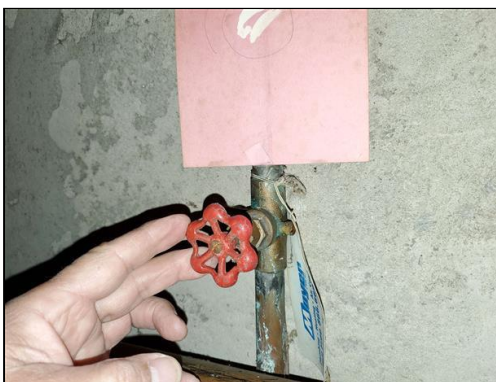
9.3 Item 1(Picture)

The main shut off is the red knob located in the basement. This is for your information.

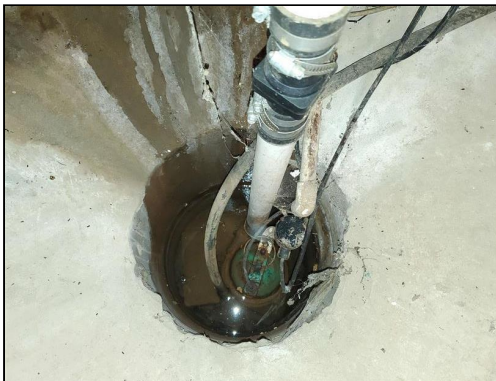
9.7 Item 1(Picture)

Missing a cover on the sump pump. Recommend to install a coverplate as needed by a qualified person.

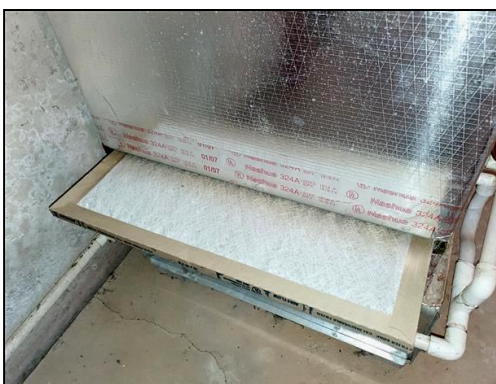
10.3 Item 1(Picture)

Air filter location. FYI

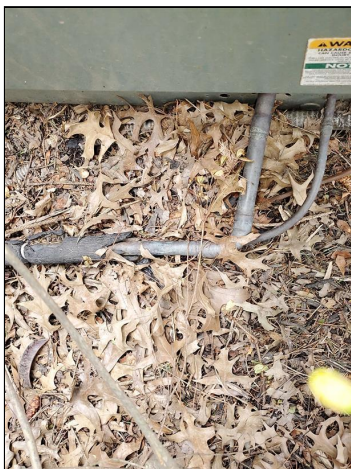
10.8 Item 2(Picture)

(1) Foam freon line cover is deteriorated and damaged. Recommend to replace foam cover as needed for maximum cooling efficiency and unit longevity. Replace as needed by a qualified person.

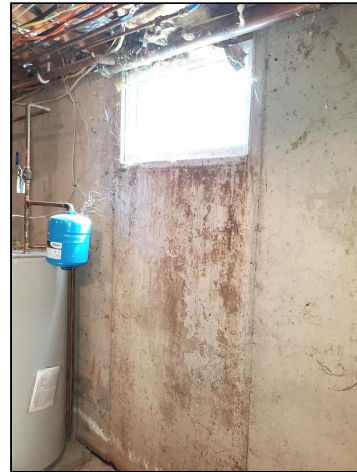
11.1 Item 1(Picture)

Water penetration at the window well. Recommend to install window well covers to prevent further water penetration.

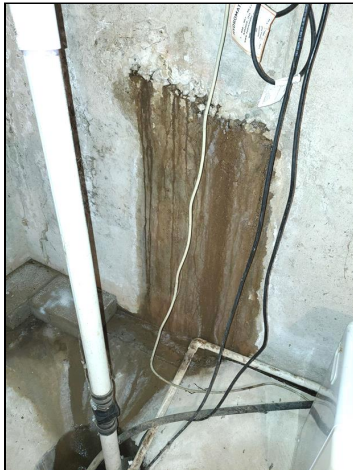
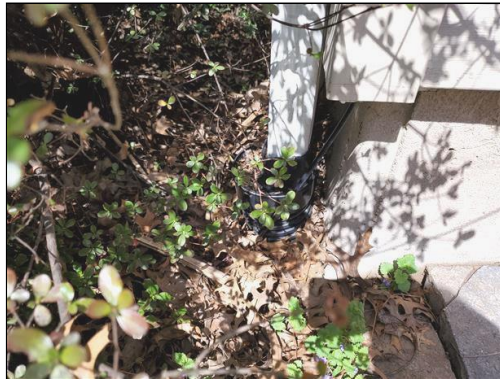
↑ (1) Area of water penetration on the wall in the basement. Recommend to patch or repair honeycombed area to prevent further water penetration. Suggest to use a hydraulic cement for repair. Also recommend to make sure downspout drain at corner of house is functional.

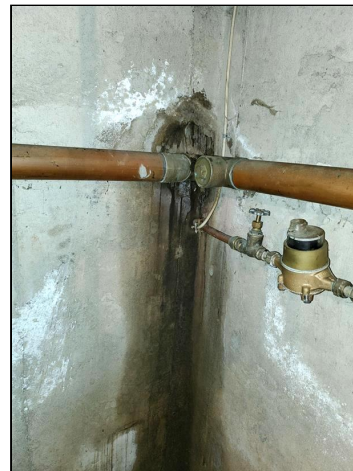
11.3 Item 3(Picture)

↑ (2) Minor water penetration in wall next to sewer and water lines. Recommend to verify downspout drains are functional.

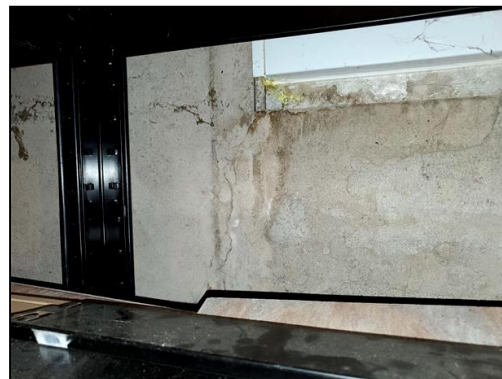
11.3 Item 4(Picture)

↑ (3) Typical settlement crack located in the foundation wall. Recommend to seal crack as discussed using a hydraulic cement. This will enable you to monitor same area for potential further movement.

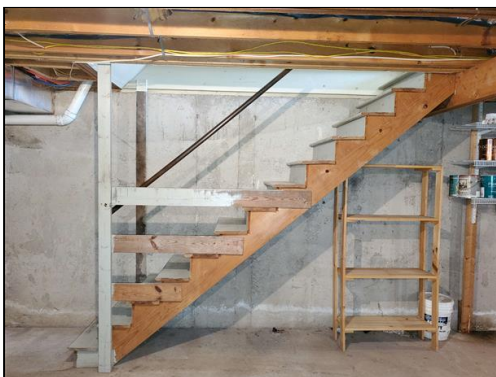
11.6 Item 1(Picture)

📌 Missing guardrail at step area. Recommend to replace missing guardrail as needed by a qualified person. Potential safety hazard for small children exists.

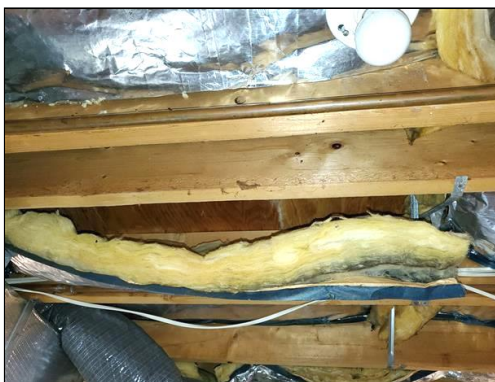
11.8 Item 2(Picture)

📌 Loose insulation in the basement ceiling. Recommend to secure as needed by a qualified person or professional.

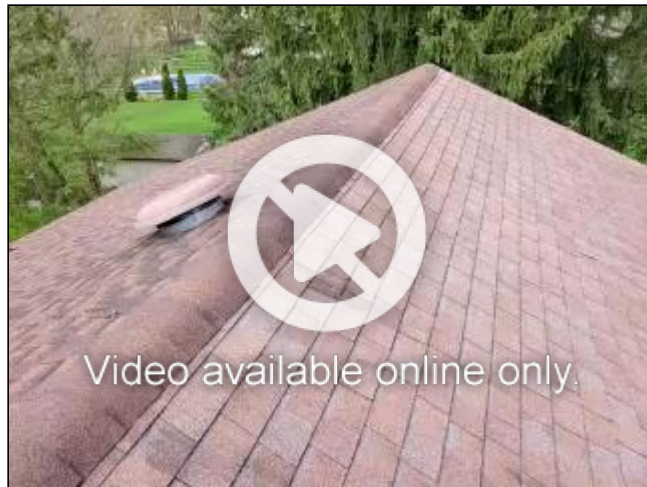
1.0 Item 1(Video) *** ROOF VIDEO ***

Suggest to view roof video for more information.

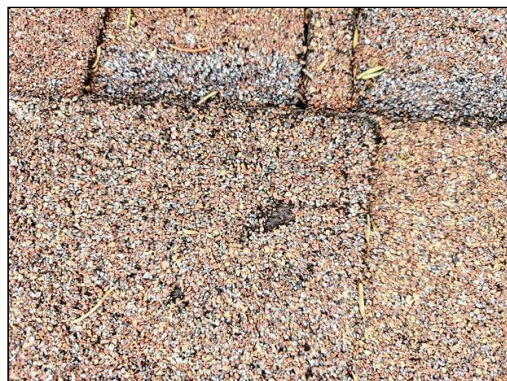
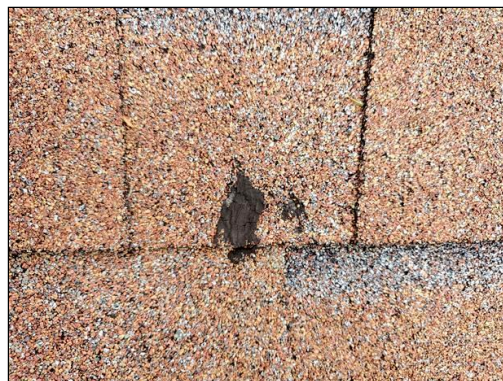
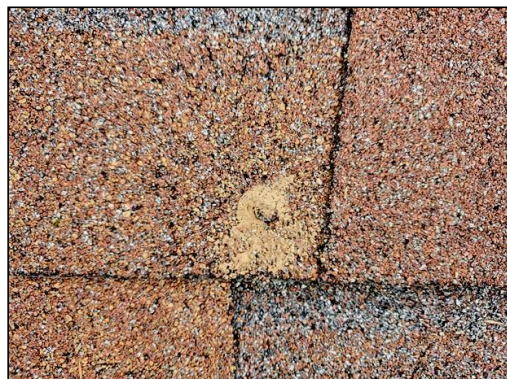
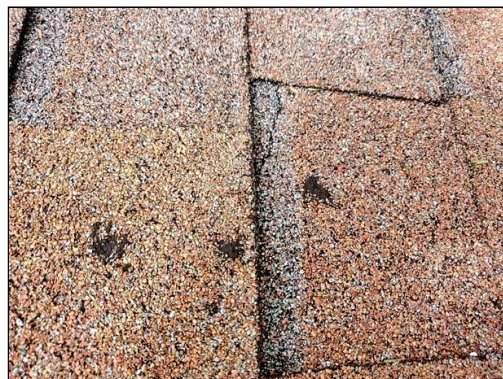
- Lower roof has signs of wear and tear and patched nail holes. Projected life span on lower roof; 5-7 years remaining with proper maintenance.
- Upper back roof appears newer and is in very good condition.

Recommend to view roof video for more information. FYI

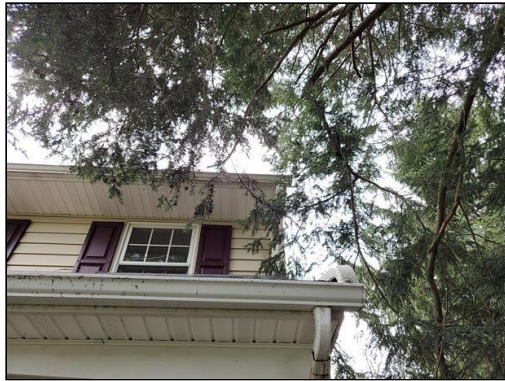
1.1 Item 5(Picture)

(2) The tree limbs that are in contact with roof or hanging near roof should be trimmed.

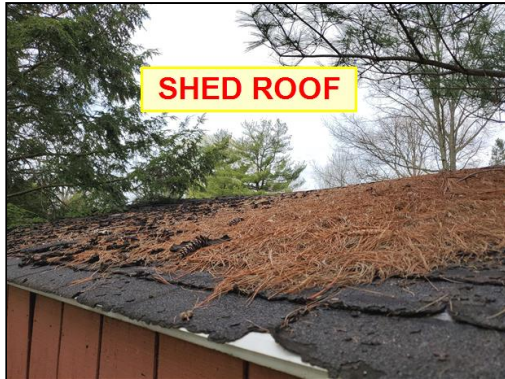
1.1 Item 6(Picture)

(3) Shed roof is at the end of its' projected lifespan. Recommend to replace shed roof as needed by a qualified professional.

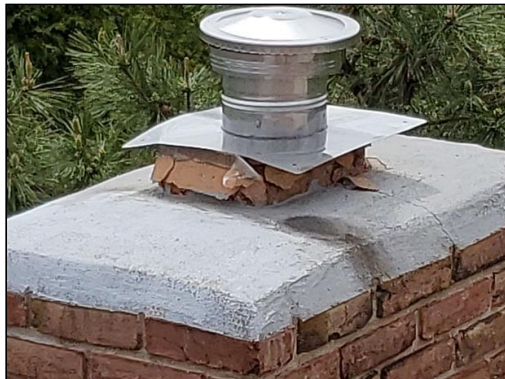
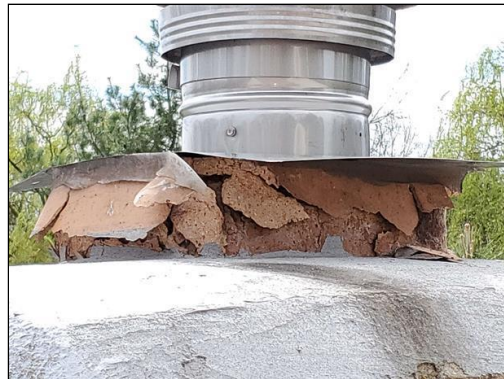
Cracked flue pipe. Recommend to repair or replace as needed by a qualified professional.

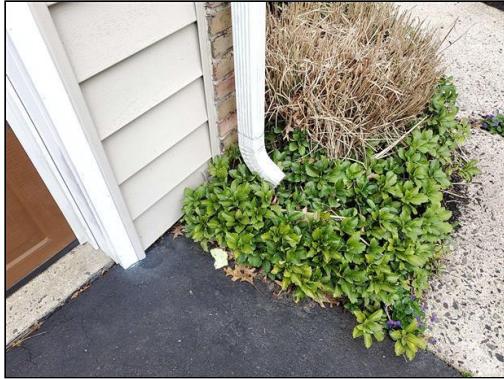
1.4 Item 1(Picture)

(1) Downspouts are not moving water effectively away from the foundation. Suggest to extend downspouts as discussed for better drainage away from the foundation. Saturating foundation walls for extended periods of time can cause potential unseen structural damage from water and insects. Could not determine how long water was flowing towards the foundation.

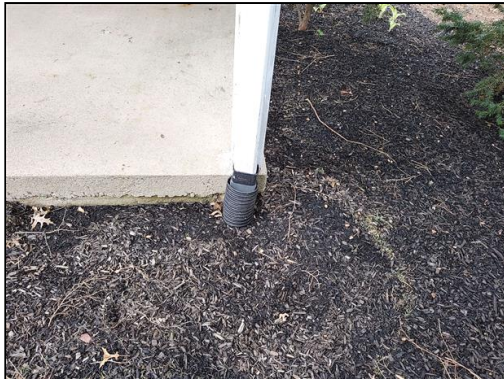
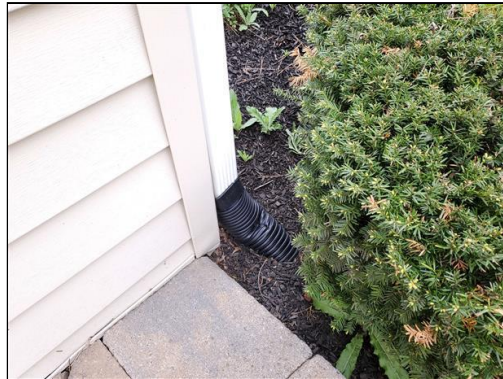
(2) Gutters appear to be working properly. Could not verify condition of the downspouts and drains. Suggest to verify condition of all downspout drains as needed. Many basement leaks occur from clogged downspout drains.

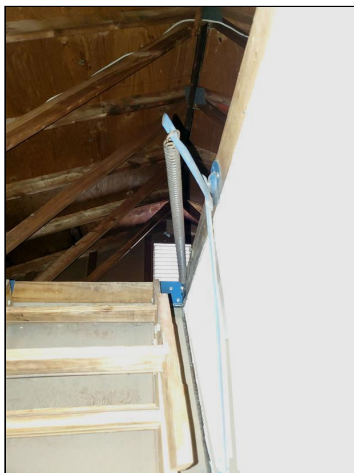
1.11 Item 1(Picture)

Bent bracket at the pull down stairs. Recommend to repair as needed by a qualified person.

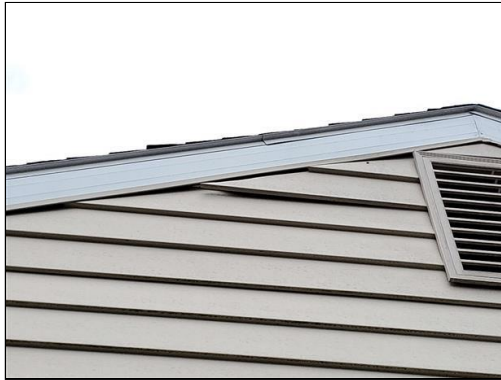
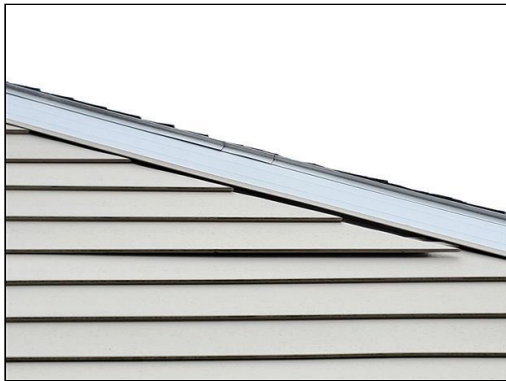
(1) Loose siding at the right and left side of the house. Recommend to secure siding as needed by a qualified professional.

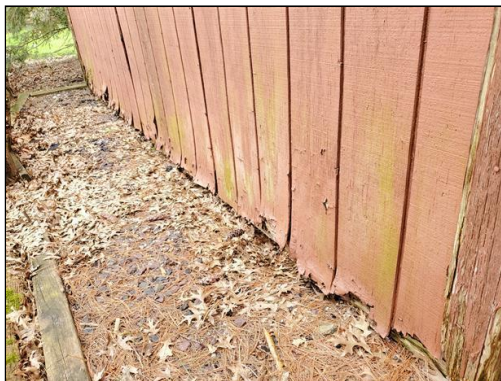
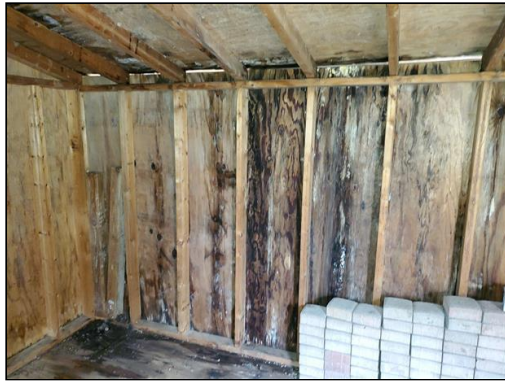
(2) Deteriorated wood siding at the bottom of shed and interior walls. Recommend to repair or replace deteriorated wood as needed by a qualified person or professional.

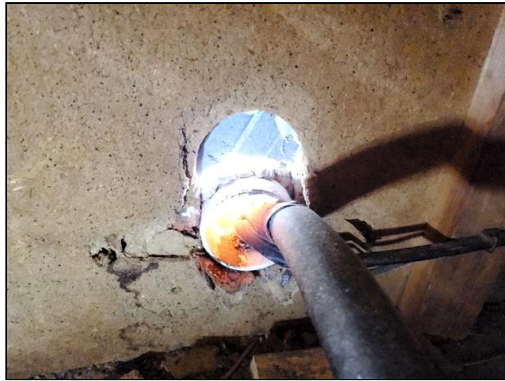
2.0 Item 7(Picture)

(3) The hole in siding needs closing off with sealant or liquid foam at the exterior where compressor lines enter the home in the attic. Potential for insect penetration.

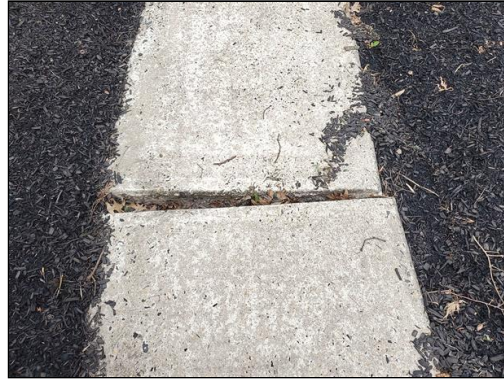
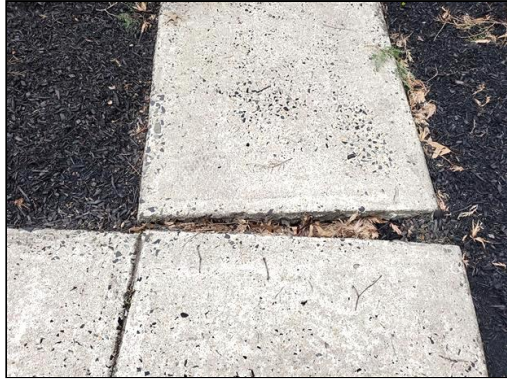
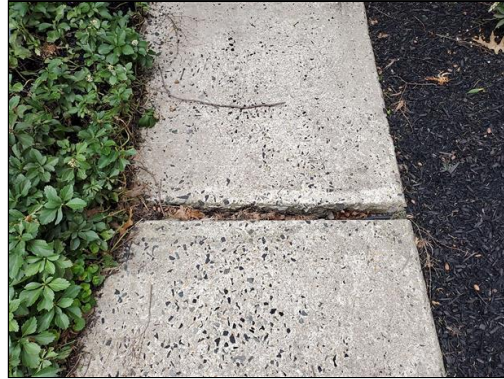
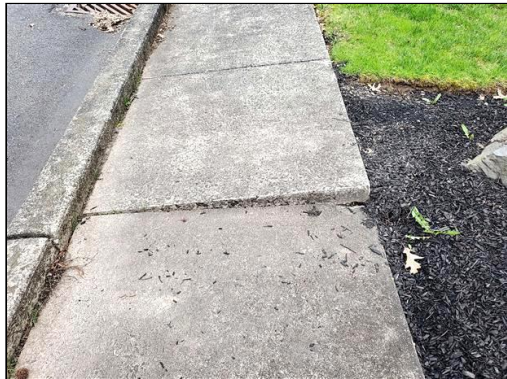
(1) Rotated and uneven concrete walkway. Recommend to repair as needed by a qualified person or professional. Potential tripping hazard exists.

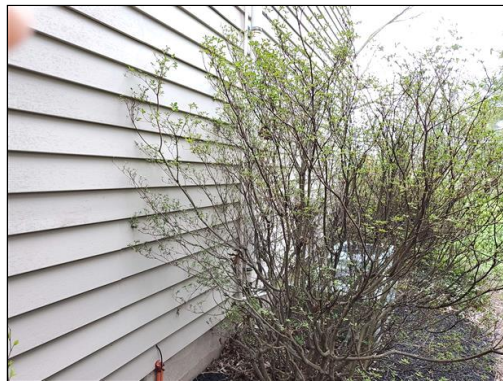
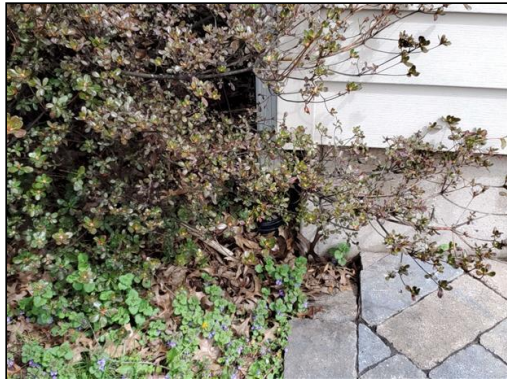
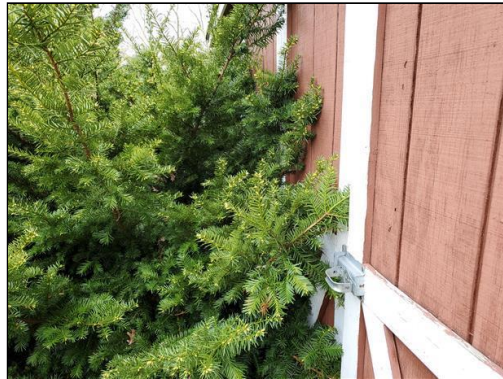
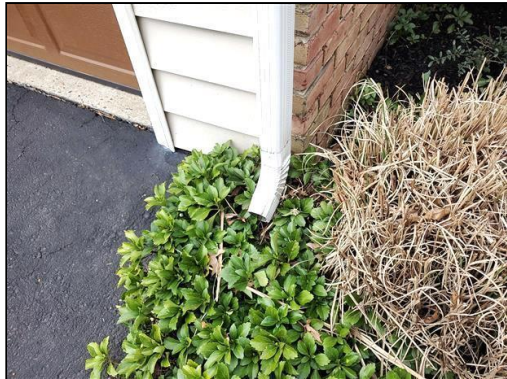
(5) Shrubbbery and vegetation is growing too close to the siding for proper ventilation. Recommend to trim shrubbbery a minimum of of 12 to 16 inches away from the siding to restore proper ventilation. This would be considered normal maintenance.

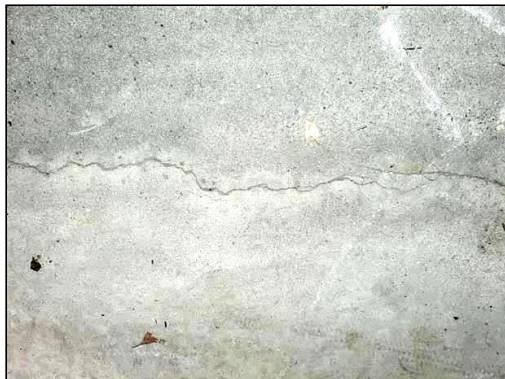
3.6 Item 1(Picture)

Typical hairline cracks located in the garage floor. Recommend to seal all cracks as discussed using a hydraulic cement as a way of monitoring floor for potential further movement. Repair as needed by a qualified person. This would be considered normal maintenance.

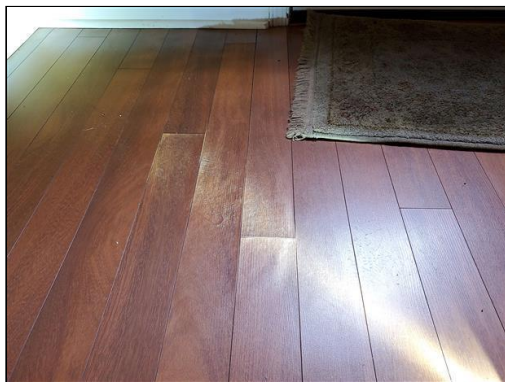
5.3.B Item 1(Picture)

Typical warped pergo floor from minor water penetration. FYI This is located in the mudroom.

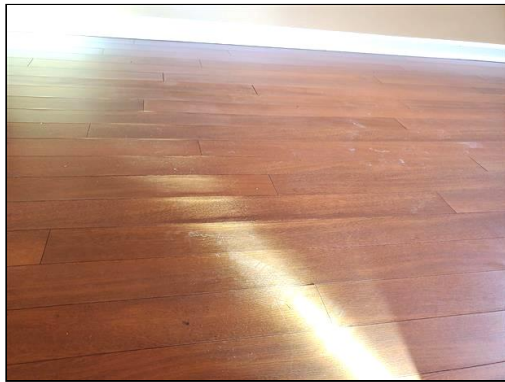
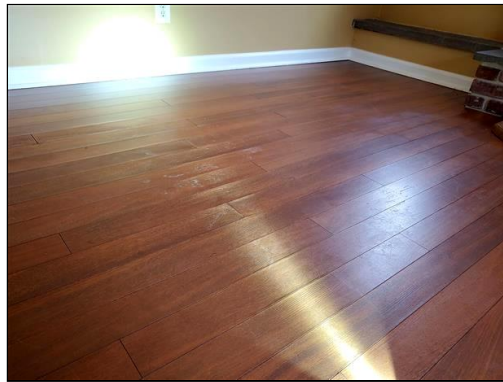
Typical warped pergo floor from minor water penetration. FYI This is located in the family room.

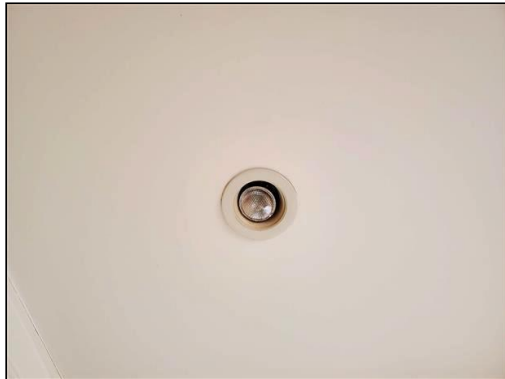
5.7.E Item 1(Picture)

Nonfunctional recessed light fixture in the family room. Recommend to replace the bulb and test for function.

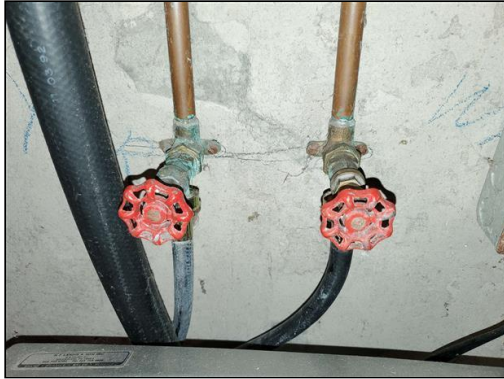
7.6 Item 1(Picture)

Suggest to replace rubber washing machine hose with stainless steel braided burst proof hose. This would be considered optional.

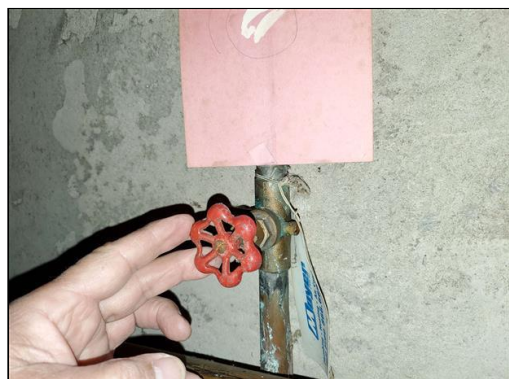
9.3 Item 1(Picture)

The main shut off is the red knob located in the basement. This is for your information.

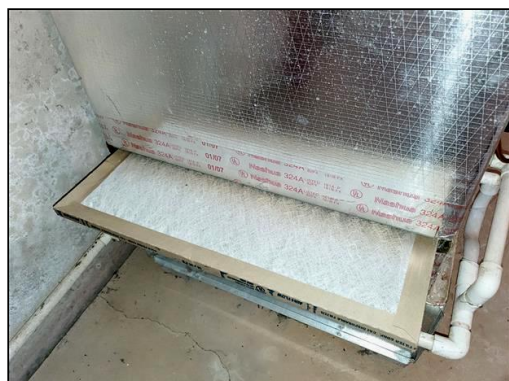
10.3 Item 1(Picture)

Air filter location. FYI

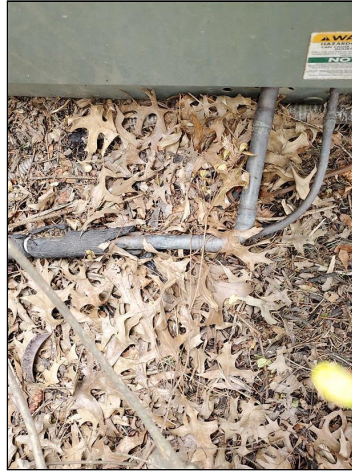
10.8 Item 2(Picture)

(1) Foam freon line cover is deteriorated and damaged. Recommend to replace foam cover as needed for maximum cooling efficiency and unit longevity. Replace as needed by a qualified person.

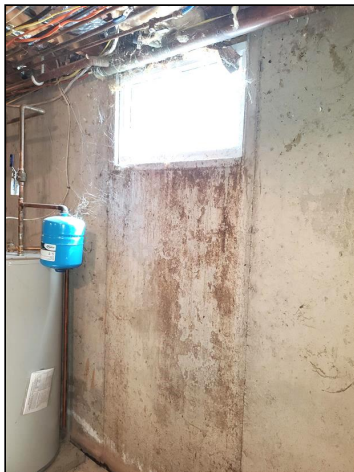
11.1 Item 1(Picture)

Water penetration at the window well. Recommend to install window well covers to prevent further water penetration.

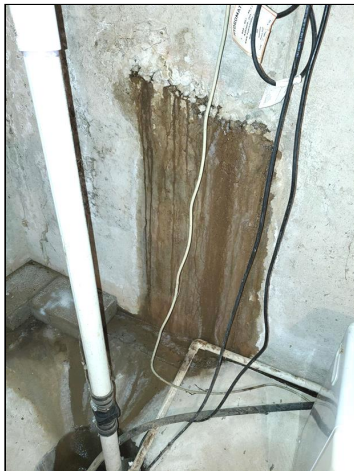
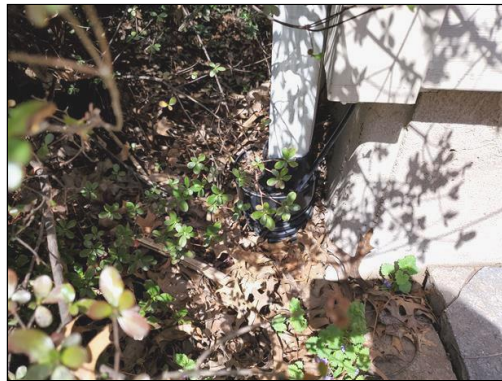
(1) Area of water penetration on the wall in the basement. Recommend to patch or repair honeycombed area to prevent further water penetration. Suggest to use a hydraulic cement for repair. Also recommend to make sure downspout drain at corner of house is functional.

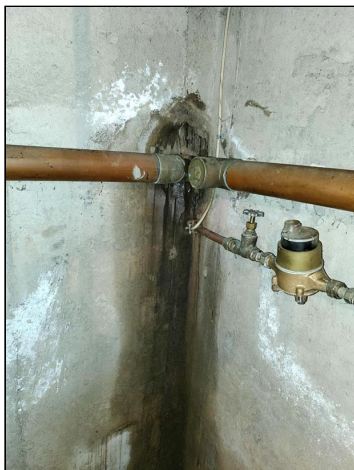
11.3 Item 3(Picture)

(2) Minor water penetration in wall next to sewer and water lines. Recommend to verify downspout drains are functional.

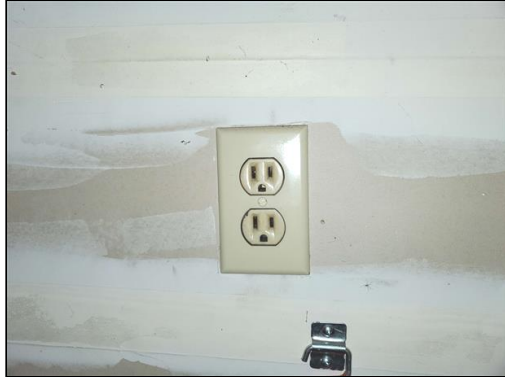
3.9 Item 1(Picture)

Recommend to replace 3 conventional receptacles in the garage with GFI receptacles. This would be considered an added safety precaution against a potential severe electrical shock. Replace as needed by a qualified person.
