Inspection Report

Property Address:
552 Colonial Ave
Souderton Pa 18964

A1 House Prep LLC and Inspections

Date: 04/14/20	Time: 11:00 AM	Report ID: 6824 Matthew Missimer
Property: 552 Colonial Ave Souderton Pa 18964	Customer: Matthew Missimer	Real Estate Professional: Lon Clemmer Sanford Alderfer Real Estate

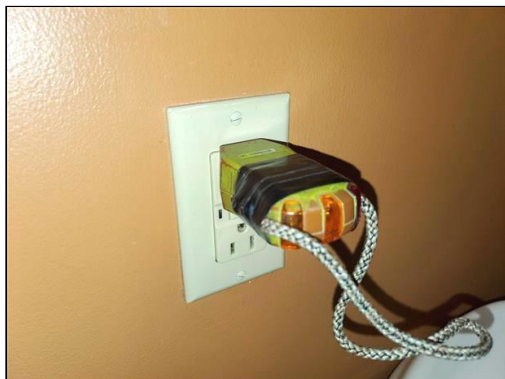
6.5.A Item 1(Picture)

Nonfunctional GFI receptacle in the 1/2 bath. Recommend to replace nonfunctional GFI receptacle as needed by a qualified electrician. Potential safety hazard exist.

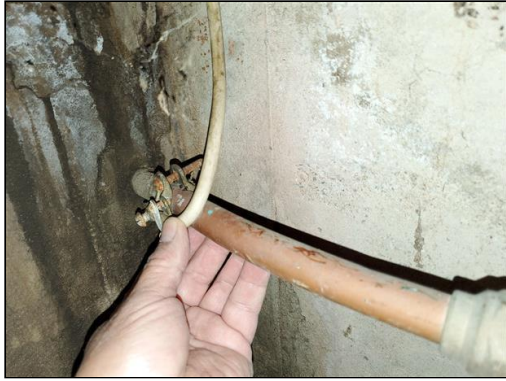
8.1 Item 1(Picture)

Ground wire must be attached to both sides of the water meter. Attach as needed by a qualified professional.

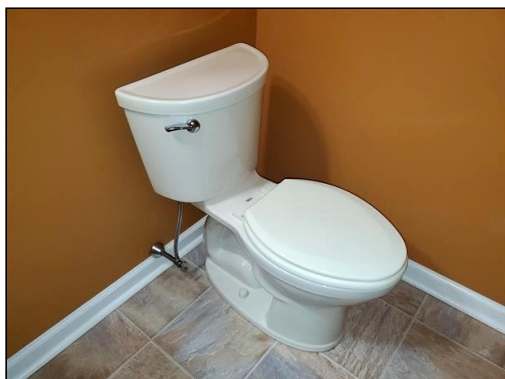
6.9.A Item 1(Picture)

The toilet is loose at floor at the 1/2 bath. Recommend to secure toilet the the floor as needed by a qualified person or plumber.

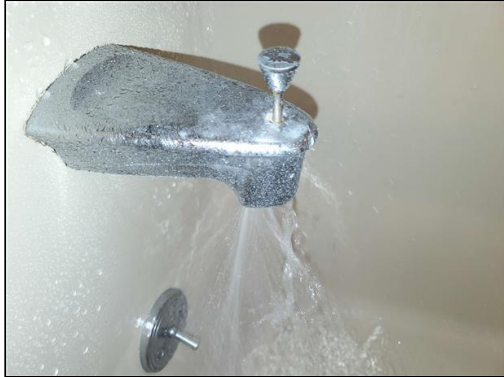
6.8.B Item 1(Picture)

Shower diverter valve in the hall bath is not functioning properly. Recommend to replace diverter valve as needed by a qualified plumber.

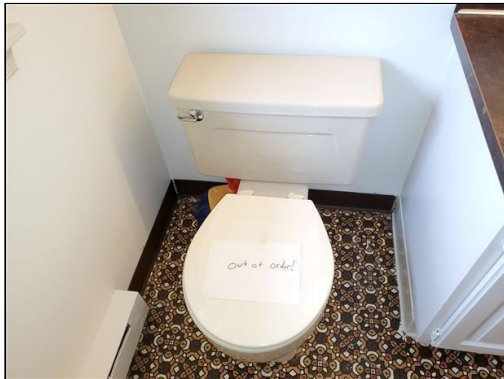
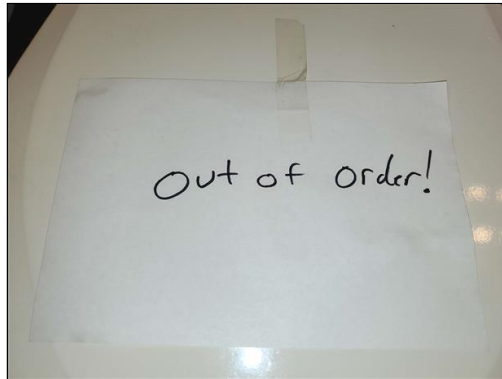
Toilet in the hall bath very loose and nonfunctional. Recommend to repair as needed by a qualified plumber.

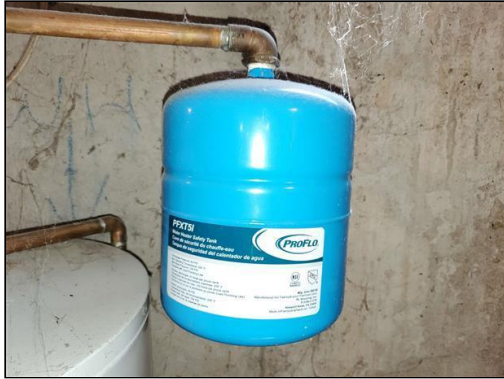
9.2 Item 1(Picture)

Hot water expansion tank is water logged. Recommend to repair or replace expansion tank as needed by a qualified person or plumber.
