ASBESTOS SURVEY REPORT

**ENGLAND
COST CENTER NO. RFC004328
100 SOUTH ALLIS STREET
ENGLAND, ARKANSAS 72046**

**Terracon Project No. 94107574.001
PO No. CA398907AR**

October 14, 2010

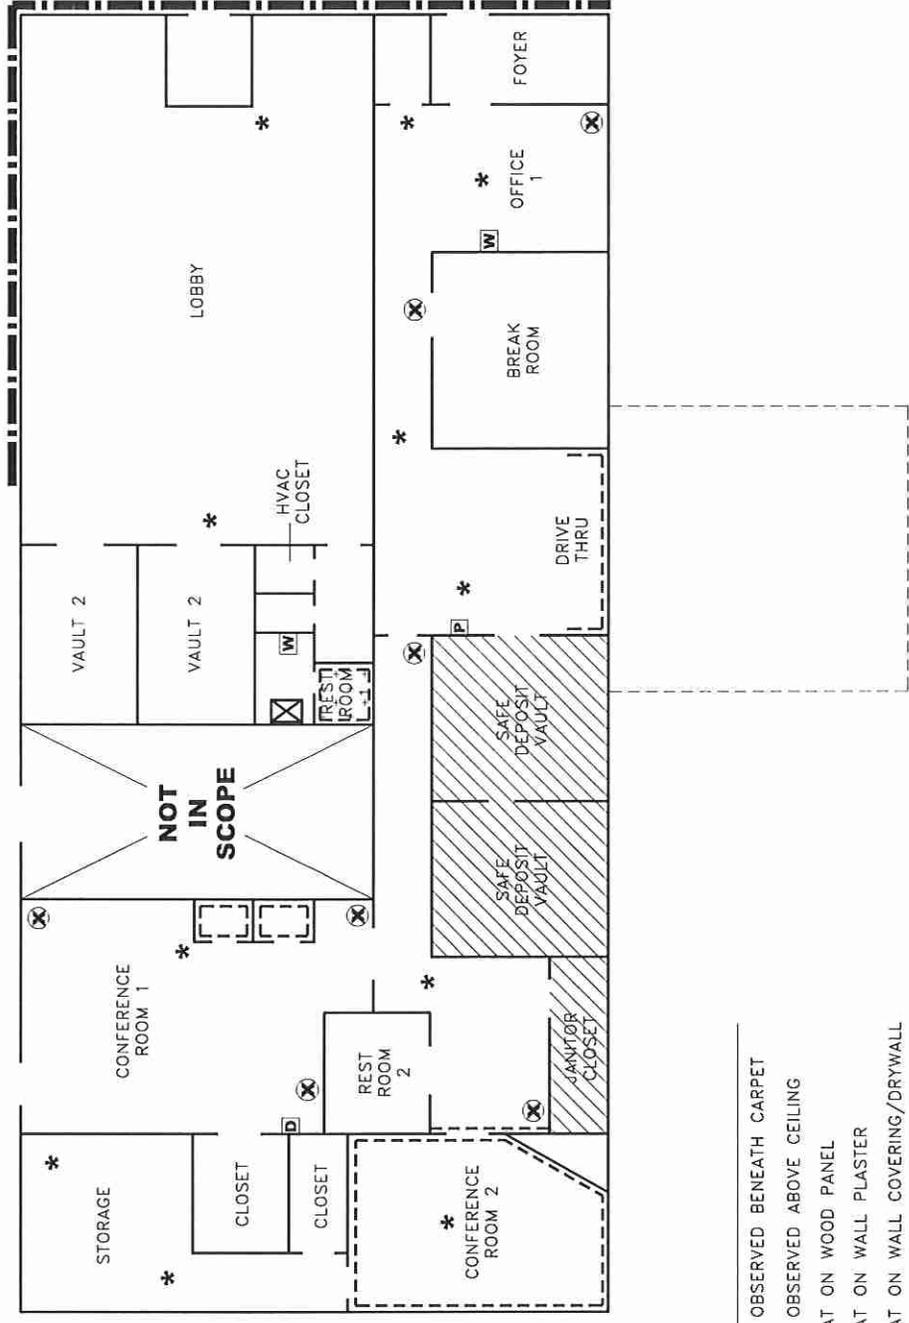
APPENDIX F
SITE DIAGRAM

The sink undercoat (white) is located in the kitchen and is assessed as a non-friable ACM in good condition.
