HOME INSPECTION

04/20/18

421 W Bute Street #203 Norfolk, VA 23510

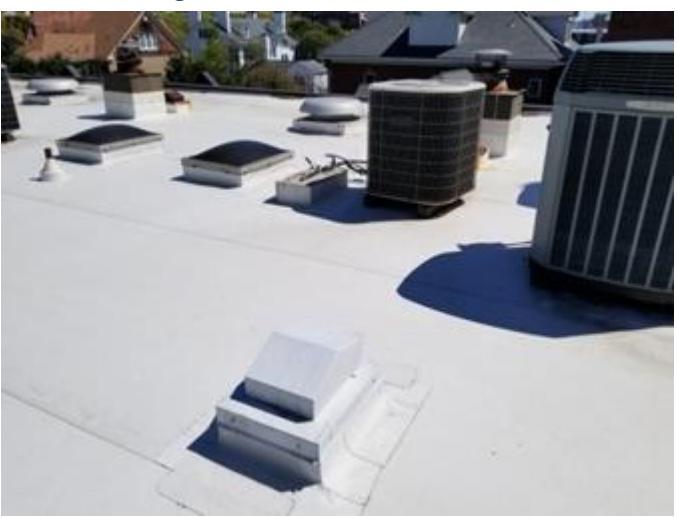
Roof - Covering No issues noted.

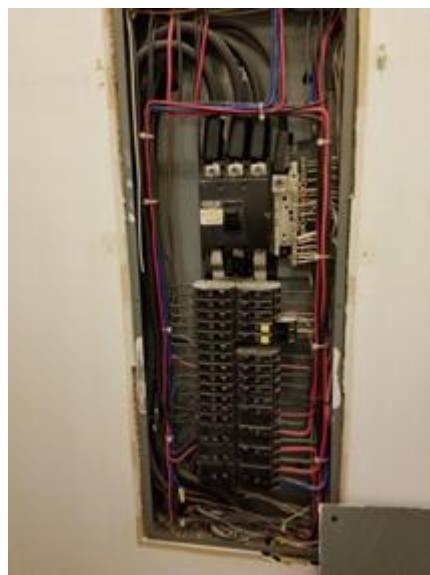
Electrical Sub-Panel 1

- **01** The sub-panel's neutral wires are not isolated from ground. This is a safety hazard. **Location:** Panel in closet. *Hire an electrician to make the required repairs.*
- 02 There are missing knockout covers at the electrical sub-panel. This defeats the panel's fire rating, and permits accidental contact with energized components. **Location:** Top of the Panel in closet. *Hire an electrician to make the required repairs*.
- **03** There are improperly secured wires at the electrical sub-panel. Safety standards require a retainer where wires enter the panel. **Location:** One top and one bottom of the panel. *Hire an electrician to make the required repairs*.
