3221 Pineridge Dr  
Chesapeake VA 23321

2/17/2020

Burke Inspection Service dba HouseMaster - VA #3380001054  
109-G Gainsborough Sq.  
#165  
(757)822-4839

Single Family

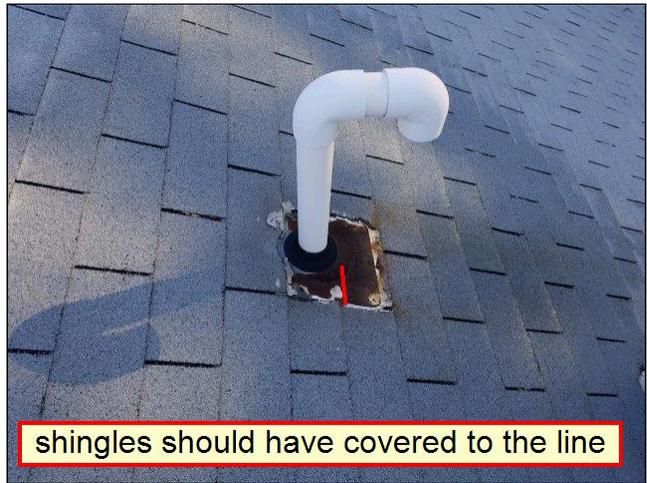
1.5(1) PLUMBING STACKS Photo 1

shingles should have covered to the line

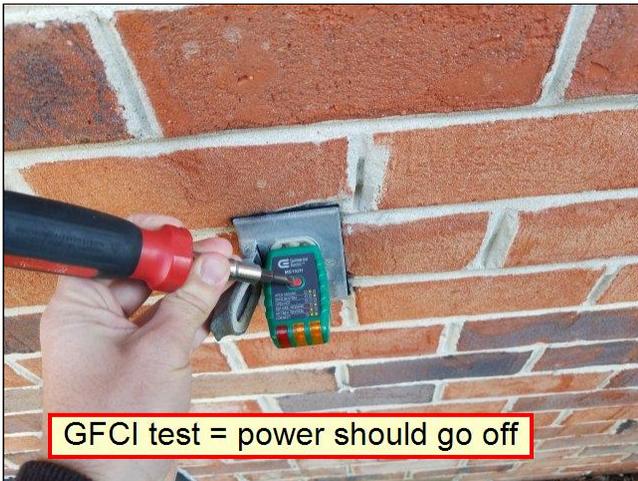
2.10(1) ELECTRIC / GFCI Photo 1

GFCI test = power should go off

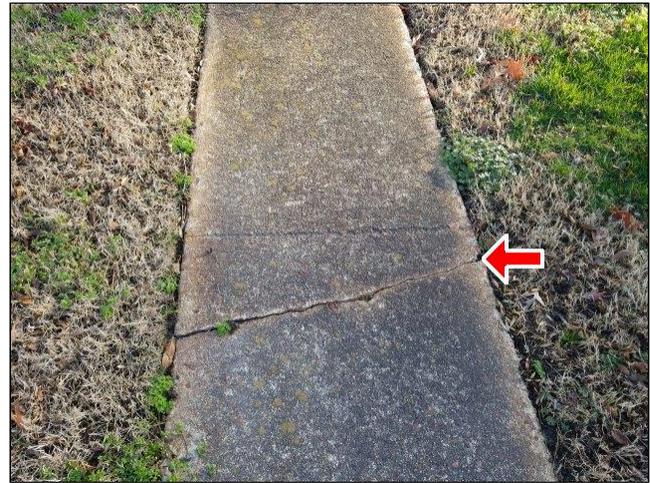
3.1 WALKWAYS Photo 1

●	<b>3.0 PATIO(S)</b>
●				<b>3.1 WALKWAYS</b> Typical condition for age. Cracking and vegetation growth noted; clear and maintain as needed.
●				<b>3.2 DRIVEWAY</b> Typical condition for age. Cracking and vegetation growth noted; clear and maintain as needed.
	●			<b>3.3 GROUND SLOPE AT FOUNDATION</b> (1) Foundation vent(s) are below ground level at left side. A half-round window well should be installed. The dirt inside well should be replaced with approximately four inches of gravel. A couple of inches clearance between gravel and vent opening recommended. (2) A few low spots were noted at foundation, add soil as needed to prevent ponding and help facilitate proper drainage away from structure.
	●			<b>3.4 SITE GRADING</b> Grading slopes towards the house at rear of the home; monitor runoff and correct as needed.
	●			<b>3.5 TREES / VEGETATION</b> Clear trees and vegetation growing close to structure. Maintain a minimum 12" gap to avoid damage to siding and roofing materials, and the possibility of subsequent water intrusion and/or insect infestation.

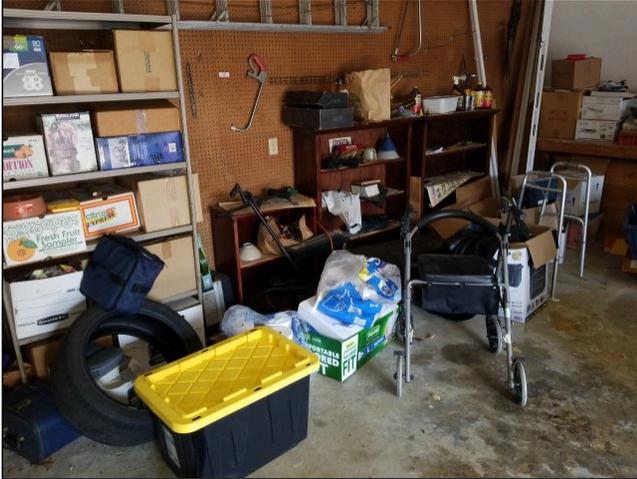
4.1 FOUNDATION / WALLS Photo 1

<b>4.0 EXPOSED FRAMING</b>
					<b>4.1 FOUNDATION / WALLS</b> Not inspected due to presence of excess storage items at time of inspection. Check conditions prior to closing, once storage has been removed.
					<b>4.2 FLOOR SLAB</b> (1) Typical cracking noted. Monitor and maintain as needed. (2) Inspection limited by presence of excess storage items at time of inspection. Check conditions once storage has been removed prior to closing to ensure that hidden damage does not exist.
					<b>4.3 SIDING / TRIM</b> Minor dents noted in trim at vehicle door, correct as desired.
					<b>4.4 WALLS / CEILINGS</b> (1) Door to the house and the Attic access do not comply with current fire safety standards. Consider upgrading for improved safety. <i>Fire rated doors are now required, and Attic accesses with wood panels for covers are generally prohibited when the Attic over the Garage is shared/open to the Attic over the finished space. Fire-rated materials (such as 5/8" drywall) are required on Garage walls and ceilings to slow the spread of a fire that starts in the Garage into the home to allow the occupants added time to escape. Walls and ceilings must also be free of holes or other damage, and the seams properly sealed with appropriate drywall tape and joint compound to prevent fumes from seeping into the home. Thickness of existing drywall was not checked, but given it's age it is unlikely to comply with these standards as well.</i> (2) Minor damage / gaps noted to drywall in some areas, correct as needed / desired. <i>Please be advised that even small holes or cracks on the ceiling or a wall that is shared with the living space can be considered breaks in the required house-garage separation. Maintain as needed to reduce the potential that fumes, flames, or smoke will enter the home and pose a risk to the occupants.</i> (3) Inspection limited by presence of excess storage items. Check conditions prior to closing, once storage has been removed.

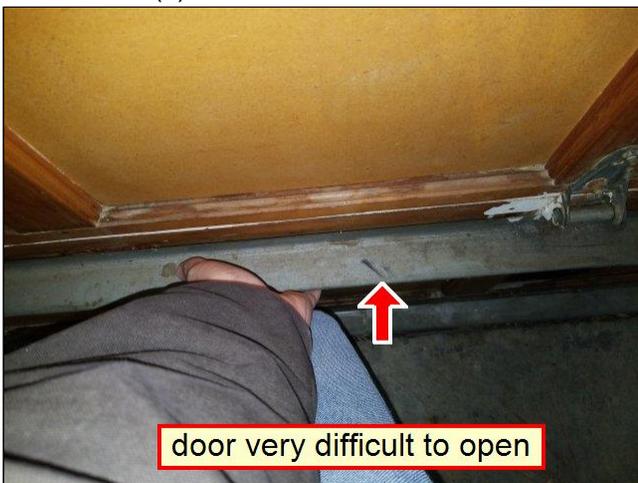
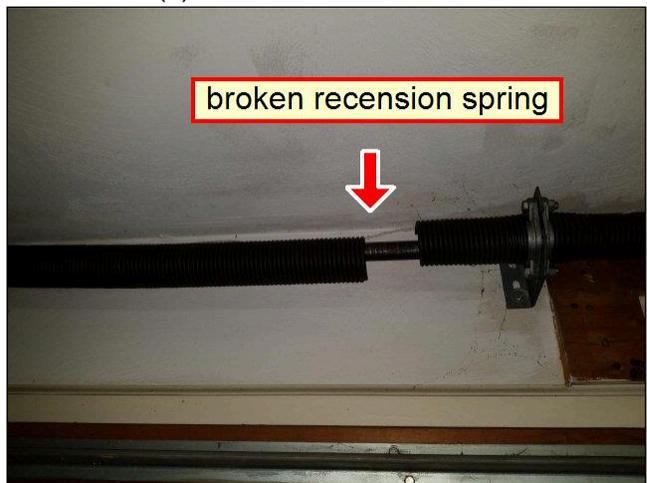
<b>4.5 OVERHEAD/VEHICLE DOOR(S)</b> (1) The balancer springs do not have enough tension on them due to a broken spring, causing the door to slam shut when detached from the opener. This is also causing the opener to work much harder than in should, and could lead to early failure. Have spring replaced and adjusted by a qualified overhead door specialist. (2) Old pressboard door is beginning to deteriorate at edges of panels, especially the base. Maintain as required and consider replacing.
					<b>4.6 DOOR OPERATOR(S)</b> Older units noted, anticipate repair and replacement needs.
					<b>4.7 ELECTRIC / GFCI</b>

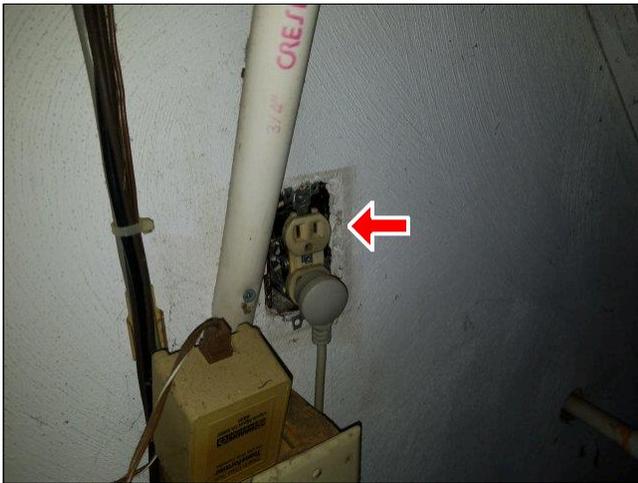
4.7(1) ELECTRIC / GFCI Photo 1

(1) Loose receptacle with a missing cover plate noted at the shared wall for the living area of the home, correct as required.  
(2) The receptacle outlets in the Garage are not GFCI protected. (structure pre-dates current requirements.) Consider installing GFCI unit(s) at receptacle(s) or in Electrical Panel as needed for improved safety.

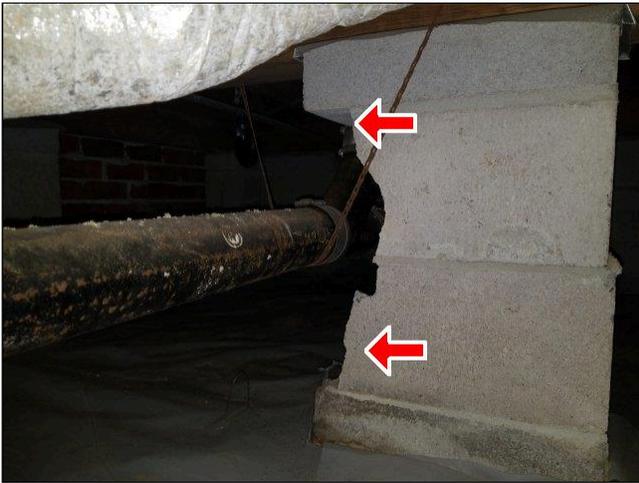
9.1 PIERS / COLUMNS Photo 1

●					<b>9.0 FOUNDATION WALLS</b>
	●				<b>9.1 PIERS / COLUMNS</b> Two piers were damaged for piping under the MBA, a pier is chipped at the Front of the home, and a piers has largely. even destroyed for the installation of a Foundation Vent under the Powder Rm. Have conditions evaluated further and corrected as required by a licensed Foundation Repair Contractor.
	●				<b>9.2 FLOOR FRAMING</b> (1) Cracked joist noted at the Living Rm; sister new joist. (2) Evidence of prior Termite activity as well as leakage at the Front Porch noted at the time of inspection. It does not appear as though the prior Termite activity reached the framing and repairs were observed at the Front Porch. However, strongly recommend having conditions evaluated further and corrected if needed by a licensed Termite & Moisture Control Specialist. (3) Evidence of prior fungal activity noted in the Crawlspace. Damage to framing does not appear to be consequential at this time, but measures should be taken to improve ventilation and reduce moisture concerns. See Ventilation note below for more detail and remedial recommendations.

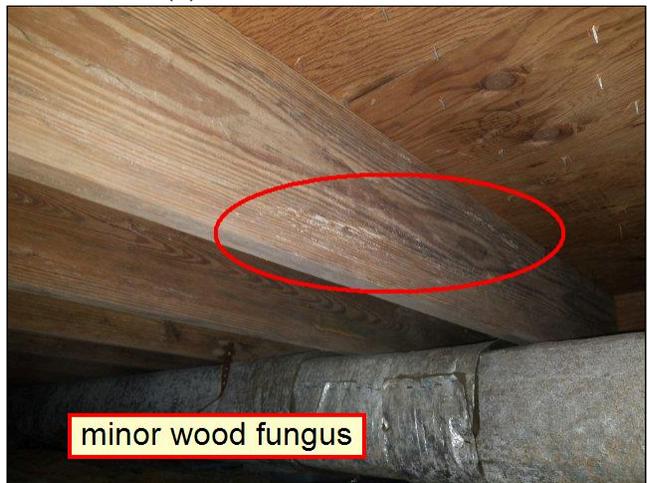
9.2(3) FLOOR FRAMING Photo 2

minor wood fungus

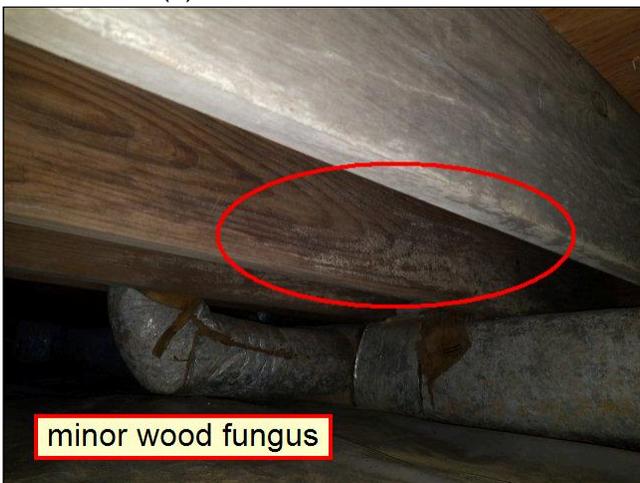
9.2(3) FLOOR FRAMING Photo 3

minor wood fungus

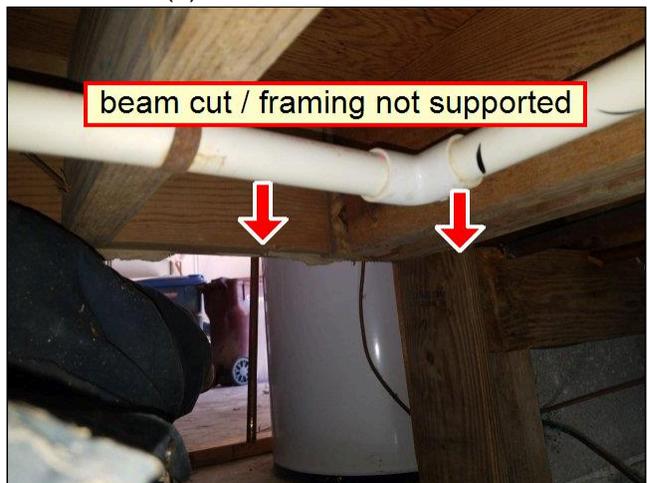
9.3(1) MAIN BEAM(S) Photo 1

●				<b>9.3 MAIN BEAM(S)</b> (1) A section of the beam was improperly removed to make a Crawlspace access in the Garage. This has left inadequate support for the framing at this location. Have conditions evaluated further and corrected as required by a licensed Substructure Repair Contractor. (2) See Framing note above regarding fungus activity.
●					<b>9.4 CRAWLSPACE VENTILATION</b> As noted above, there is evidence of prior fungus growth on the framing and beams. Damage does not appear to be consequential, but measures should be taken to reduce moisture levels. Maintain a proper (6 mil minimum) plastic vapor barrier on the floor of the Crawlspace, keep foundation vents open during the warmer months of the year, and have annual termite & moisture inspections performed each year in the late summer or early fall, when moisture levels can be expected to be at their highest.
		●			<b>9.5 INSULATION</b> Typical of older homes, there is no floor insulation present, recommend adding for improved comfort and efficiency.

beam cut / framing not supported

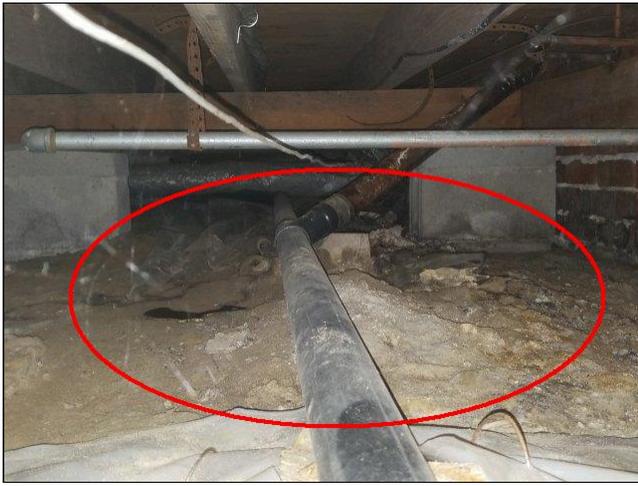
9.6 VAPOR BARRIER Photo 1

●					<b>9.6 VAPOR BARRIER</b> Gap in the vapor barrier noted under the Kitchen, correct as needed.
