422 Crawford St  
Portsmouth VA 23704

3/17/2020

Burke Inspection Service dba HouseMaster - VA #3380001054

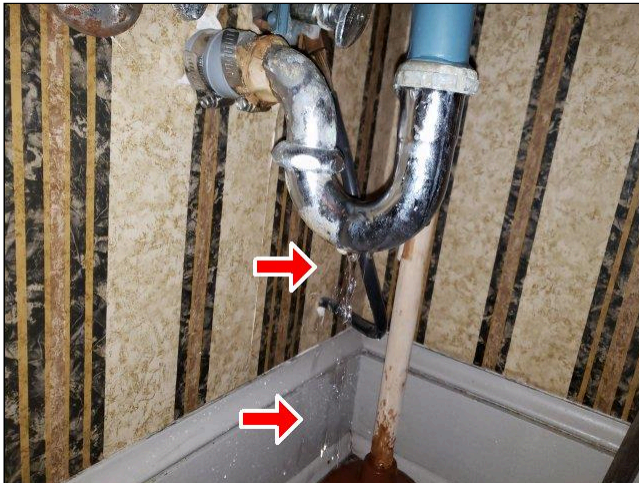
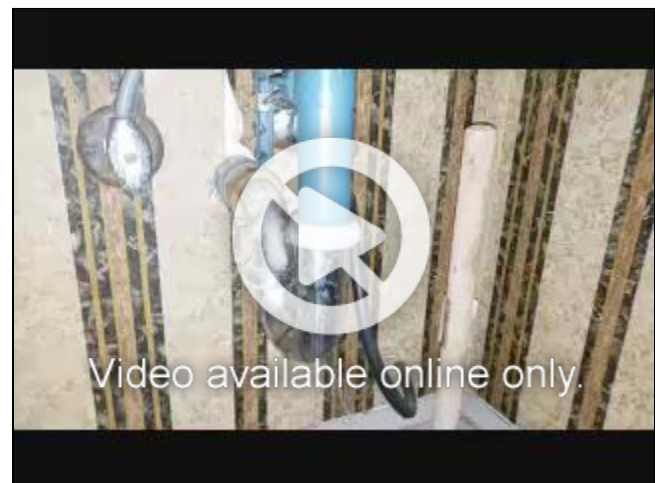
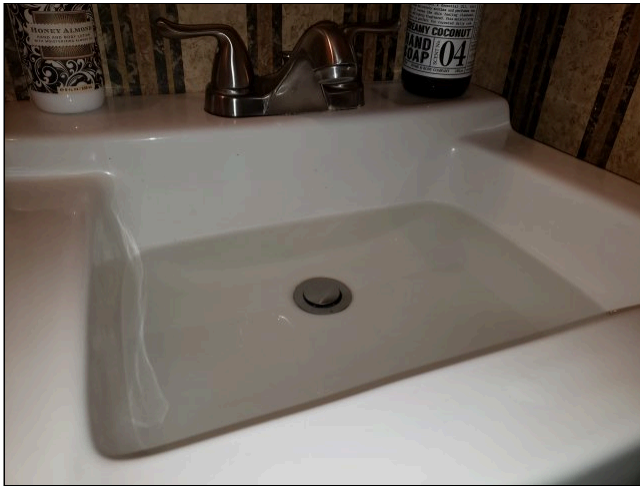
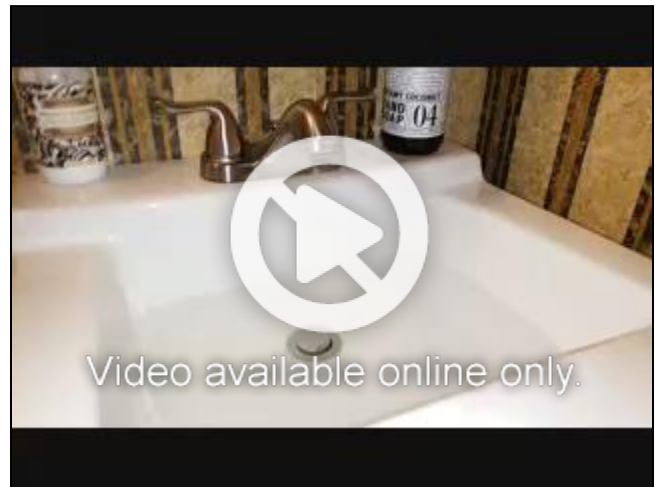
5.0.A SINK(S) Photo 1

●				<b>5.0.A SINK(S)</b> The drain was clogged and significant leakage was observed at the drain piping, have checked and corrected as needed by a licensed Plumbing Contractor.
	●					<b>5.1.A TOILET(S)</b> Aging toilet and flush hardware noted, anticipate periodic repair needs.
●						<b>5.2.A FLOOR(ING)</b>
●						<b>5.3.A WALLS / CEILINGS</b>
	●					<b>5.4.A VENTILATION</b> The cover for the exhaust fan is not properly secured to the wall, correct and maintain as needed.
	●					<b>5.5.A ELECTRIC / GFCI</b> There is no receptacle outlet present at this location. Recommend adding a GFCI protected outlet for added convenience.

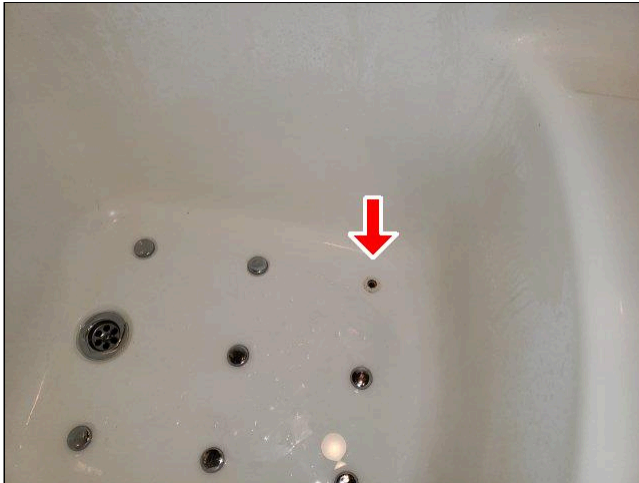
5.2.B(2) JETTED TUB(S) Photo 1

●					<b>5.0.B SINK(S)</b>
●					<b>5.1.B TOILET(S)</b>
	●				<b>5.2.B JETTED TUB(S)</b> (1) See note below regarding lack of GFCI protection at the pump for the Jetted Tub. (2) A cap / cover is missing from one of the jets, correct as desired.
●					<b>5.3.B SURROUNDS / ENCLOSURES</b>
	●				<b>5.4.B FLOOR(ING)</b> Carpeting not recommended in baths, recommend installing ceramic tile or vinyl flooring to avoid moisture related concerns. (such as mold/fungus growth)
●					<b>5.5.B WALLS / CEILINGS</b>
	●				<b>5.6.B VENTILATION</b> Aging fan noted; anticipate future repair or replacement needs.
		●			<b>5.7.B ELECTRIC / GFCI</b> The circuit for the Jetted Tub is not GFCI protected, have checked and corrected as needed by a licensed Electrical Contractor to ensure safety.

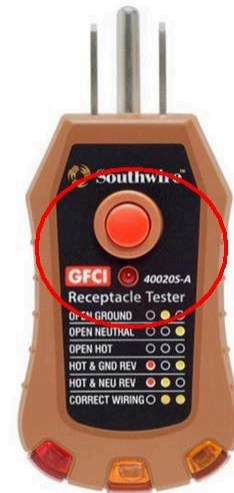
5.7.B ELECTRIC / GFCI Photo 2

power should go off when button is pressed

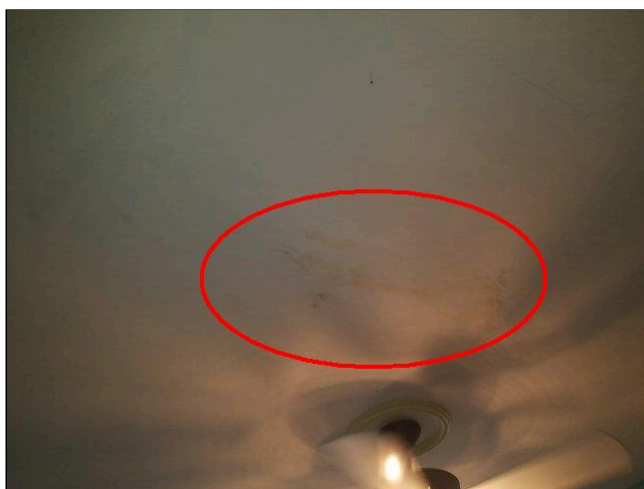
7.0(1) CEILINGS Photo 1

●				<b>7.0 CEILINGS</b> (1) Stains and minor damage noted in the 3rd FI rear BR and 1st FI Laundry Rm. Have conditions evaluated further and corrected as required by a licensed Contractor. (2) Otherwise, old plaster with typical cracking noted. Monitor conditions closely and maintain as needed.
	●			<b>7.1 WALLS</b> (1) Moisture stains noted in the 2nd floor Office below one of the HVAC wall units. Though this tested dry at the time of inspection, it is likely from condensation in the unit running down the wall. Recommend having conditions evaluated further and corrected as needed by a licensed HVAC Contractor. (2) Minor damage from prior leakage noted in the 2nd Floor Family Rm and 3rd FI front BR, have checked and corrected as required by a licensed Contractor. (3) Otherwise, old plaster with typical cracking and holes noted. Monitor conditions closely and maintain as needed.
●				<b>7.2 FLOORS (FRAMED)</b> (1) Typical stains and wear noted in the carpeting, correct and maintain as needed / desired. (2) Typical wear noted in the wood flooring, sand and refinish as needed. (3) Please Note: The Basement / 1st FI floors appear to be on a wood frame that is resting directly on or in close contact with grade. There does not appear to be a void / Crawlspc below these floors to allow for periodic inspections of the foundation and framing. As such, damage could occur and go undetected for long periods of time. In particular, termite damage could become a concern, and there is a potential that some hidden damage exists. Strongly recommend having a thorough inspection by a licensed Termite & Moisture Control Specialist performed prior to closing, having annual inspections performed by same, and having chemical treatments of the foundation performed every 5 yrs or as needed to mitigate these concerns.

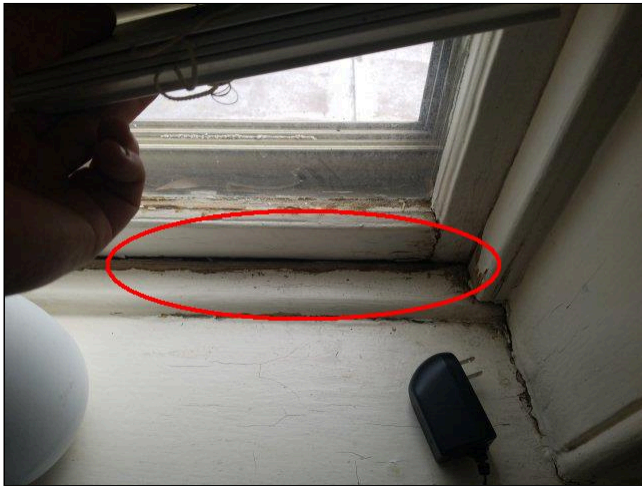
7.6(1) WINDOWS Photo 1

●		<b>7.3 FLOORS (SLAB)</b>
●				<b>7.4 STAIRS</b> Low headroom was noted at the stairs to the Basement / 1st FI, exercise caution.
●				<b>7.5 RAILINGS</b>
	●			<b>7.6 WINDOWS</b> (1) In addition to the concerns noted in the Exterior Section, stains from prior leakage noted in window sills at a few locations, and several windows were sealed / painted shut. Correct and maintain as needed to eliminate leaks and for proper function. In particular, the BR windows must be operable to allow for egress in an emergency. (2) Windows in stairs should be tempered by current standards, consider upgrading for improved safety.
●				<b>7.7 ROOM DOORS</b> (1) Cracks noted in several doors, correct as needed / desired. (2) Door at the top of the 1st floor stairs rubs its jamb, adjust as needed.

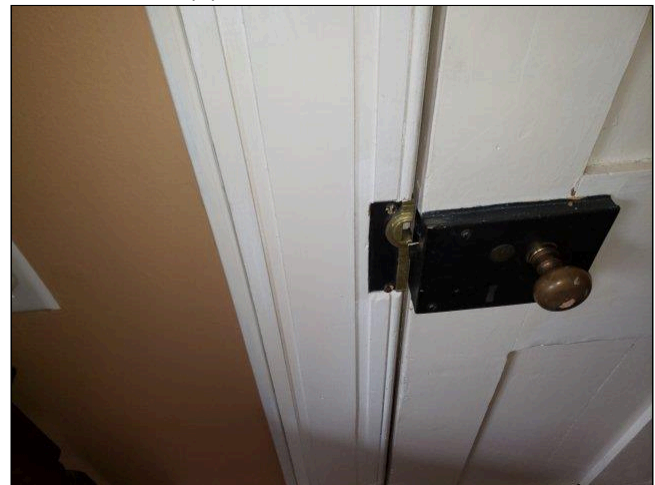
7.7(3) ROOM DOORS Photo 1

(3) The doors to the Basement Office and 3rd Fl Hall Bath do not latch, adjust as needed / desired.
		●			<b>7.8 DETECTOR TEST</b> (1) 4th Floor smoke detector is missing, replace as required. (2) Detectors do not meet current standards in terms of number and placement. Recommend upgrading the existing smoke detectors with combination smoke/CO alarms, and adding smoke detectors in each BR for improved safety and to comply with current standards.
		●			<b>7.9 FIREPLACE(S)</b> (1) Vent-free gas burner log sets is in place. Be sure to consult the manufacturer's operating instructions prior to use, and take all recommended safety precautions to reduce the risks associated with elevated levels of carbon monoxide from the burner exhaust. Recommend installing a CO alarm nearby for safety as well. (2) Fireplace trim in the 2nd Floor Family Rm has cracked / dropped. Correct as needed. (3) There are no spark arrestor screens or door assemblies present in a few locations, be sure to install prior to using fireplaces. (4) Please Note: The 1st Floor fireplace is only decorative at this time.

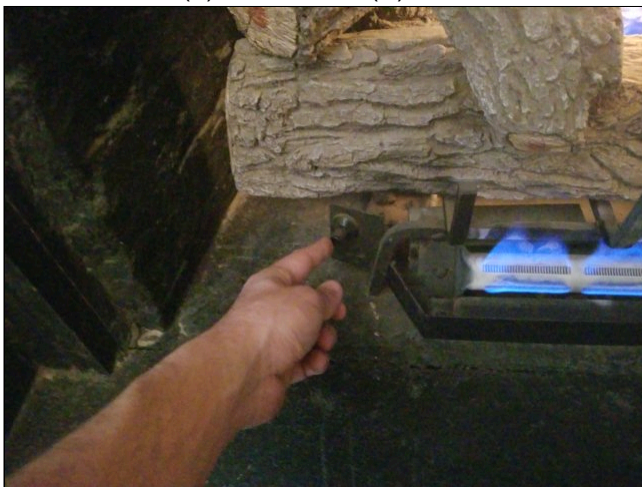
7.10(1) FIREPLACE GAS BURNERS Photo 1

●			<b>7.10 FIREPLACE GAS BURNERS</b> (1) The piezoelectric ignitor was inoperable at the logs in the Dining Rm at the time of inspection. Have corrected as needed by a qualified gas appliance specialist. (2) Recommend installing a CO alarm nearby for safety. See Vent-Free Fireplace note in Supplemental Info. (3) Gas log sets require periodic cleaning and maintenance. Check manufacturer's specifications, and have serviced as needed.

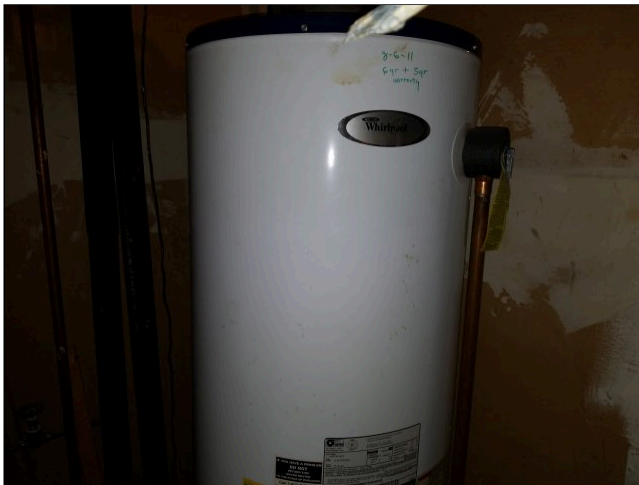
11.0 WATER HEATER(S) Photo 1

●					<b>11.0 WATER HEATER(S)</b> Unit nearing end of its design life, monitor and anticipate future replacement needs. (no signs of leakage or excess wear noted)
●					<b>11.1 VENT CONNECTOR(S)</b>
	●				<b>11.2 GAS / POWER LINES AT UNIT(S)</b> The drip / settlement leg is not turned the right direction (down) rendering it useless, correct as required to prevent debris from clogging the burner orifices.
●					<b>11.3 SAFETY VALVE PROVISIONS</b>
●					<b>11.4 OVERFLOW PAN</b>

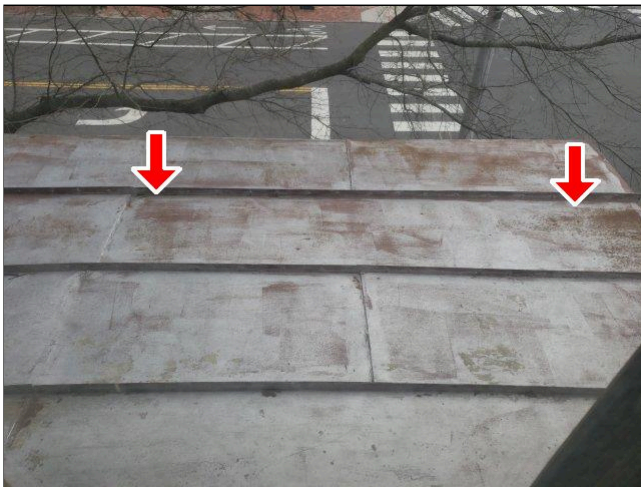
1.1 Photo 1

The metal roofing on both of the porches are aging. Metal roofing of this type can have a very long service life, but it must be re-sealed / coated with an appropriate fiber reinforced sealant. Have checked and re-sealed as needed by a licensed Roofing Contractor every 3-5 yrs.

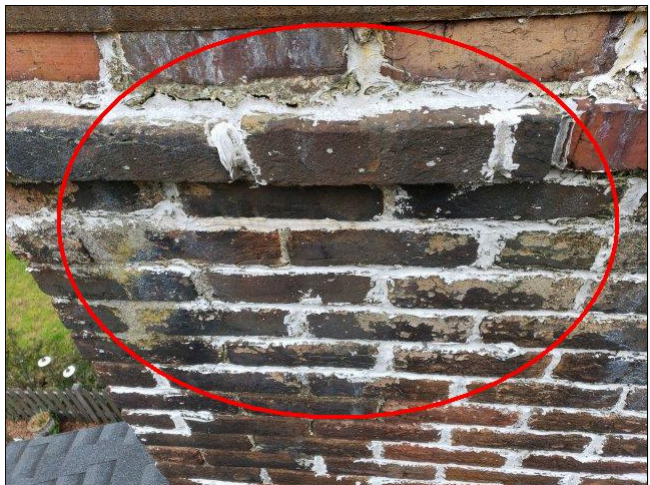
1.2 Photo 2

The chimney at the rear of the Slave Quarters appears to have been re-pointed with an improper type of mortar and/or caulk, which can lead to additional cracking and damage; the metal cap that was used to seal that chimney is rusting; and the parge coating that was added to the other two chimneys has cracked in a few locations. Inspection was limited to readily accessible and visible components. Recommend having more intrusive "Level 2" inspections performed by a (CSIA) Certified Chimney Sweep prior to the sale of the property.

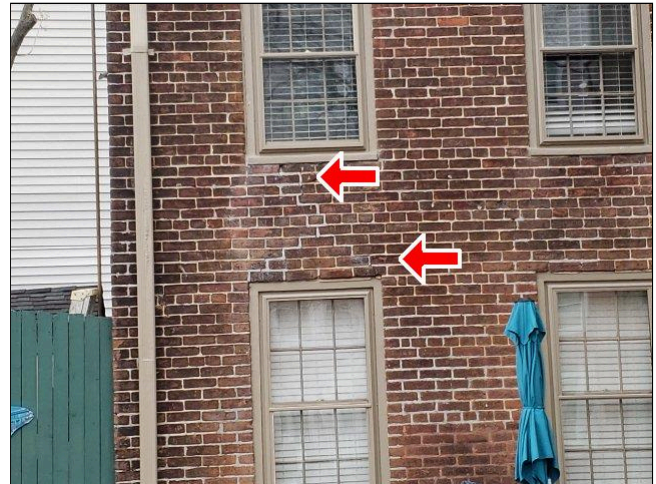
2.0 Photo 2

Settlement cracking is evident in the brick walls in a few locations, a few damaged bricks were noted as well. This is a relatively normal condition for a structure of this age. Have checked and re-pointed as needed by a licensed Masonry Contractor and anticipate periodic re-pointing needs.

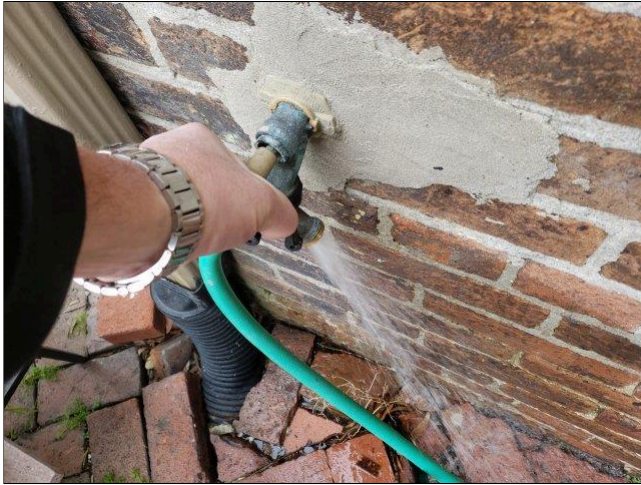
2.9 (1) The hose bib is defective / will not close, (water was being contained by the valves on the adapter that was added) have checked and corrected as needed by a licensed Plumbing Contractor.

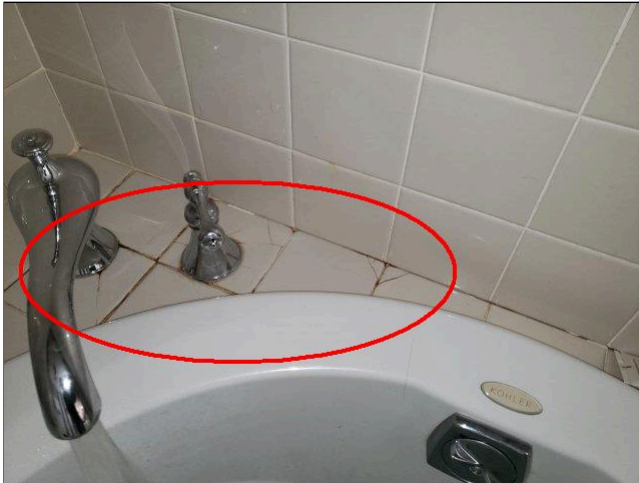
5.3.D Photo 1

Cracked and damaged tiles and grout were noted, correct and maintain as needed to prevent water intrusion into the walls and ceiling below.

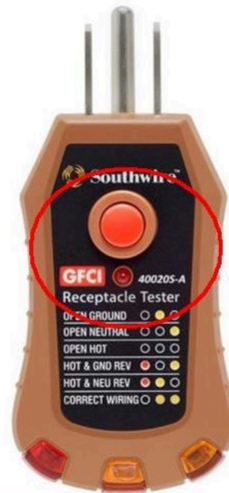
6.3.A (1) GFCI test failed at counter accessible outlets, and no GFCI units were observed in the Kitchen. (structure predates current requirements) Consider installing GFCI units for additional safety.

power should go off when button is pressed

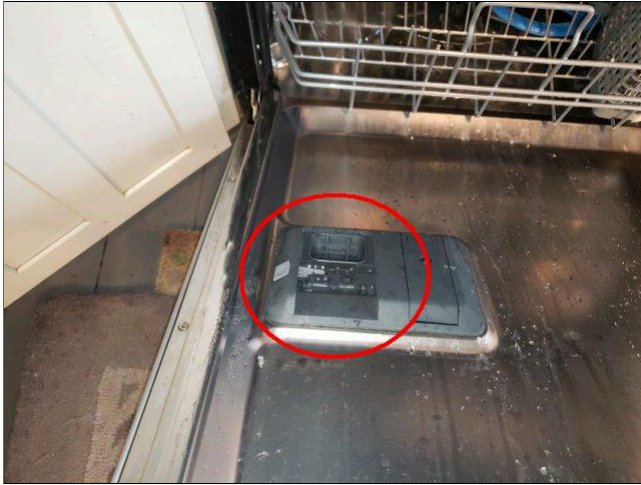
6.5.A (1) The soap dispenser compartment door is missing, replace as needed.

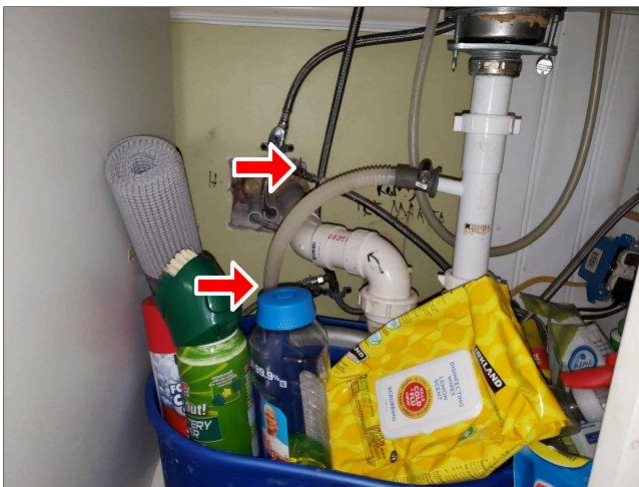
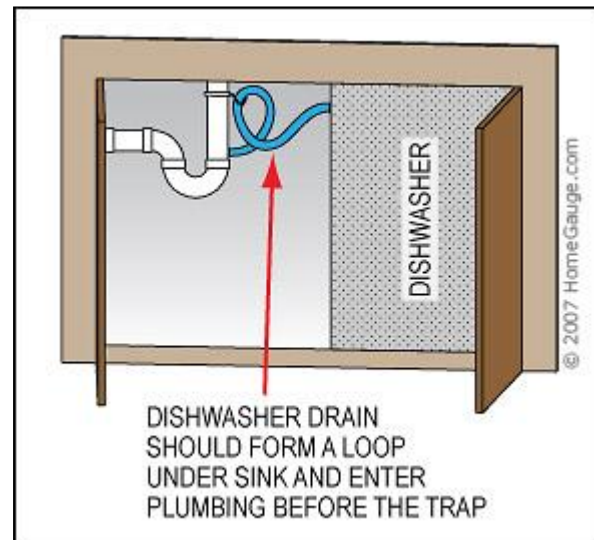
6.5.B (1) A "high loop" is not visible in the drain hose below sink. Having the dishwasher drain hose extend above the level of the sink drain forms a trap, and prevents sink waste from entering unit. Correct (move or strap hose) as required.

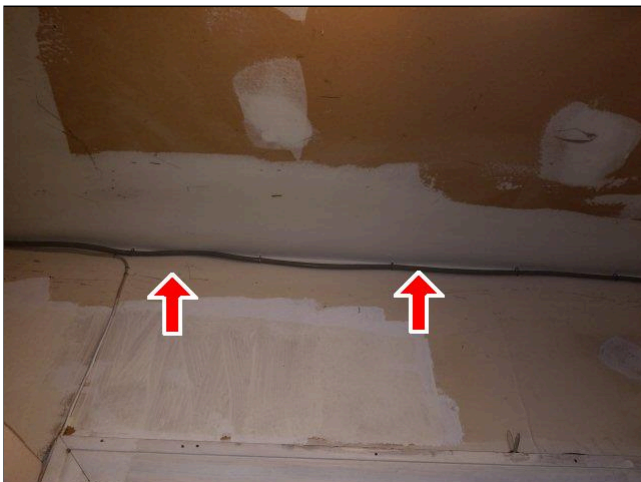
8.4 (3) Improperly exposed NM (aka Romex) wiring noted in the Utility Rm, in the Sheds, and in the Electrical Rm. Have placed in a protective conduit to reduce the potential for accidental damage by a licensed Electrical Contractor.

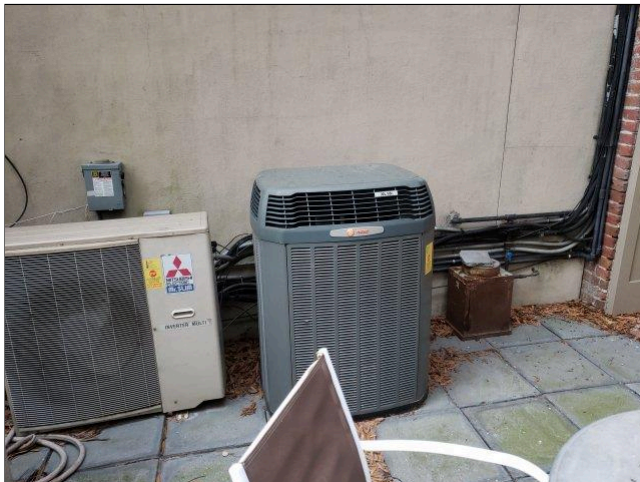
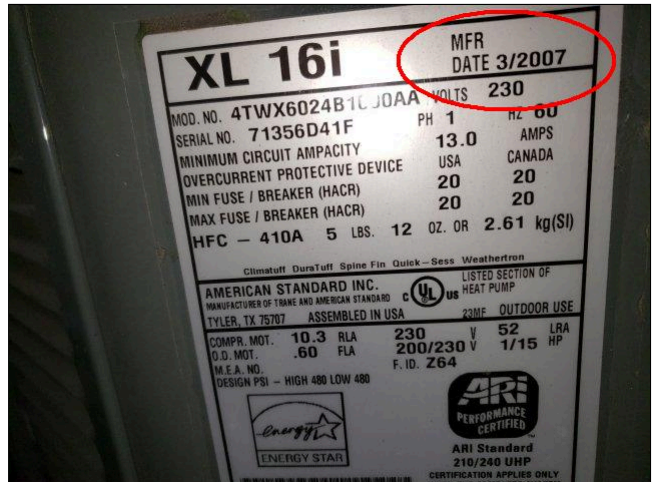
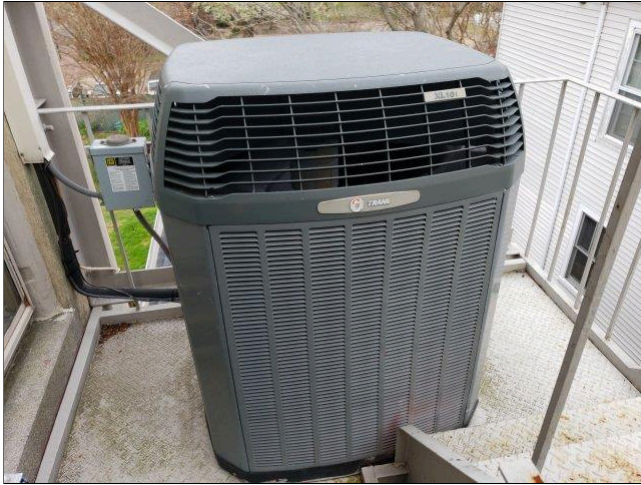
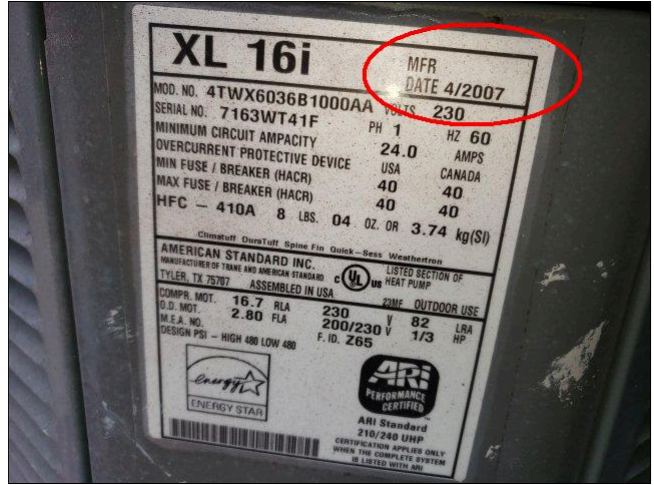
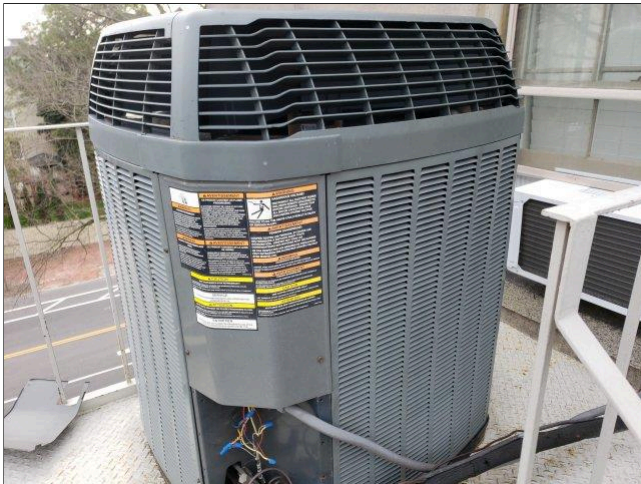
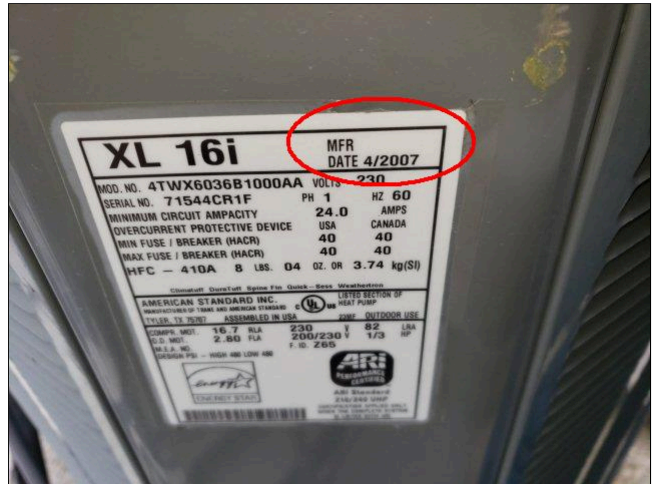
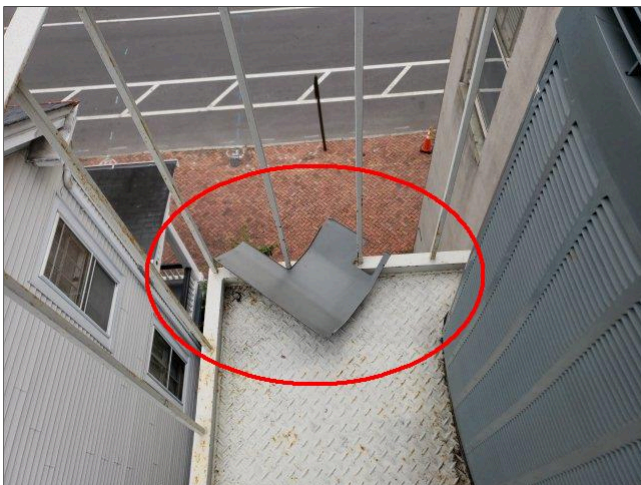
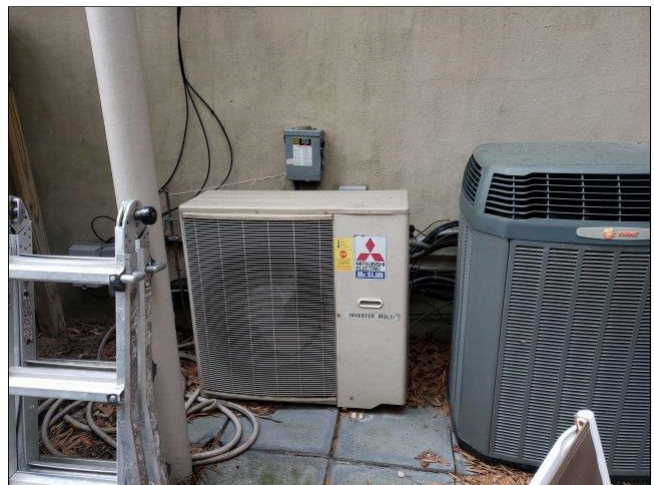
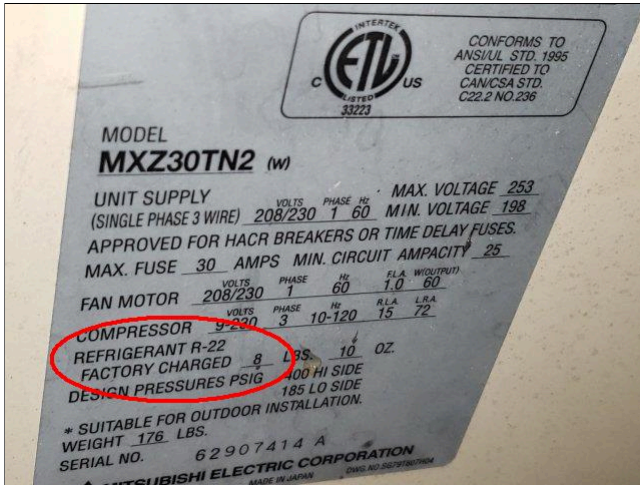
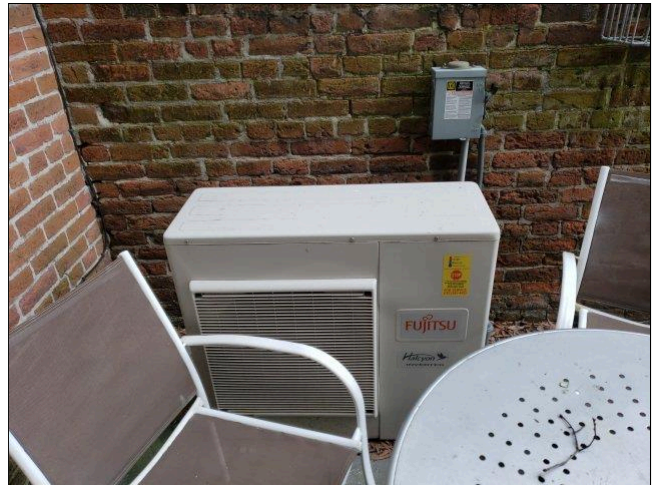
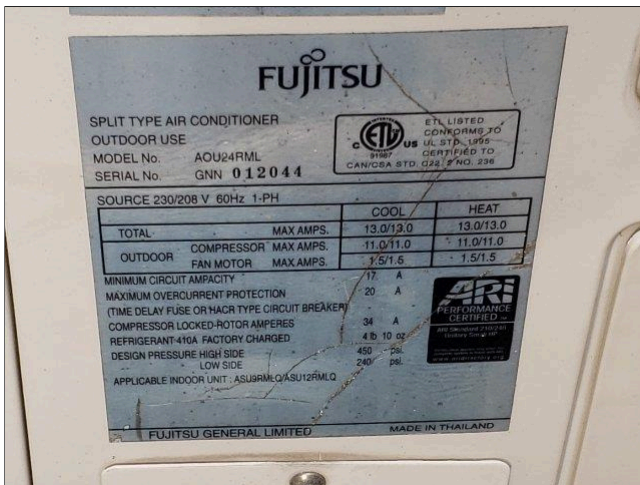
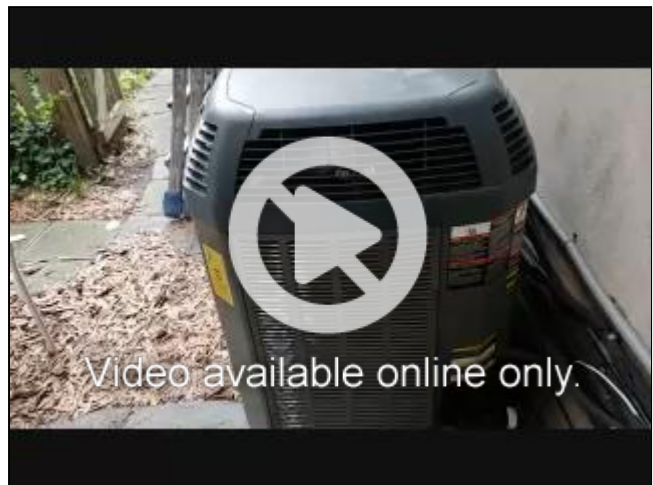
9.0 (1) Most of the systems were inoperable and/or defective at the time of inspection. Only the main system for the 2nd FI appeared to be functioning as intended. No temperature differential was detected between the high and low pressure refrigerant lines for the Basement and 3rd & 4th FI systems, the wall mounted Air Handler in the 1st FI BR was noisy at the time of inspection, as was the condenser for the main 1st FI system, and the cover was falling off the Air Handler in the main Kitchen. That system could not be operated as well, as the remote control for it was missing. Additionally, the cover panel to access the wiring compartment was off the outdoor unit for the 3rd & 4th FI system. All of the equipment appears to be at or near the end of it's intended service life as well. Have evaluated, serviced, and repaired as needed by a licensed HVAC Contractor, and plan for replacements.

See notes above and in the Exterior Section. (condensers on fire escape should be relocated when they are replaced)
