Report ID: 20033980-A / Asset Management

1.1 ROOFING #2

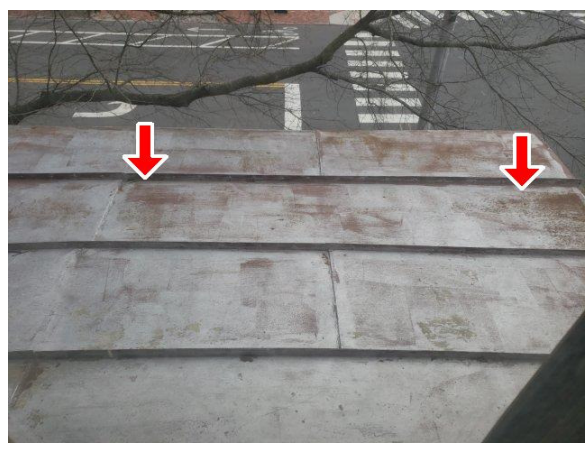
1.1 Photo 1

Fair

The metal roofing on both of the porches are aging. Metal roofing of this type can have a very long service life, but it must be re-sealed / coated with an appropriate fiber reinforced sealant. Have checked and re-sealed as needed by a licensed Roofing Contractor every 3-5 yrs.

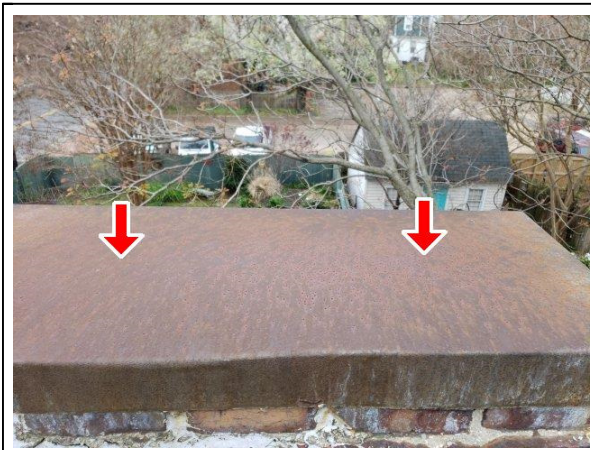
1.2 Photo 3

Poor/Defective

The chimney at the rear of the Slave Quarters appears to have been re-pointed with an improper type of mortar and/or caulk, which can lead to additional cracking and damage; the metal cap that was used to seal that chimney is rusting; and the parge coating that was added to the other two chimneys has cracked in a few locations. Inspection was limited to readily accessible and visible components. Recommend having more intrusive "Level 2" inspections performed by a (CSIA) Certified Chimney Sweep prior to the sale of the property.

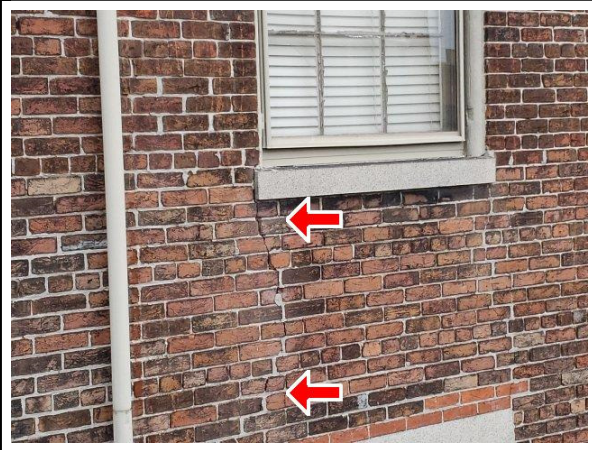
2.0 Photo 3

Fair

Settlement cracking is evident in the brick walls in a few locations, a few damaged bricks were noted as well. This is a relatively normal condition for a structure of this age. Have checked and re-pointed as needed by a licensed Masonry Contractor and anticipate periodic re-pointing needs.

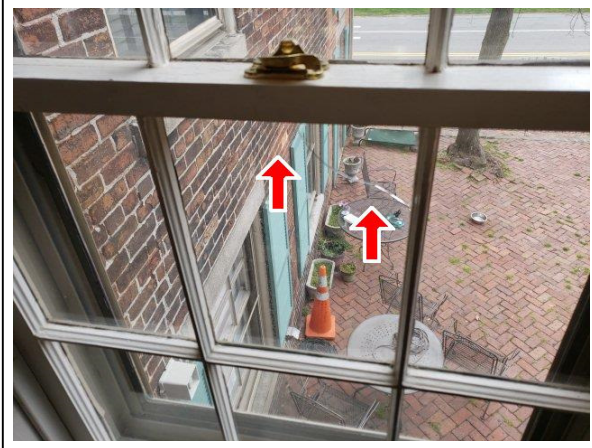
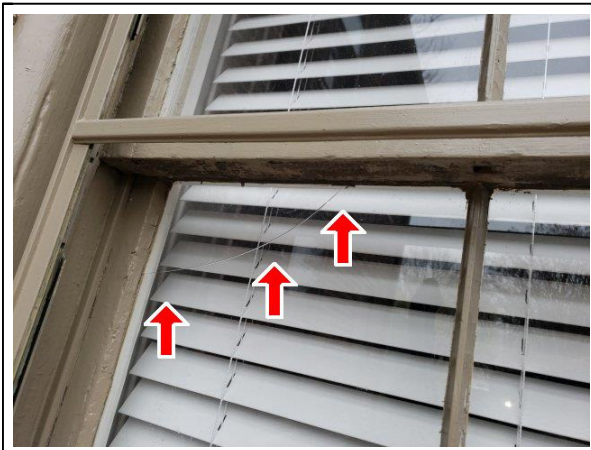
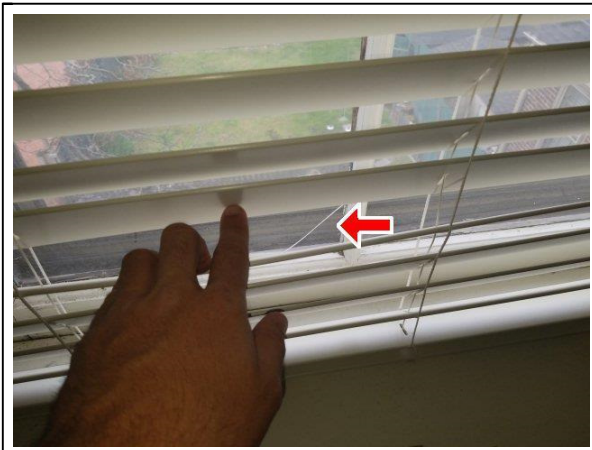
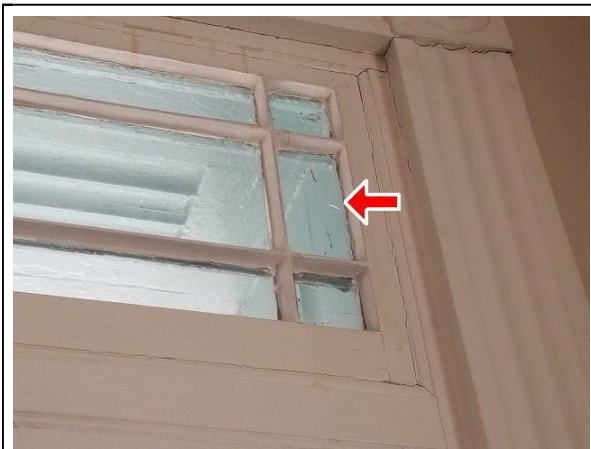
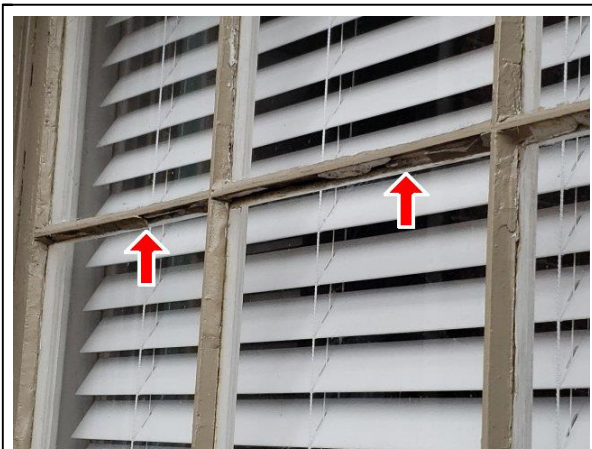
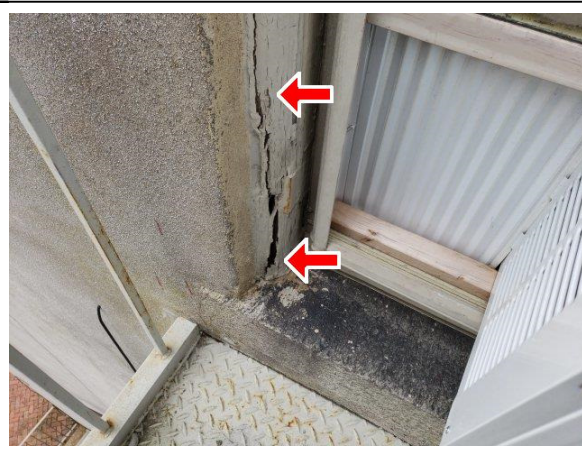
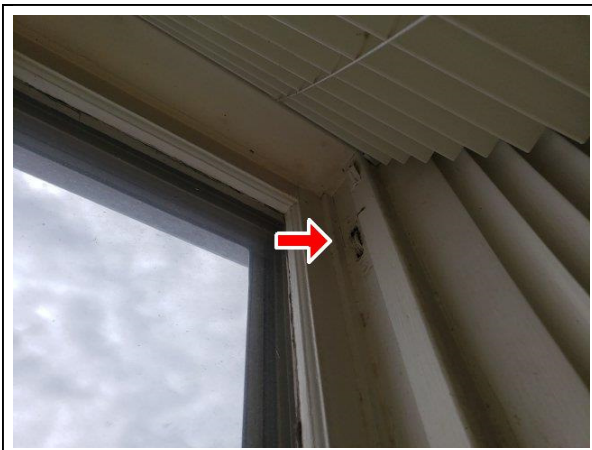
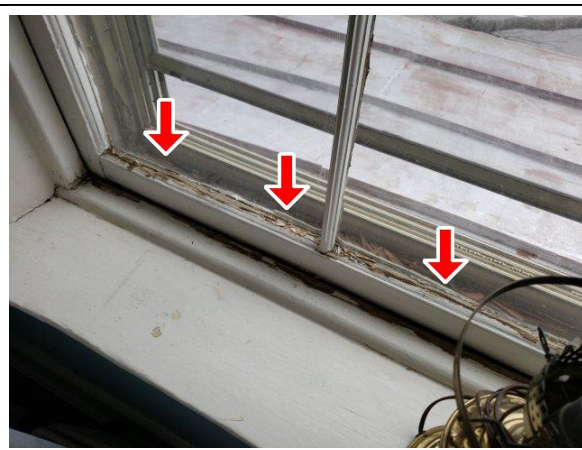
Poor/Defective

Cracked panes were noted at multiple windows, as was deteriorated paint and glazing; in particular, a portion of a pane is missing from a window at the rear 3rd FI BR; minor decay was found in the wood exterior trim in a few locations as well; and the sash cords are missing from many of the windows, making them inoperable. Have all of the windows checked and corrected as needed by a licensed Contractor.

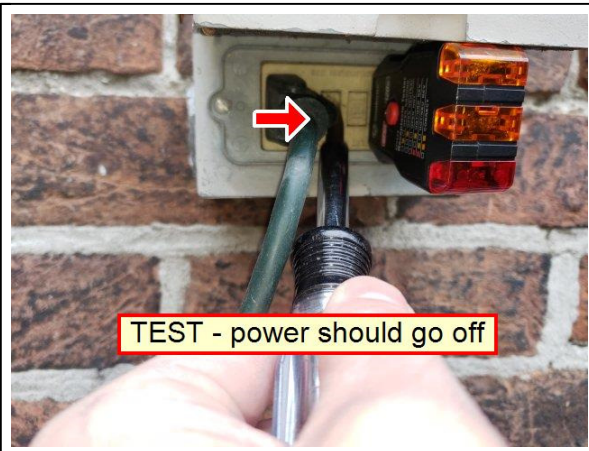
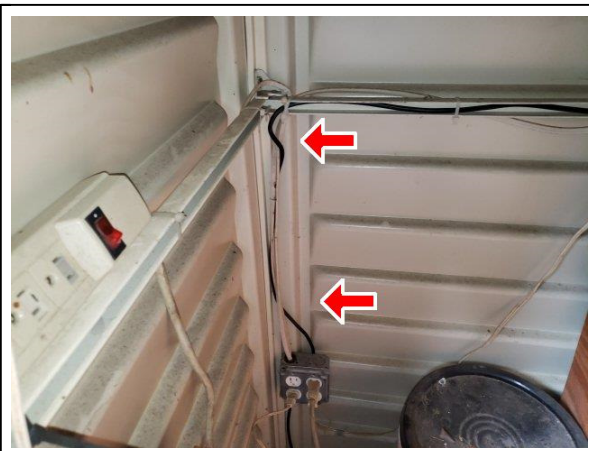
2.8 **ELECTRIC / GFCI**
Poor/Defective

No power was detected at the receptacle outlet on the front of the Slave Quarters; the GFCI on the rear of the main house is defective / will not test; the receptacle outlets in the Sheds and in the Electrical Rm are not GFCI protected; and improperly exposed cabling was noted in those locations as well. Have checked and corrected as needed by a licensed Electrical Contractor.

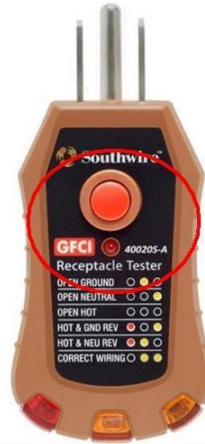
5.7.B Photo 2

power should go off when button is pressed

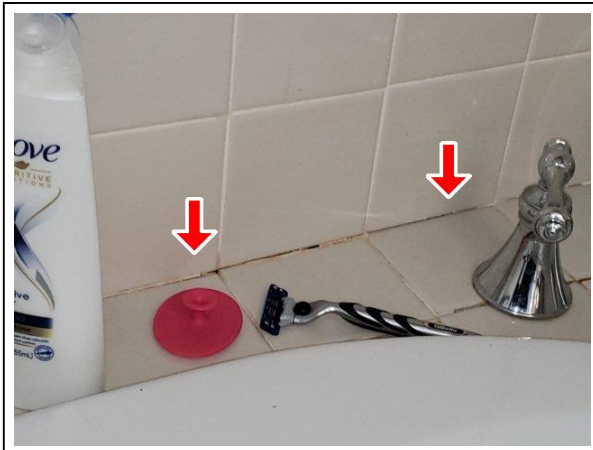
5.3.D Photo 2

Poor/Defective

Cracked and damaged tiles and grout were noted, correct and maintain as needed to prevent water intrusion into the walls and ceiling below.
