Re: **Asbestos Survey Update**
Site Name: Byrdstown
Cost Center No.: RFC024564
202 West Main Street
Byrdstown, Tennessee
Terracon Project No. 1816P079

Terracon Consultants, Inc. (Terracon) is pleased to present the results of the asbestos survey update of the Byrdstown bank branch located at the address above. The asbestos survey update inspection was conducted on June 22, 2016 by a trained and Tennessee-licensed asbestos building inspector in general accordance with our Task Order dated May 23, 2016 and the Master Services Agreement dated August 12, 2011.

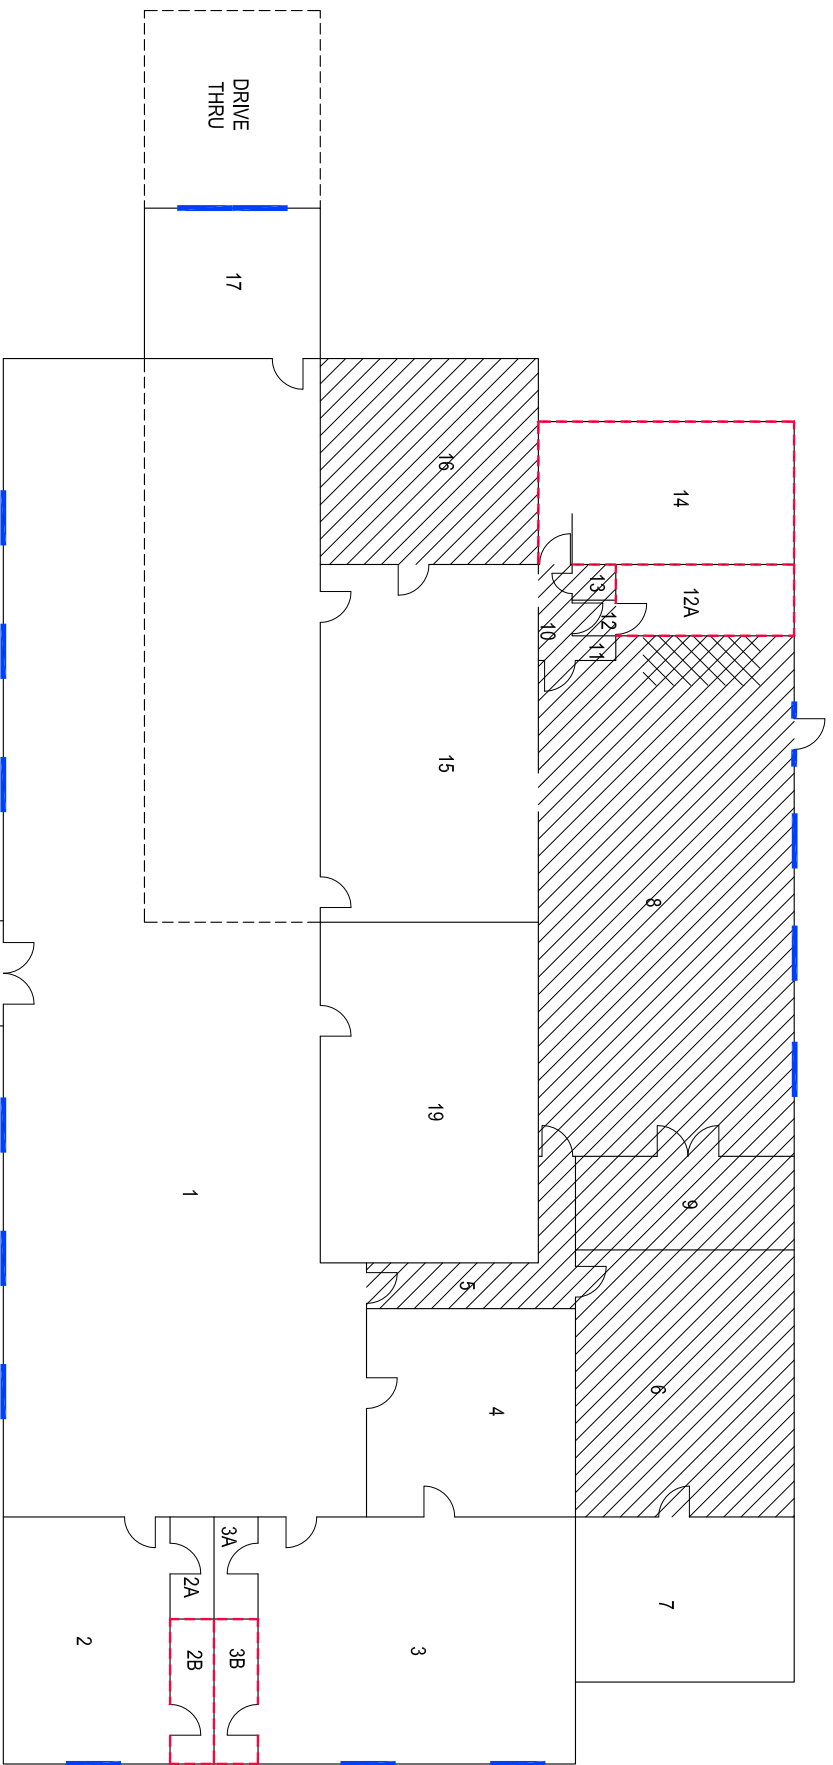
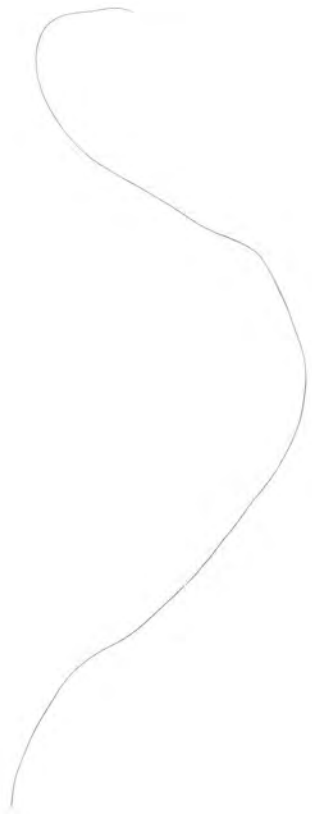
A Previous asbestos survey was conducted in October 2009 (Terracon Project No. 18097057) by Terracon. Asbestos was identified during the 2009 survey in the samples collected and analyzed from the 12"x12" vinyl floor tile and mastic located in rooms 5, 6, 8, 9, 10, 11, 12, 13 and 16, the sink undercoat in room 8 and the gray window caulk located on the building exterior. Assumed asbestos-containing ceramic tile floor and wall mastic was also identified in rooms 2B, 3B, 12A and 14. Per Regions' Corporate Asbestos Operations & Maintenance (O&M) Plan, a re-assessment was required.

12"X12" VINYL FLOOR TILE
-

OFF-WHITE WITH GREEN SPECS) WITH ASSOCIATED MASTIC
-

SINK UNDERCOAT (BLACK)
-

CERAMIC TILE WALL MASTIC WINDOW CAULK (GRAY)
